Short Investigation Bulletin

DATE: 4th January 2021
REPORT # AO-000268
AIRCRAFT REGISTRATION: C6-FLI
INVESTIGATION STATUS: Completed

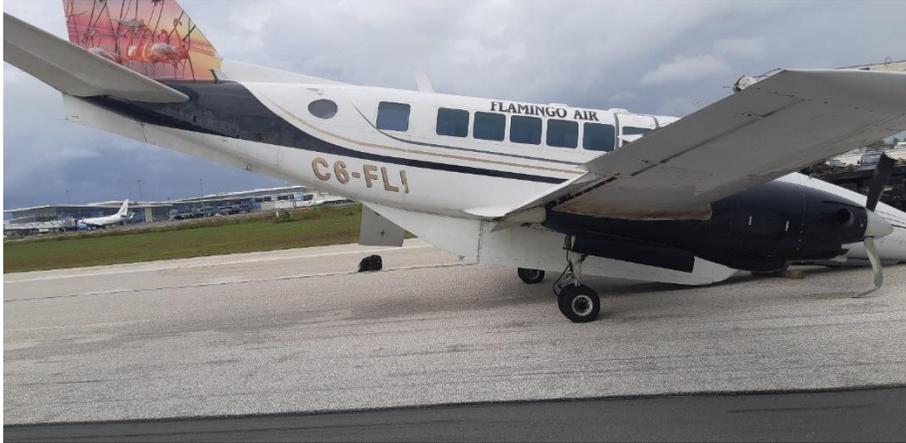
The weather at the time of the occurrence was visual meteorological conditions. No injuries were reported. The aircraft sustained damages to the nose landing gear, underside of the nose compartment, and both propellers.

Prior to removal of the aircraft from the runway surface, an inspection of the nose landing gear was conducted. It was noted that the nose gear actuator was unable to fully extend to allow the insertion of a mechanical down lock (fix metal bracket) to be installed, to allow for safe removal. The inability to safely lock the gear would indicate possible internal failure of the landing gear actuator.

The nose gear actuator was sent to APPH Wichita Inc. in Wichita, Kansas United States of America for overhaul. The report received from APPH Wichita Inc. presented evidence to support the initial inspection findings that the nose gear actuator had failed internally.
