Aviation Short Investigation Final Report

Occurrence involving
Israeli Aircraft Industries
Westwind – 1124A, Registration N790JR

**Treasure Cay, Abaco, Bahamas
5th July, 2021**

**AAIA Aviation Occurrence Investigation
Controlled Flight into Terrain
AO21-022**

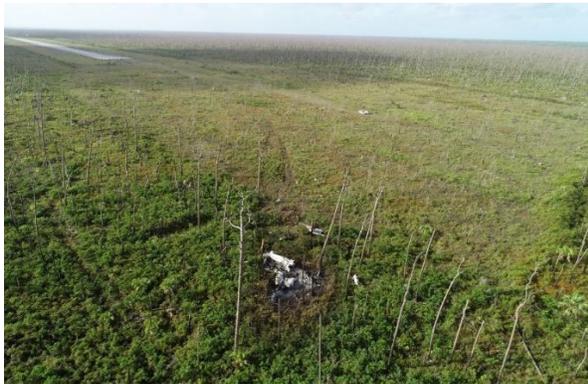
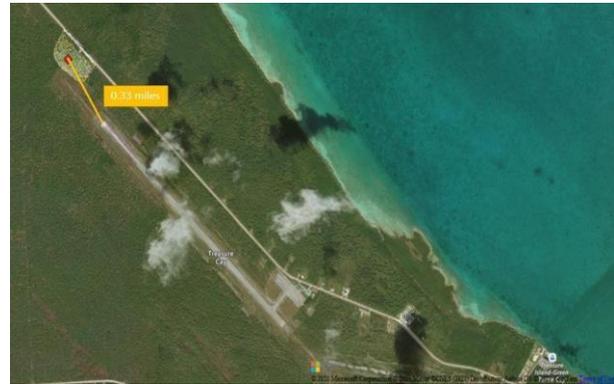
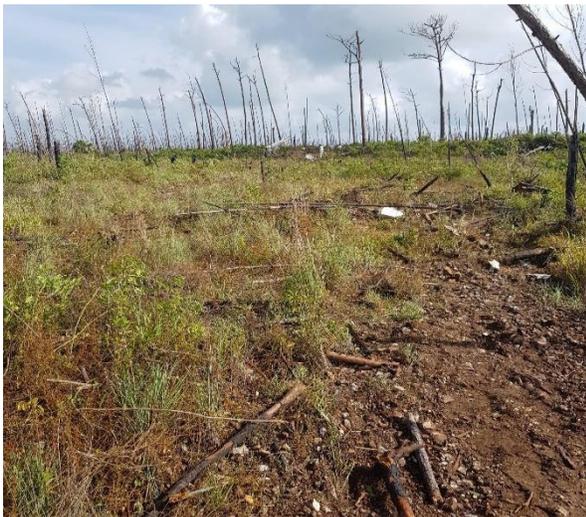
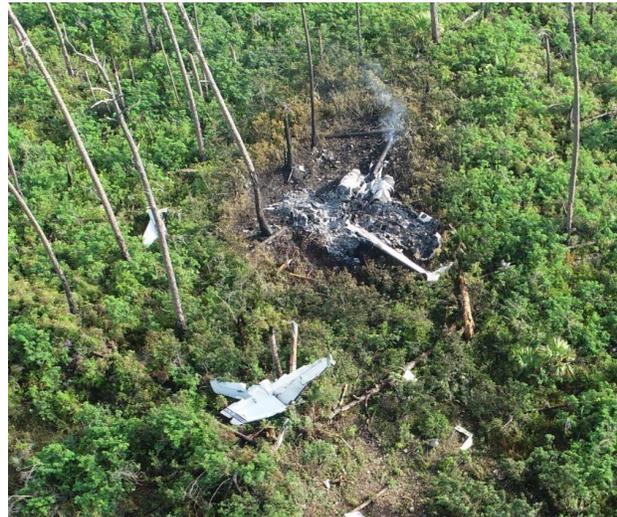
The aircraft landing gear left behind indentation on the surface of the ground about 60-80 feet from the threshold of runway 14. As the wing struck the approach lights, it created a hole in the left-wing, as evidence of fuel burn to the underbrush and fuel trail marks were evident and led to the crash site. Along its flight path, and closer to the mound that was struck, pine trees were dislodged, ground scarring was evident and pieces of aircraft and avionics from the flight deck and other debris were strewn about on the ground, leading up to the final resting place of the aircraft.

The tail of the aircraft which included the elevator, horizontal stabilizer, vertical fin and rudder (which control movements of the aircraft), was detached and lodged in between two pine trees, thereby separating the fuselage of the aircraft from the tail section.

During onsite inspection of the wreckage, there were still smoldering aircraft parts and components which hindered efforts to closely examine all components of the aircraft. A search was made for the Cockpit Voice Recorder and/or Flight Data Recorder (which would have revealed a more accurate account of what transpired) to no avail. All avionics and other components located in the aft section of the aircraft where recorders are housed, were all destroyed by impact and the post-crash fire. Most of the aircraft, with the exception of a few components and control surfaces that were strewn about, out of the direct path of the fire, was destroyed by the post-crash fire.

Photo 1: N790JR ground scars and post-crash fire at accident site
