Short Investigation Bulletin

DATE: 4th January 2021
REPORT # AO-20-000271
AIRCRAFT REGISTRATION: C6-KRC
INVESTIGATION STATUS: Completed

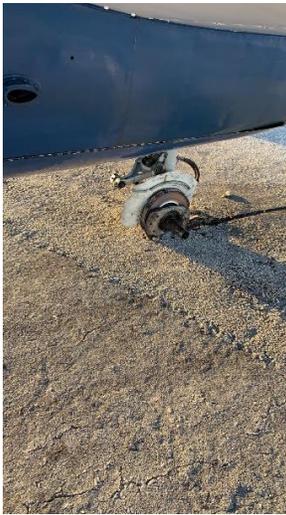
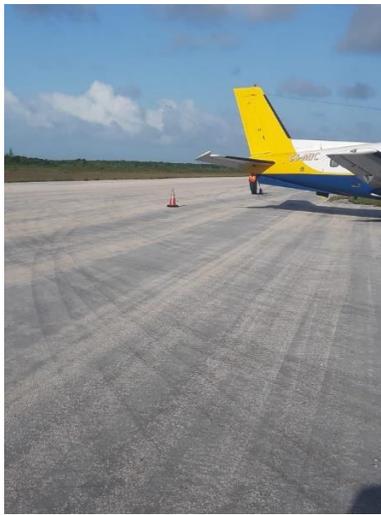
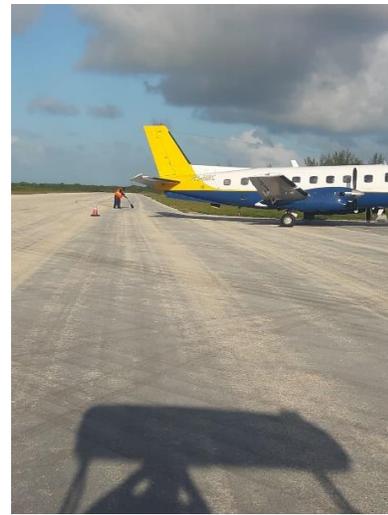
An Embraer E110 aircraft with Bahamas registration C6-MIC, also operated by the same Operator, was disabled after landing which prompted the closure of the aerodrome. The incident occurred at the turn off entrance into the ramp area (approximately 2,890 ft. from runway 07 threshold). The tail section of the aircraft (rudder and stabilizer) protruded onto runway 07 after the main gear tire detached from the left landing gear during landing roll-out.

Investigations uncovered that runway 07 received damages due to the rim of the left main landing gear of the disabled aircraft grinding into the runway surface. Remedial works to repair the runway were carried out by Ministry of Works personnel. A runway inspection was conducted at 10:12 AM after which ATC was notified that the aerodrome was now operational.
