## Accident Preliminary Report

<b>Location</b>	<b>Accident number</b>
Deadman's Cay Airport (MYLD), Long Island, Bahamas	OCC-2022/0018
<b>Date &amp; Time</b>	<b>Registration</b>
5 <sup>th</sup> June, 2022, 9:05 AM EST	N711JW
<b>Flight Conditions</b>	<b>Injuries</b>
Visual Flight Rules	4 Serious, 2 Injured (Extent Unknown), 1 Fatal

On June 5, 2022 at approximately 9:05am, a Piper Navajo aircraft with United States registration N711JW crashed moments after takeoff from the Deadman's Cay Airport (MYLD), Long Island, Bahamas.

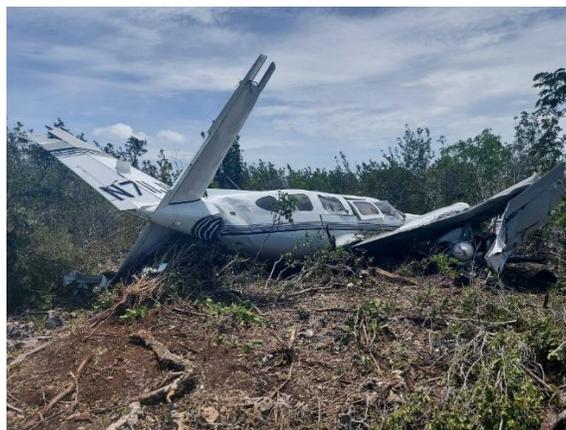
- The right wing of the aircraft appeared to have made first impact with the trees. Shortly thereafter, the fuselage of the aircraft and the left wing made contact with the ground and surrounding trees. The density and thickness of the trees in the area where the aircraft crashed, limited the distance the aircraft traveled after impact with the surface.
