N900DU Preliminary Occurrence Report

Release Date 8th March 2024

Location	Accident number
Lynden Pindling Int'l Airport (MYNN), Nassau, Bahamas	OCC-2024/0011
Destination	Registration
Hartsfield-Jackson Atlanta Int'l Airport (KATL), Georgia, USA	N900DU
Occurrence Date & Time	Serial Number
8 th February 2024 1:31 pm local (1831 UTC)	62779
Flight Conducted	Make/Model
Under Instrument Flight Rules	Boeing 737-900ER

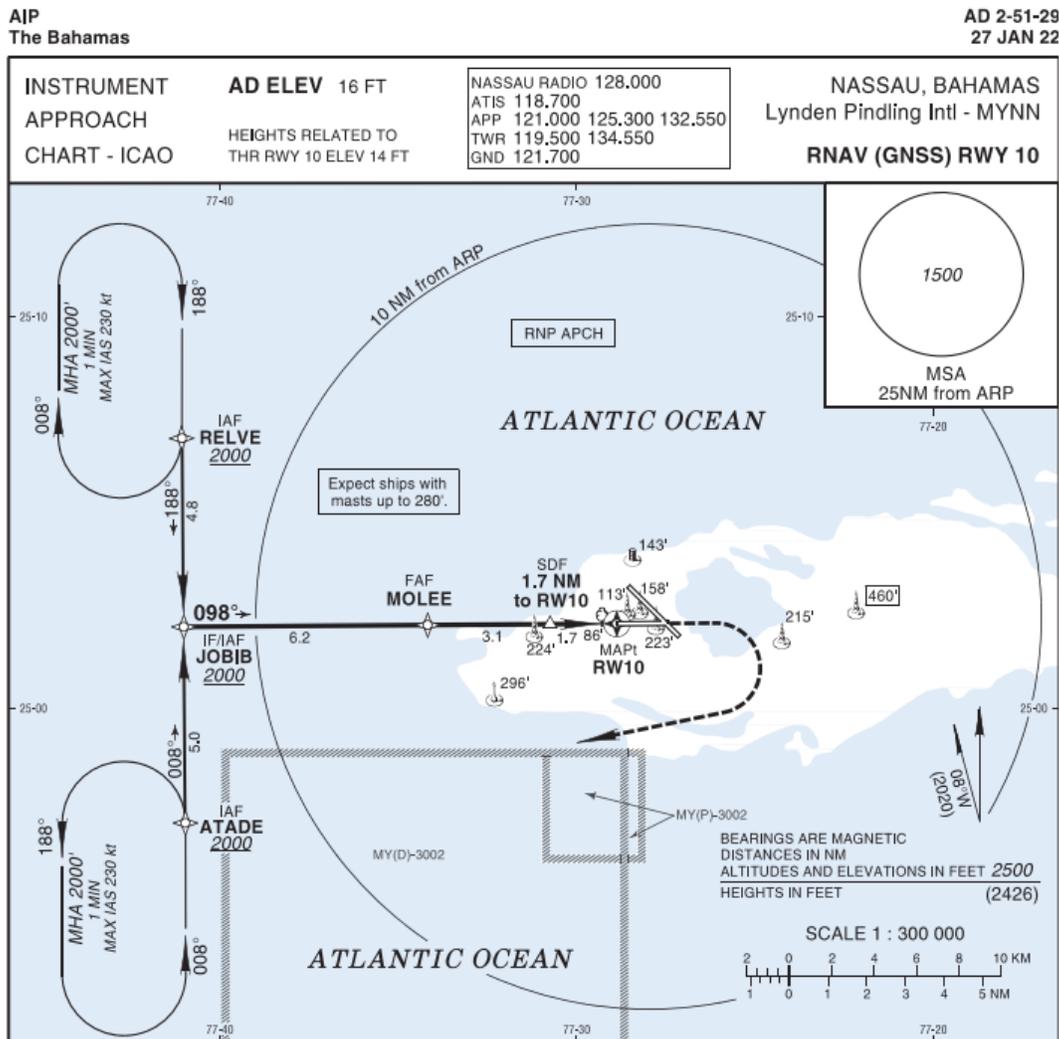
The next aircraft in sequence for landing runway 10 at MYNN, a Bombardier CRJ200 with Canadian registration C-GDTD, operating as FEX850, subsequently was forced to execute a go around at approximately 1:31 pm (1831 UTC) as the air traffic controller had not issued a landing clearance at the point of the aircraft reaching the missed approach point (as identified by “MAPt” on figures 1 and 2).

Fig.1 Plan view of Instrument Approach Procedure (RNAV Runway 10) at MYNN showing MAPt

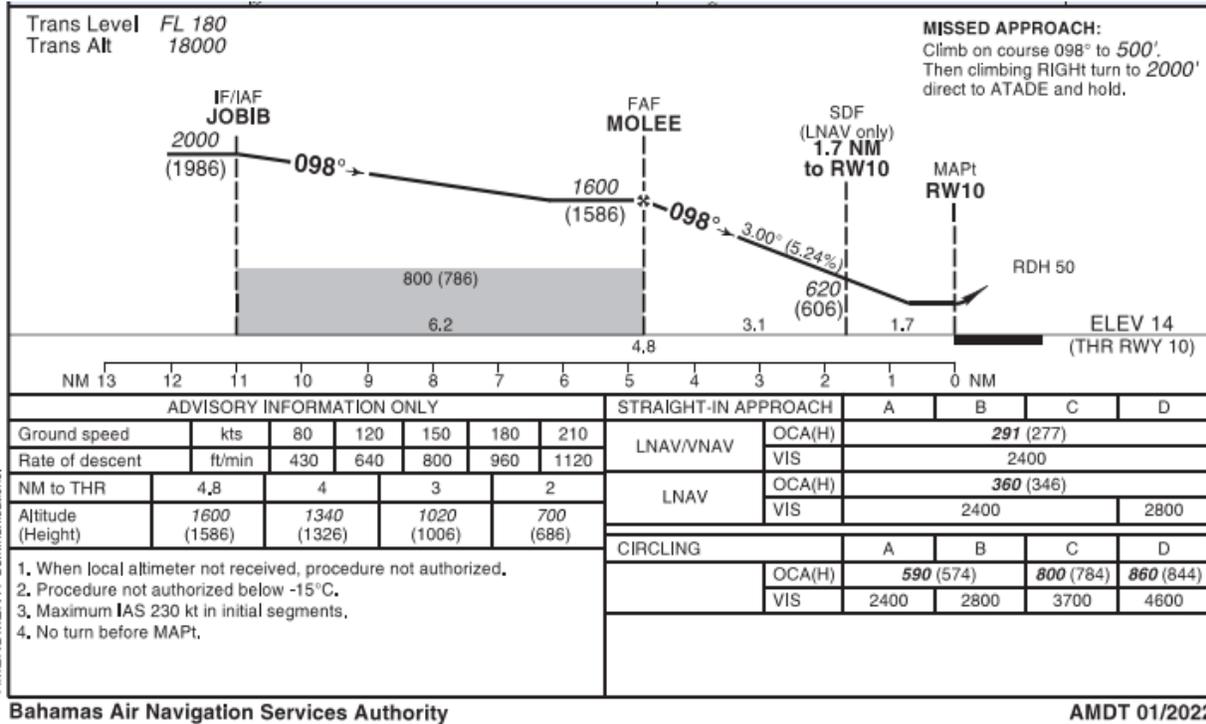
Fig.2 Profile view of Instrument Approach Procedure (RNAV Runway 10) at MYNN showing MAPt

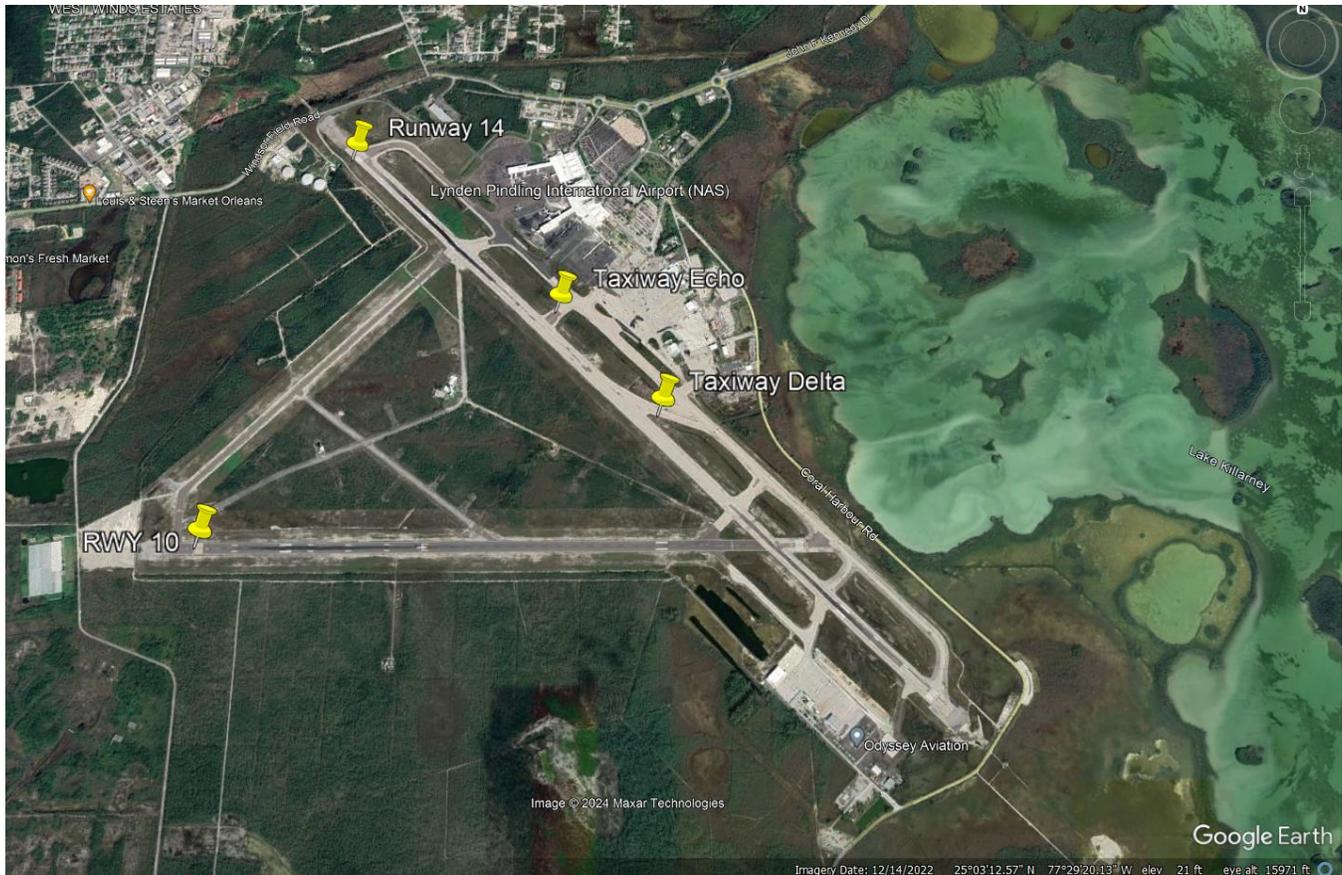
A witness account from a passenger on board the aircraft indicated that the abrupt braking maneuver resulted in several of the overhead bins becoming opened. The pilots were able to bring the aircraft to a stop and exited the runway at taxiway Echo (see figure 3 below).

Fig. 3: MYNN Aerodrome showing N900DU exit point at Taxiway Echo after aborted take-off
