Short Investigation Bulletin

DATE: 25th January 2021
REPORT # AO-20-000270
AIRCRAFT REGISTRATION: C6-MIC
INVESTIGATION STATUS: Completed

Aircraft Type and Registration:	Embraer 110; C6-MIC
Year of Manufacture & Serial #:	1982; 110-407
Number and Type of Engine(s)	Two; Pratt & Whitney PT6A-34
Type of operation:	Commercial
Information Source:	Field Investigation
Nature of Damage:	Left main wheel

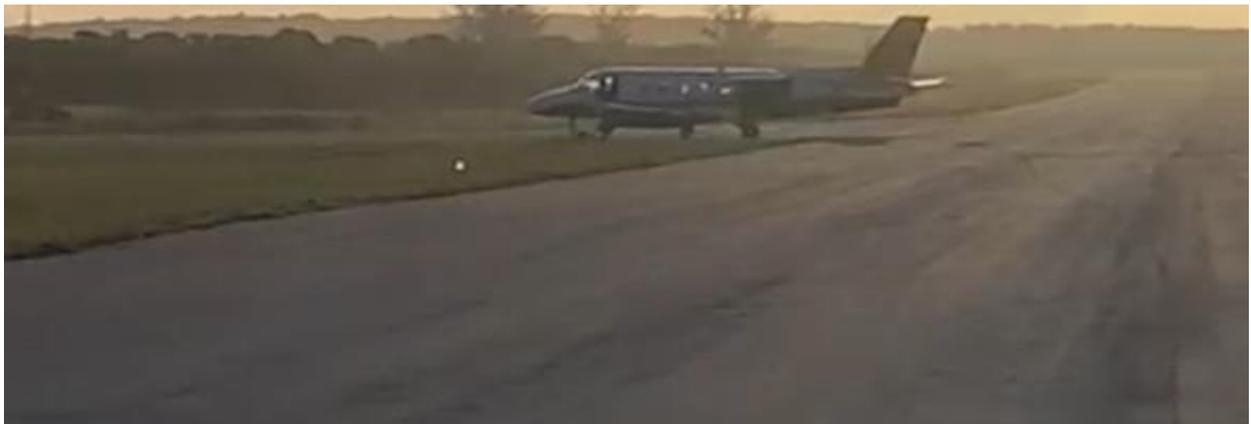
The aircraft sustained minor damages to the left main axle assembly and brake disc. The main wheel assembly, bearings, nut, lock pin could not be located after the landing. It is possible these parts/components could have been detached and lost somewhere on the runway environment after touch down.

Post incident evaluation by company personnel was not able to determine whether the locking pin used to secure the main wheel onto the left landing gear axle was installed. Additionally, there were no signature marks, found on the axle to point to a bearing failure, a fatigued washer or a faulty nut.
