Short Investigation Bulletin

DATE: 1st March 2023
REPORT # OCC-2023/0005
AIRCRAFT REGISTRATION: N5982Y
INVESTIGATION STATUS: Completed

Aircraft Type and Registration:	Piper Aztec PA-23-250/ N5982Y
Year of Manufacture & Serial #:	1966 S/N 27-3155
Number and Type of Engine(s)	Twin Lycoming, TIO-540 Series
Type of operation:	Private
Information Source:	Notification
Nature of Damage:	Right wing, cabin door

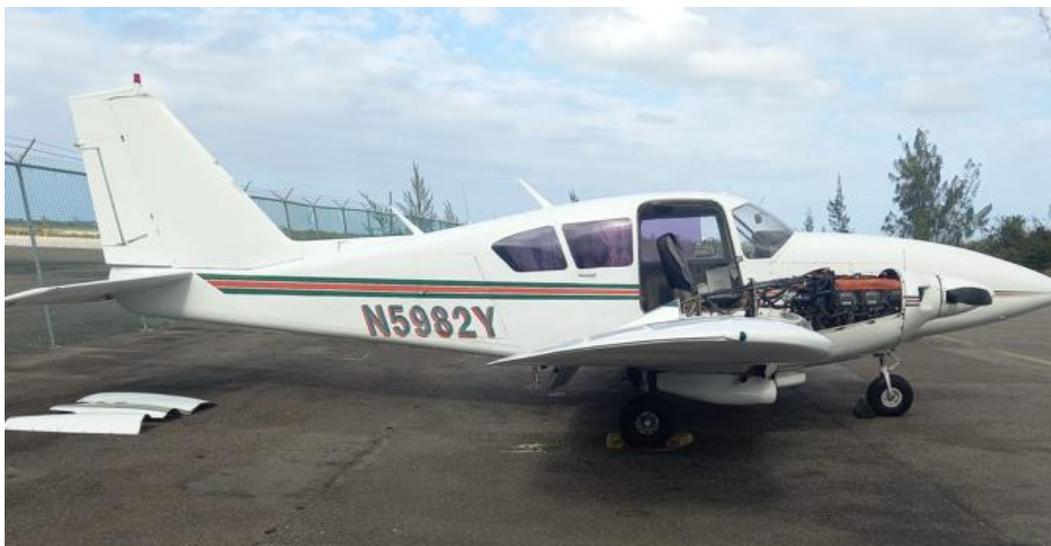
It was reported by the pilot that shortly after departure from MYNN, and while at an altitude of approximately 2,000 feet AGL, he observed that a hinge on the main cabin door had broken loose. With the force of the oncoming air now exerting pressure on the unsecured cabin door, it eventually blew open, becoming detached from the fuselage.

The aircraft sustained damage to the right wing and main cabin door area. There were no injuries reported.

During the AAIA's investigation into this occurrence, no evidence was provided to demonstrate that preceding the event, the aircraft was maintained in accordance with applicable State of Registry (United States of America) regulations and requirements, specifically Title 14 US Code of Federal Aviation Regulations Part 91.409 *Inspections* (a) 1.

Fig. 1 Photo of N5982Y at MYNN after occurrence

As a result, the AAIA communicated a safety concern to the United States Federal Aviation Administration (FAA) on 21st February 2023, who advised that as the State of Registry, it will enhance collaboration with the Bahamas via the Civil Aviation Authority of The Bahamas (CAA-B) to mitigate the future occurrence of such events.
