Short Investigation Bulletin

DATE: 9th April 2021
REPORT # AO-21-000005
AIRCRAFT REGISTRATION: N75392
INVESTIGATION STATUS: Completed

Aircraft Type and Registration:	Piper PA-28-140, N75392
Year of Manufacture & Serial #:	1976; 28-7625217
Number and Type of Engine(s)	One; Lycoming 0320-E3D
Type of operation:	Private
Information Source:	Field
Nature of Damage:	Left and right wing detached, stabilator, underside of fuselage

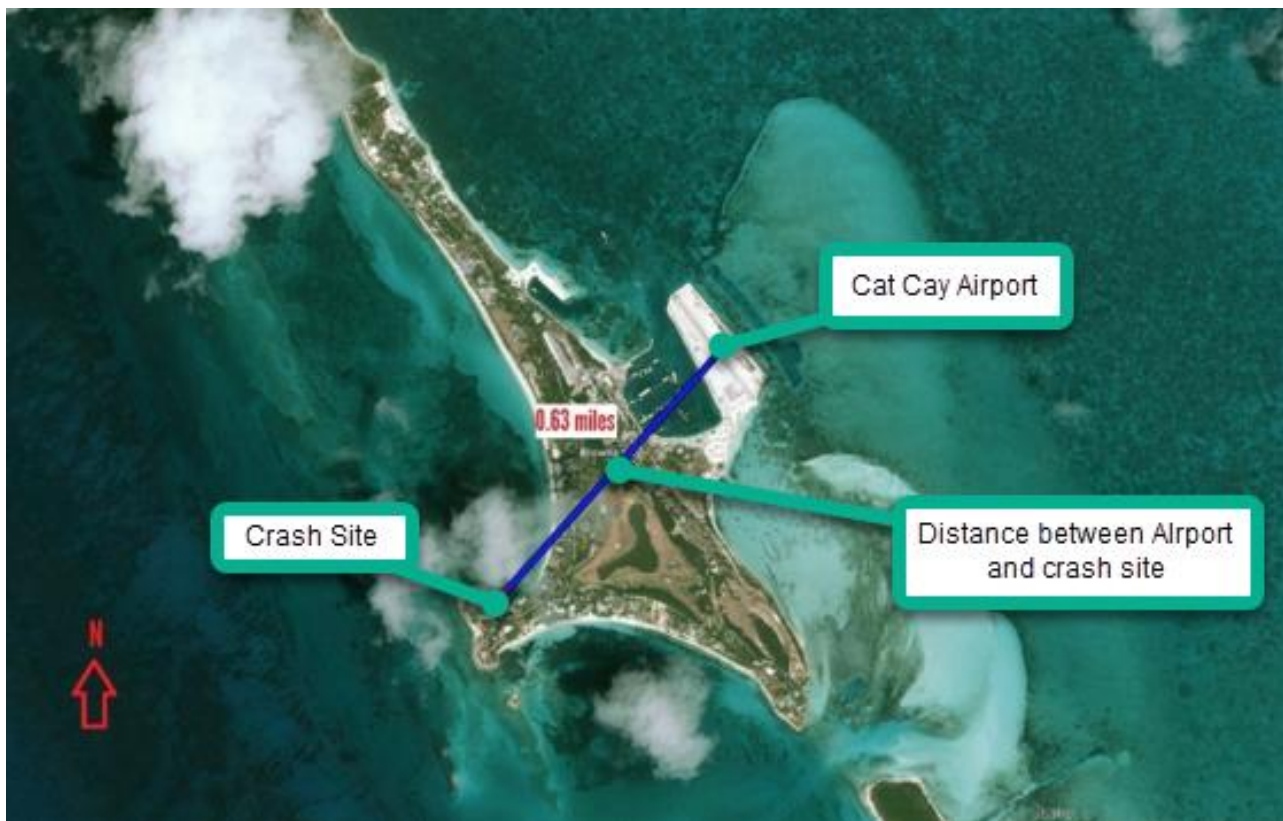
Fig. 1 Aircraft accident site and Cat Cay Airport (MYCC), Bimini, Bahamas

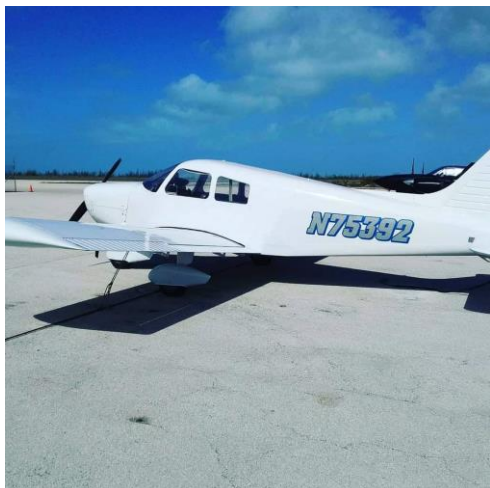
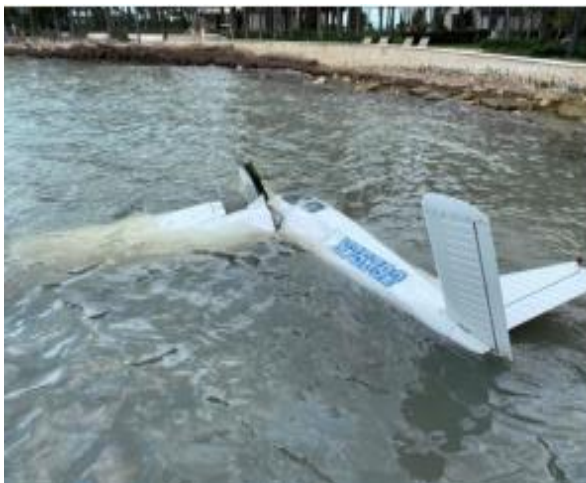
Noted damages to the aircraft were confined to the propeller, the left and right wings (detached), the stabilator and the underside of the fuselage.
