AIRCRAFT ACCIDENT FINAL REPORT
AAIA# AO-20-000282

Loss of Control Ground (LOC-G)

Embraer EMB-145LR
N674RJ American/Envoy Flight 4194
Grand Bahama International Airport
Freeport, Grand Bahama, Bahamas

24th October 2020

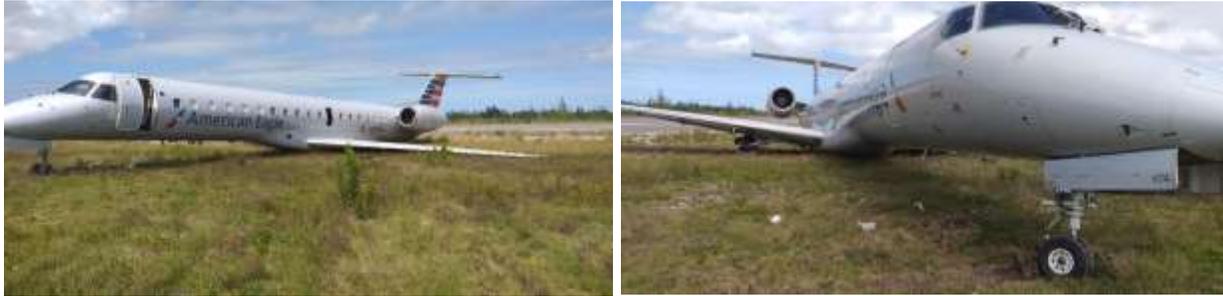
Assessment of the aircraft in the aftermath of the occurrence identified substantial damages to both wings, center fuselage, and the right, left, and nose landing gears.

Below is a listing of aircraft parts that received damages as a result of the occurrence:

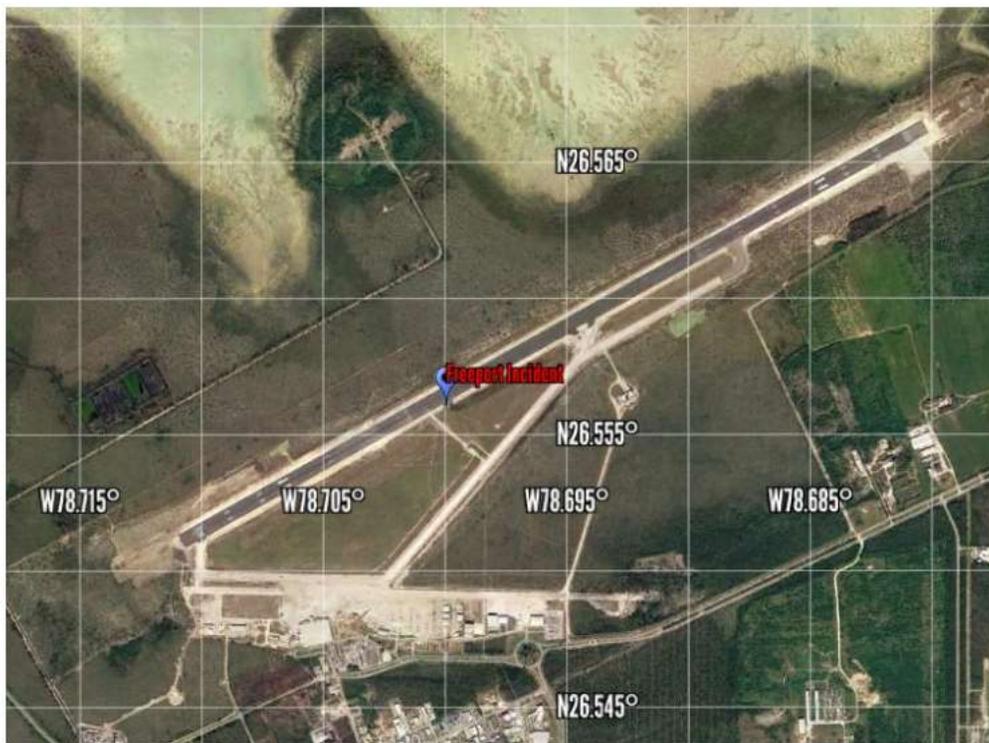
Fig. 5 Position of N674RJ at the Grand Bahama International Airport

At a distance of approximately 2,478 ft from the threshold of runway 06, aircraft signature markings shifted significantly to the right of runway centerline and continued along that trajectory. The aircraft exited runway 06 and came to rest at a distance of approximately 3,715 ft. from the threshold of runway 06. The tail section of the aircraft was the most exposed to the active runway as it came to rest approximately 15 ft. from the runway's edge. Significant rubber markings from both main landing gear tires were noted on the runway from the point of touchdown to the point of runway excursion.

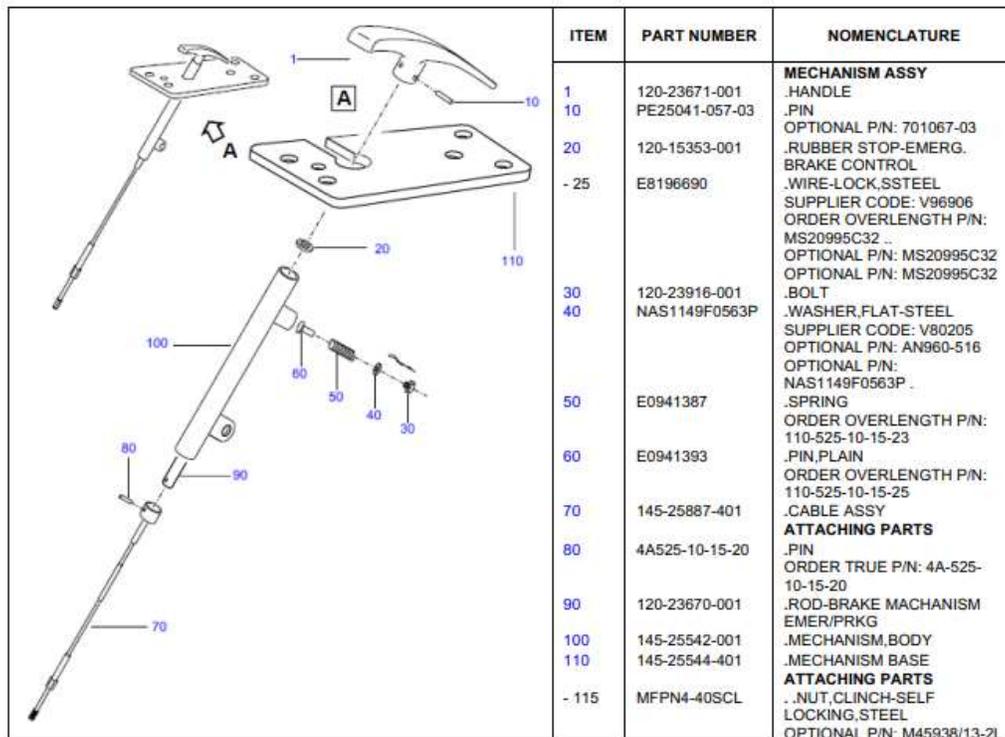
Fig. 6 Parking Brake Handle and Cable subset parts

Housing: external appearance looks good and no signs of inadequate removals were noticed. There were still some signs of the original graphite-based oil used to lubricate the moving parts.

Steel cable integrity: visual check and cloth test revealed no identifiable wearing, nor loose strands.

Missing part: [20] Part Number: 120-15353-001- RUBBER STOP-EMERG. BRAKE CONTROL could not be found. It provides a resilient seat to avoid vibration, and its absence does not affect the operational properties of the subset.

Removing the lock wire and the bolt [30], it was possible to get access to the guiding mechanism parts, pin [60] and spring [50]. Both pin and spring were found broken, probably due to the handle [1] being pulled misaligned to the body. From the wearing signs, this damage was judged as not recent. Nevertheless, even this damage presented no contribution for jamming the axle. Although damaged, the assembly was still functional, still guiding the L-shape slot and keep the movement in its desirable limits, as broken parts were kept in position.

As per the visual analysis and the tests performed, this subassembly was still operational, even with the damage noted to some of its parts/components; no scenario could be created that would point to this subassembly as contributing to the reported event, due to any potential malfunction.

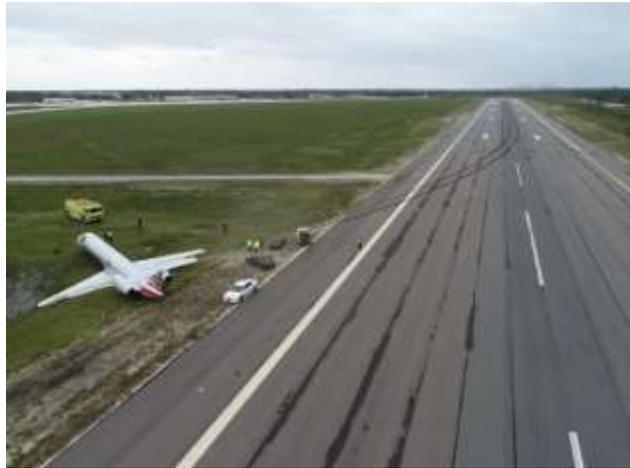
Fig.7 N674RJ tire signature markings on runway

Heavy braking signature marks are indicative of possible brakes being engaged at the point of landing and throughout rollout, up to the point of runway excursion.

As a result of evidence of heavy brake signature markings, additional analysis were conducted of several components related to the braking system of the aircraft, which were suspected of being contributory to the accident.
