Aviation Short Investigation Final Report

System Component Failure – Powerplant
(dual) (SCF-PP)
Cessna 402B, N145TT

**Near Chub Cay, Berry Islands, Bahamas
5th January 2022**

**AAIA Aviation Occurrence Investigation
Report # OCC-2022/0001
Date of Final Report – 22nd August 2022**

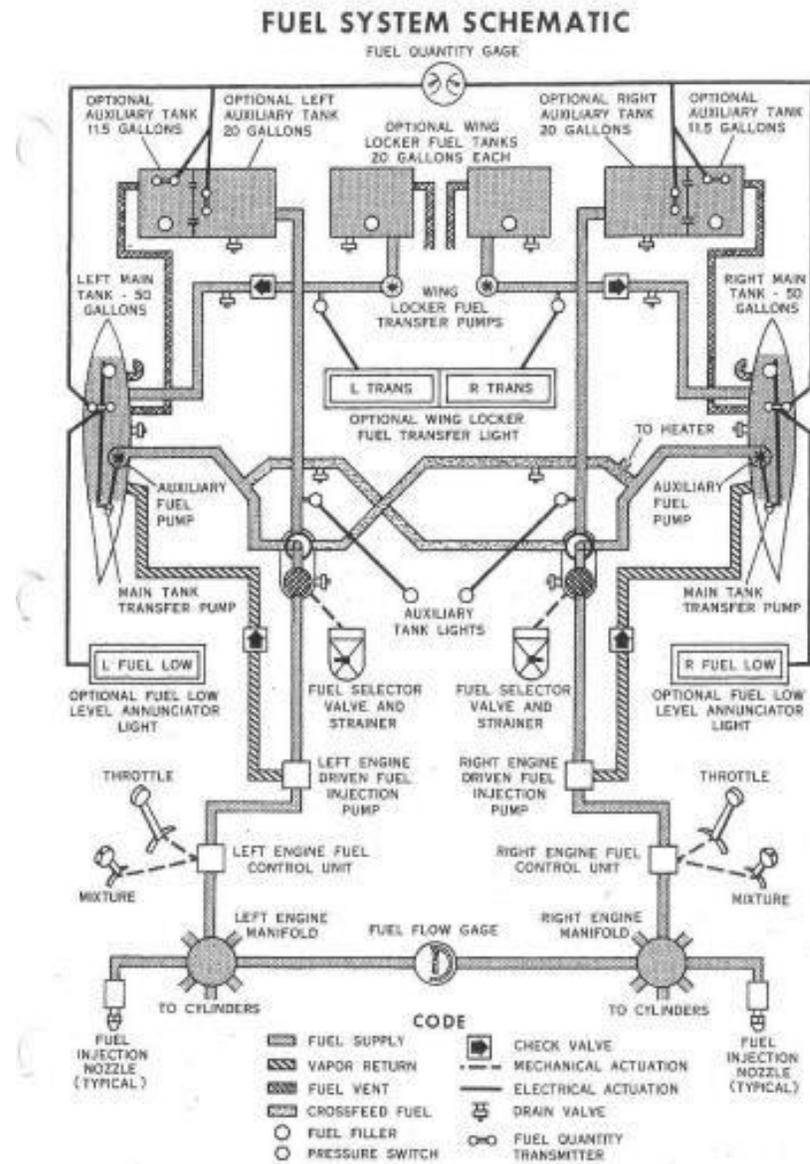
Diagram of fuel System schematic from Pilot's Operating Handbook, Cessna Aircraft Company, 1977 Model 402B Revision 1

The fuel system, see Figure 2, consist of two main tanks, two optional auxiliary tanks, two optional wing locker tanks, fuel selector for options of main, auxiliary or crossfeed fuel and other necessary components to complete the system.

It is unclear why the pilot would switch fuel selectors from the main tanks to the auxiliary tanks considering no fuel was added to the auxiliary tanks and no mention of how much fuel remained in the auxiliary tanks prior to departure. According to the POH, auxiliary fuel on the side of the failed engine is unusable.

Additionally, according to the Cessna 402B POH, Engine Failure During Flight Checklist, once an inoperative engine has been determined, item 4 requires Fuel Selector to be positioned to the Main Tanks. It is possible the action taken of positioning the fuel selector to “Auxiliary Tanks” instead of “Main Tanks” may have exacerbated the engine emergency resulting in dual engine failure. (See note and Checklist below)
