Short Investigation Bulletin

DATE: 3rd June 2024
REPORT # OCC-2024/0026
AIRCRAFT REGISTRATION: N208P
INVESTIGATION STATUS: Completed

Aircraft Type and Registration:	Beechcraft Baron 58; N208P
Year of Manufacture & Serial #:	1991; TH-1626
Number and Type of Engine(s)	Twin Continental IO-550
Type of operation:	Private
Information Source:	Occurrence Report Notification
Nature of Damage:	None

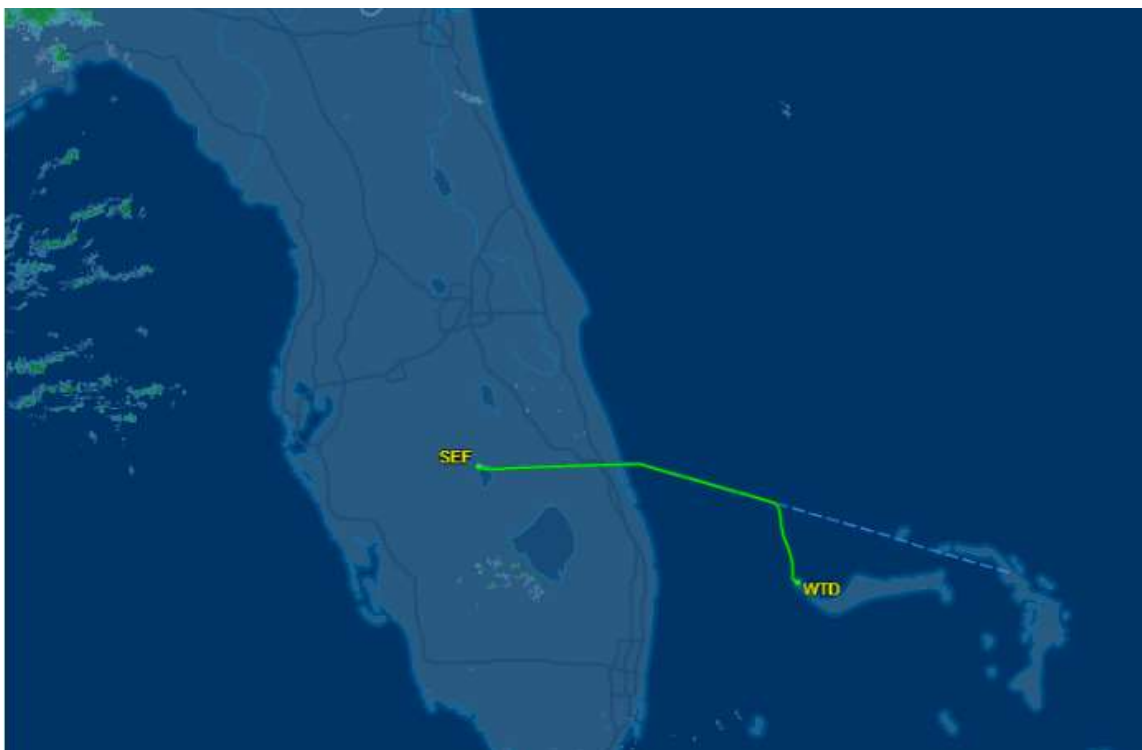
Subsequently, the pilot contacted Miami Center (Air Traffic Control) to advise of an emergency situation and requested nearest airport to divert. Miami Center advised that the West End Airport (MYGW), Grand Bahama, Bahamas was the nearest aerodrome at a distance of 35 miles from present position, and the pilot altered course to MYGW as required.

Fig. N208P Route of flight and diversion to MYGW (Flightaware)
