## Short Investigation Bulletin

**DATE:** 8<sup>th</sup> September 2023  
**REPORT #** OCC-2023/0031  
**AIRCRAFT REGISTRATION:** C6-FLR  
**INVESTIGATION STATUS:** Completed

<b>Aircraft Type and Registration:</b>	Beechcraft 99; C6-FLR
<b>Aircraft Serial #:</b>	U-149
<b>Number and Type of Engine(s)</b>	Two (2) Pratt & Whitney PT6
<b>Type of operation:</b>	Commercial
<b>Information Source:</b>	Occurrence Report Notification
<b>Nature of Damage:</b>	Cargo pod, undercarriage, propellers

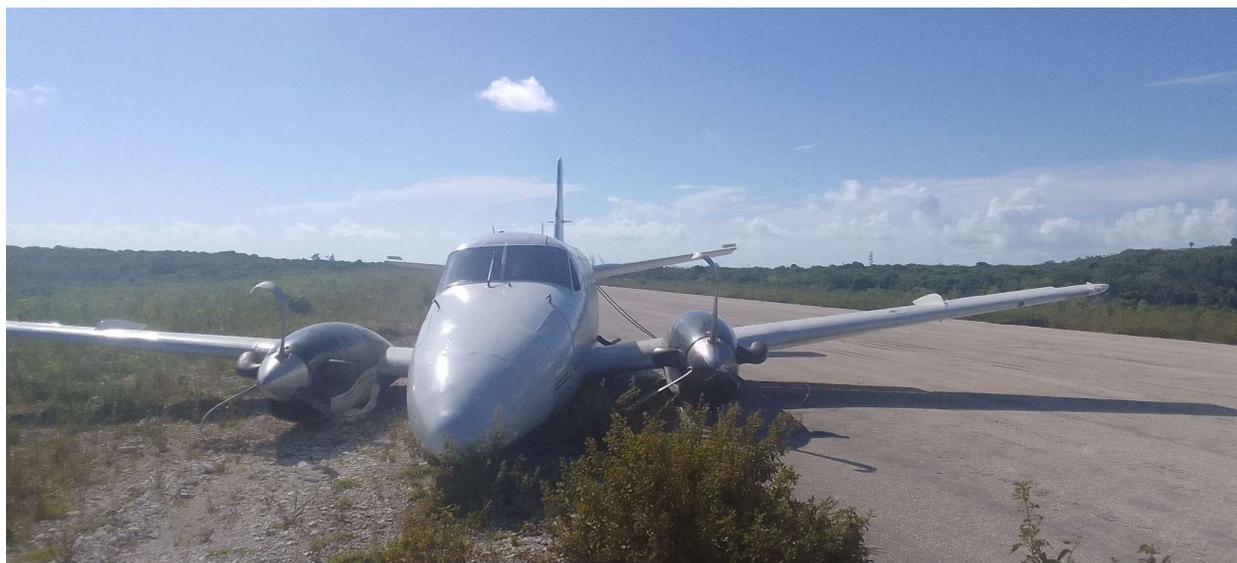
According to the flight crew, the flight was uneventful up and until the point of landing. Prior to the landing, the flight crew did not follow the prescribed pre-landing checklist as per the manufacturer's specifications. Subsequently, they proceeded to land the aircraft without the benefit of its landing gear which led to the underside of the aircraft fuselage coming into contact with the runway surface thus resulting in damages to the cargo pod, propellers and undercarriage.

*Fig. 1: Post accident photo of Beech 99 C6-FLR at Black Point Airport (MYEB)*

In the immediate aftermath of the occurrence, the Civil Aviation Authority Bahamas (CAA-B) commenced a process for re-evaluation of the competency of both pilots. There were no safety recommendations issued in relation to this occurrence.
