Short Investigation Bulletin

DATE: 29th January 2024
REPORT # OCC2024/0002
AIRCRAFT REGISTRATION: C6-EAR
INVESTIGATION STATUS: Completed

Aircraft Type and Registration:	Saab 340A; C6-EAR
Serial #:	046
Number and Type of Engine(s)	Two Turbo-prop; General Electric CT7-5A2
Type of operation:	Commercial Cargo
Information Source:	Occurrence Report Notification
Nature of Damage:	Minor nose gear damages

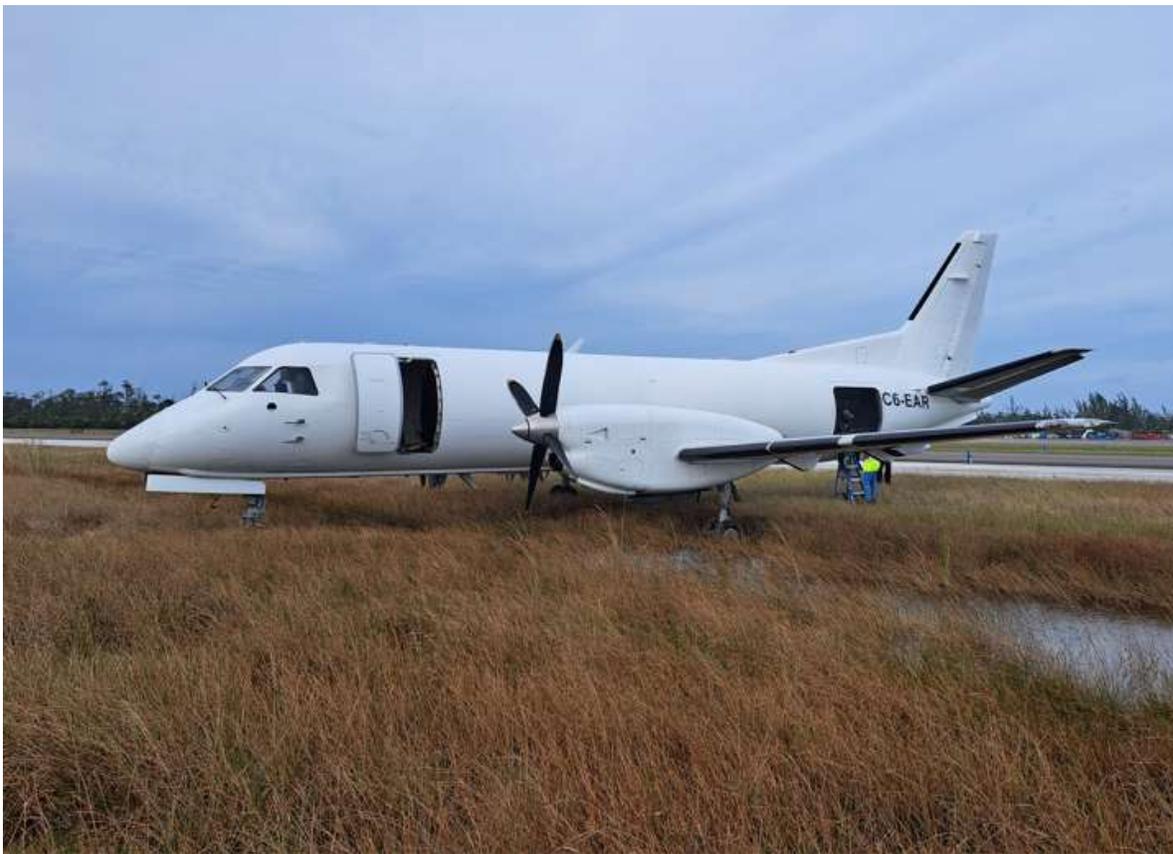
Fig 1: Photo of C6-EAR off of Taxiway Hotel at MYNN

Subsequently, the flight crew loss control of the aircraft as they were unable to steer the aircraft or use the braking system. The aircraft exited the paved surface of taxiway Hotel, to the left, and came to a stop in an area of grass after travelling a distance of some 98 feet from the edge of the paved surface of the taxiway, at a position of approximately 130 feet from the entrance of Apron 1 (Hotel 1).

The aircraft received minor damages to the nose landing gear. There were no injuries reported in relation to this occurrence. The weather at the time of the occurrence was visual meteorological conditions and not a factor.

Post-accident analysis and inspection of the aircraft hydraulic system was conducted, in accordance with the manufacturer's procedures, and revealed that a faulty relay switch was the root cause of the hydraulic pressure loss. The faulty switch was replaced with a serviceable part and the aircraft was subsequently returned to service. There were no safety recommendations issued in relation to this occurrence.

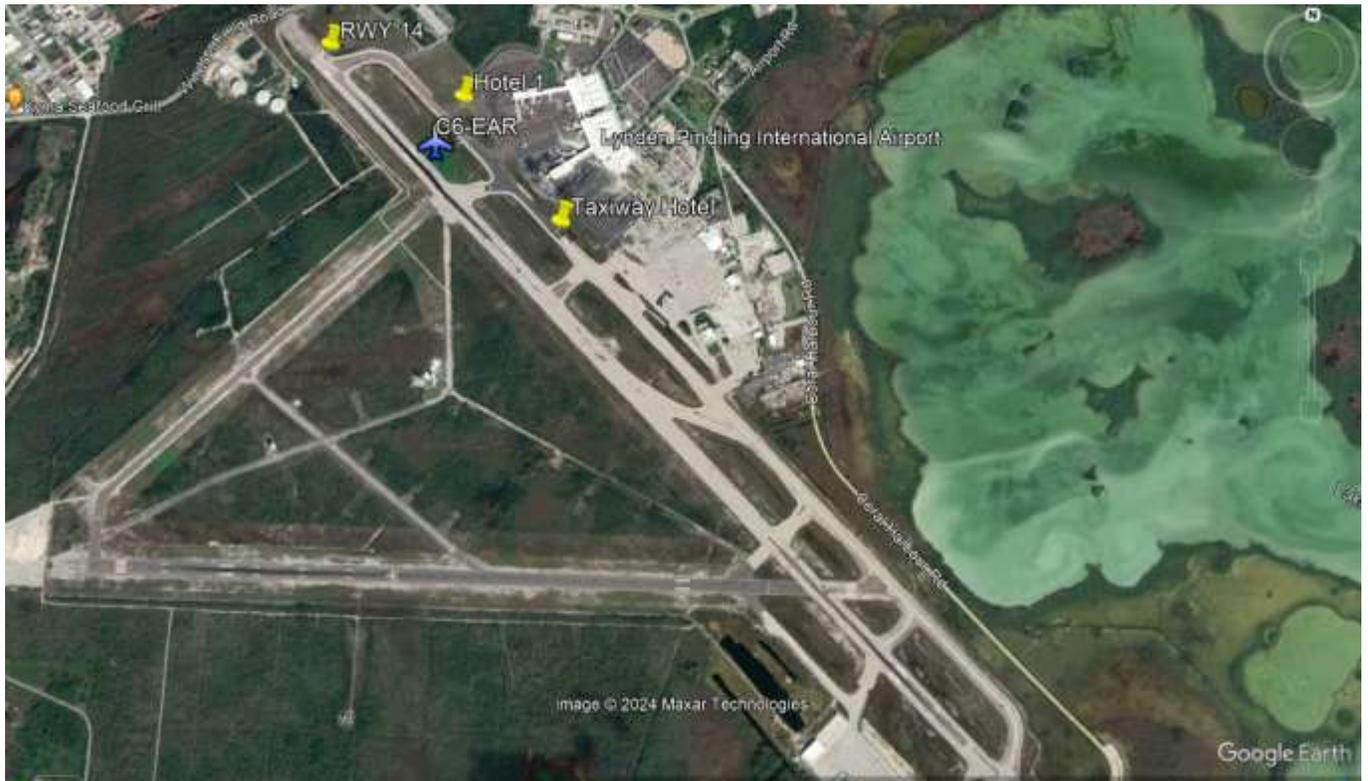
Fig.2: Imagery of aircraft position at MYNN after occurrence
