Aviation Short Investigation Final Report

Controlled Flight into Terrain (C-FIT)
Piper PA-32-260 – N3790W

Waters near North Andros, Bahamas
1st June 2023

AAIA Aviation Occurrence Investigation
Report # OCC-2023/0019

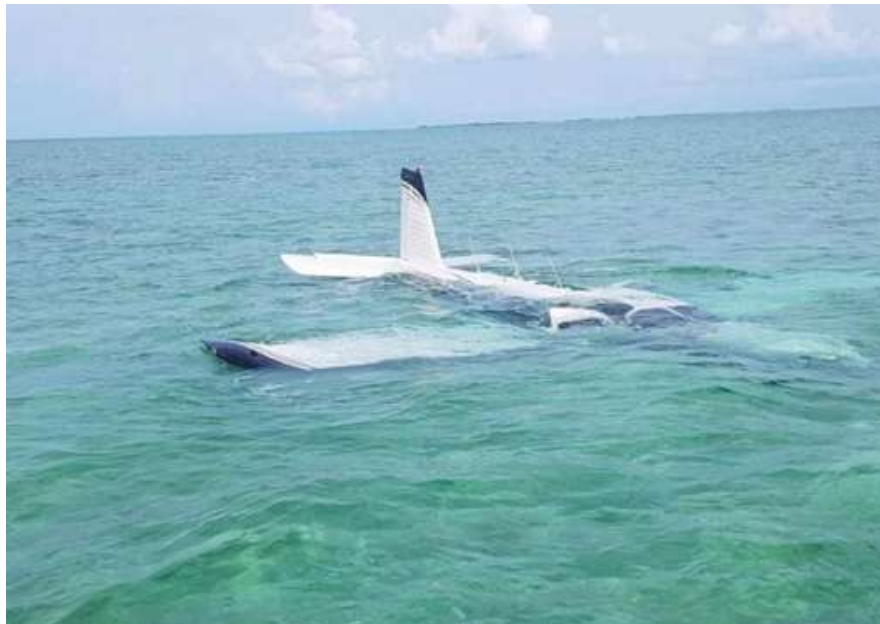
Fig. 3: Photo of aircraft submerged in waters off North Andros, Bahamas

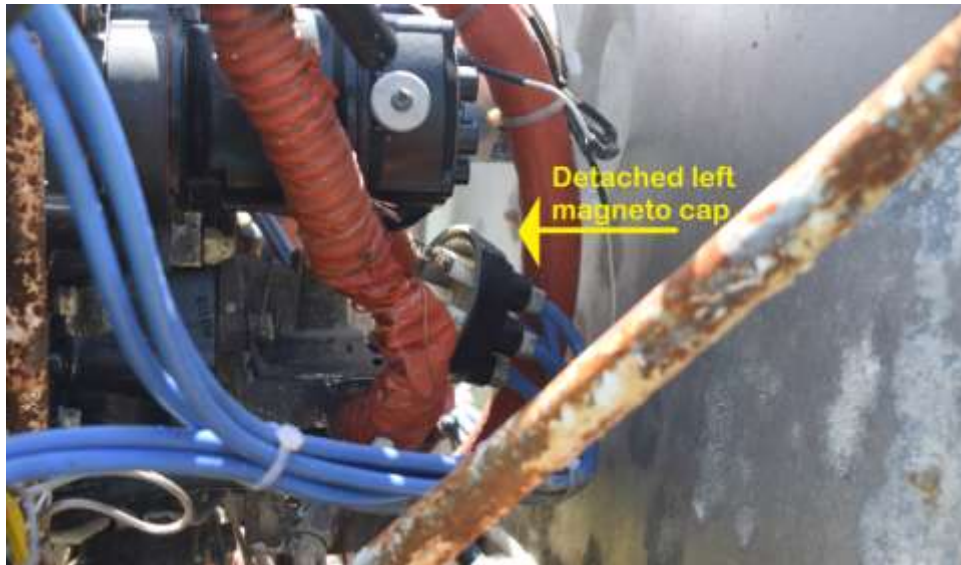
Both magneto distributor caps were found un-attached from their respective magnetos when the airplane was removed from the ocean, as documented during the recovery process. The three screws on each magneto that would normally hold these caps in place were not present.

During post-accident recovery of the aircraft and inspection, the top and bottom cowlings for the engine were removed where it was observed that both magneto leads/distribution caps were found to be fully detached from each of the magneto housings (left and right) at the rear/back of the engine.

Fig. 5: Left magneto cap detached from housing

It could not be determined at which point and time both of the magneto distribution caps would have become detached from their respective magnetos. If it were the case that the detached position of both magneto caps, as they were observed post-accident, were to have taken place sometime prior to the accident sequence, a subsequent loss of power event would be a logical result.

- Inability of aircraft to produce sustainable power due to detachment of left and right magneto distributor caps from their respective magnetos (cause undetermined).

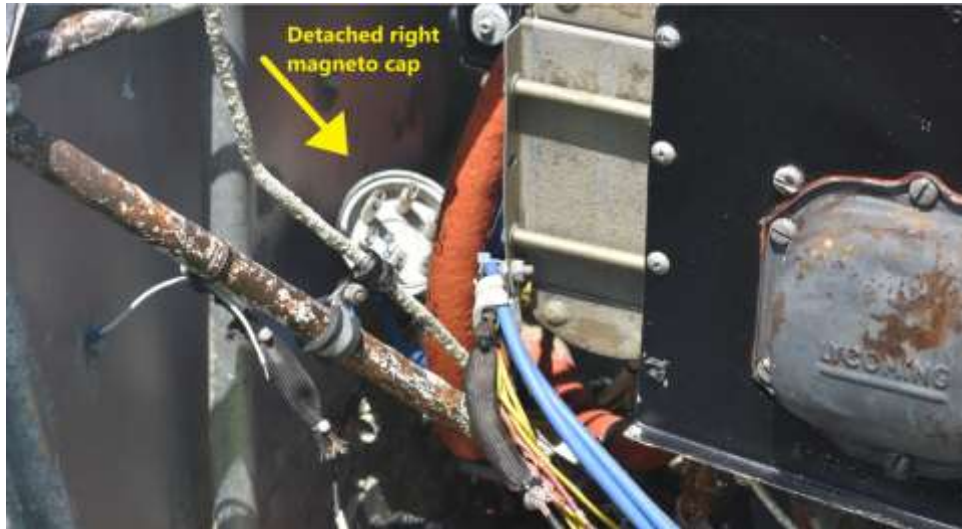
The magnetos were tested – Neither magneto sparked when rotated. Internal examination of the magnetos revealed corrosion on the internal components.

Fig. 6: Right magneto cap detached from housing

14) The cause of the observed detached magneto distributor caps was undetermined.
