Short Investigation Bulletin

DATE: 6th March 2024
REPORT # OCC- 2024/0009
AIRCRAFT REGISTRATION: C6-PIN
INVESTIGATION STATUS: Completed

Aircraft Type and Registration:	Piper PA-23-250, C6-PIN
Year of Manufacture & Serial #:	S/N 27-7954107
Number and Type of Engine(s)	Twin Lycoming IO-540
Type of operation:	Commercial
Information Source:	Occurrence Notification
Nature of Damage:	Both propellers, underside of fuselage

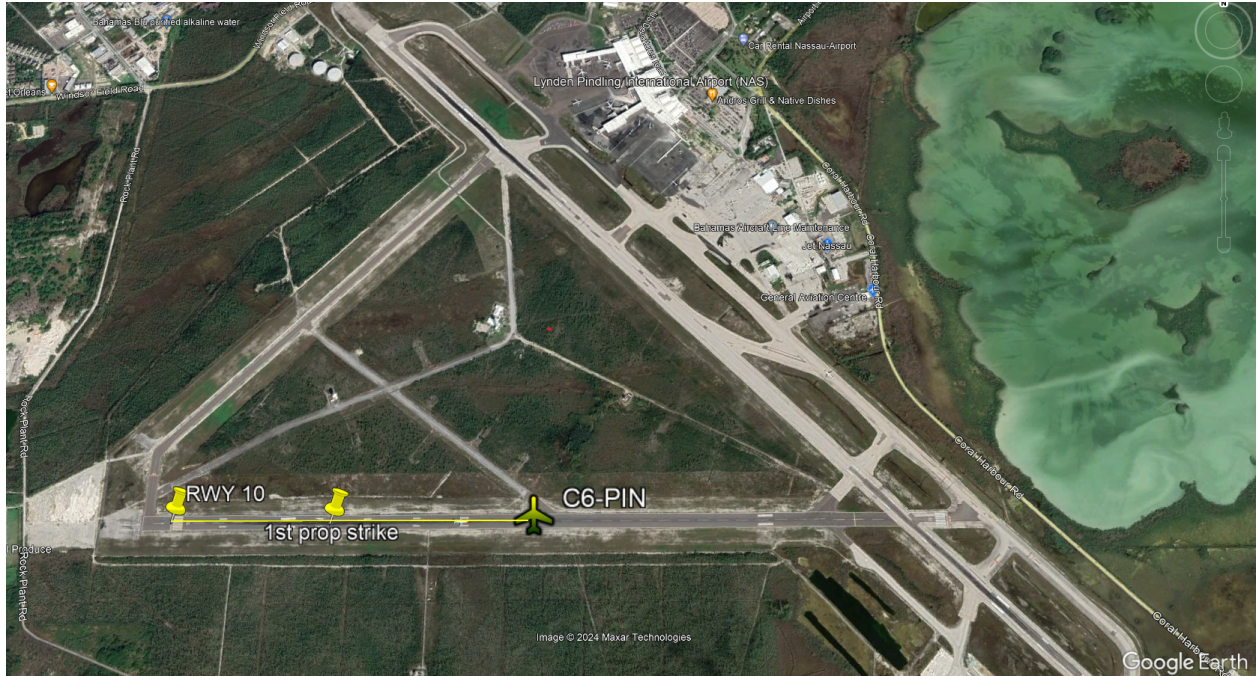
The pilot executed an emergency landing without the benefit of the aircraft nose and right main landing gears. Post accident documentation of the accident site indicated that the aircraft’s first point of contact with the runway was at a distance of approximately 1,618 feet from the threshold of runway 10, as indicated by left propeller prop strike marking on runway. The aircraft received damage to both propellers and the underside of the fuselage.

The next prominent runway signature marking observed on runway 10 was at a distance of approximately 1,728 feet from the end of the threshold of runway 10, as indicated by right propeller prop strike marking. These markings were consistent with accounts given by passengers on board the aircraft who indicated that the pilot had landed the aircraft with the left main landing gear touching first and travelling some distance before the right side of the aircraft made contact with the runway surface.

Fig.1: Imagery of runway 10 at MYNN showing C6-PIN first point of contact and point of rest

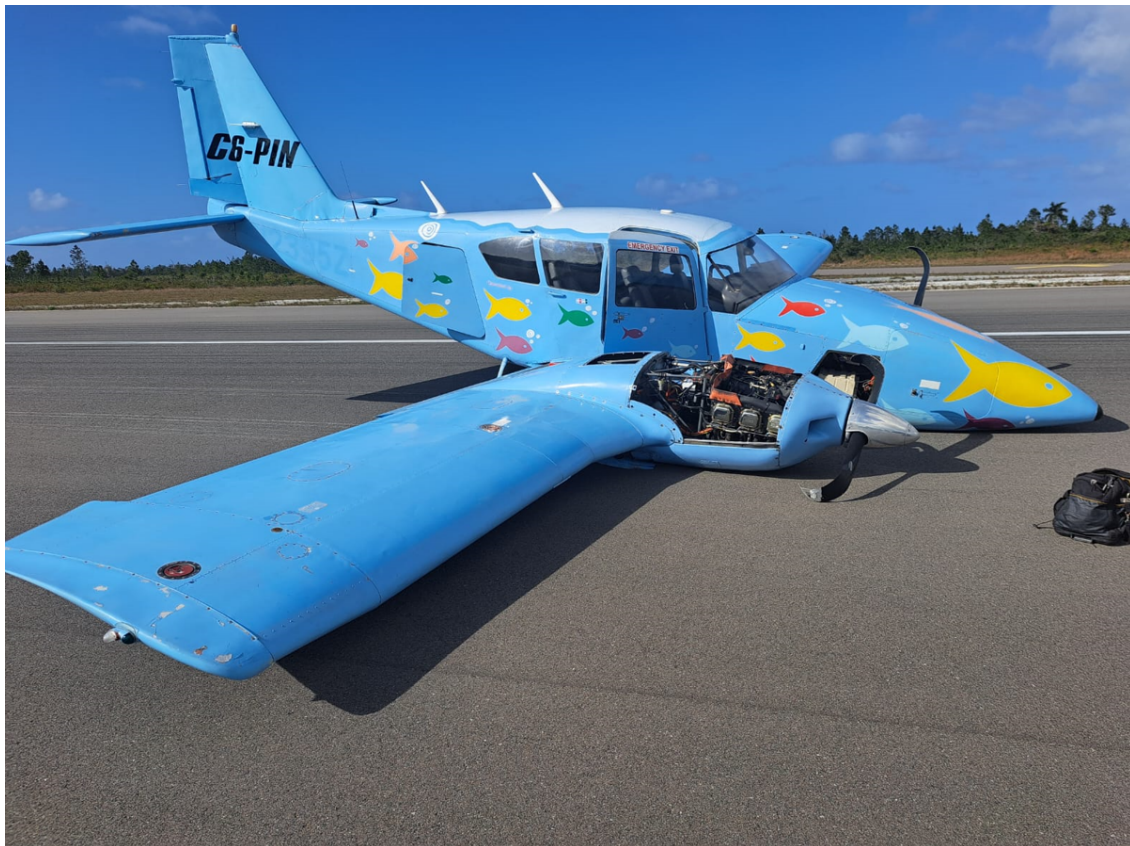
Fig.2: Photo of aircraft on runway 10 at MYNN after emergency landing

Post accident investigation and analysis revealed that a substantial amount of hydraulic fluid used for landing gear operation was lost. Further investigations revealed that there was a failure of the landing gear control unit (hydraulic power pack), which ultimately was the root cause of the occurrence.
