Short Investigation Bulletin

DATE: 19th July 2021
REPORT # AO21-021
AIRCRAFT REGISTRATION: N21955
INVESTIGATION STATUS: Completed

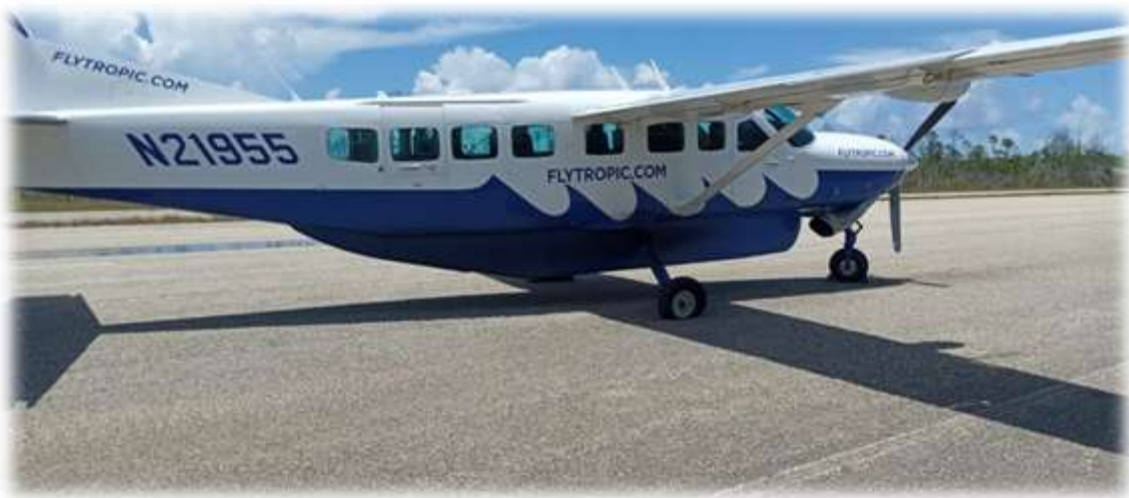
The aircraft departed the Fort Lauderdale-Hollywood International Airport (KFLA), Fort Lauderdale, Florida, USA with a total of eight (8) persons on board (6 passengers, 2 flight crew). The pilots advised that upon landing at MYAF, the aircraft became temporarily disabled on runway 09/27 due to a flat right main gear tire.
