# Aviation Short Investigation Final Report

Collision with Obstacle during Take-off  
and Landing (CTOL)

Cessna 208B, N384TA

**Investigation Number #OCC-2024/0032**

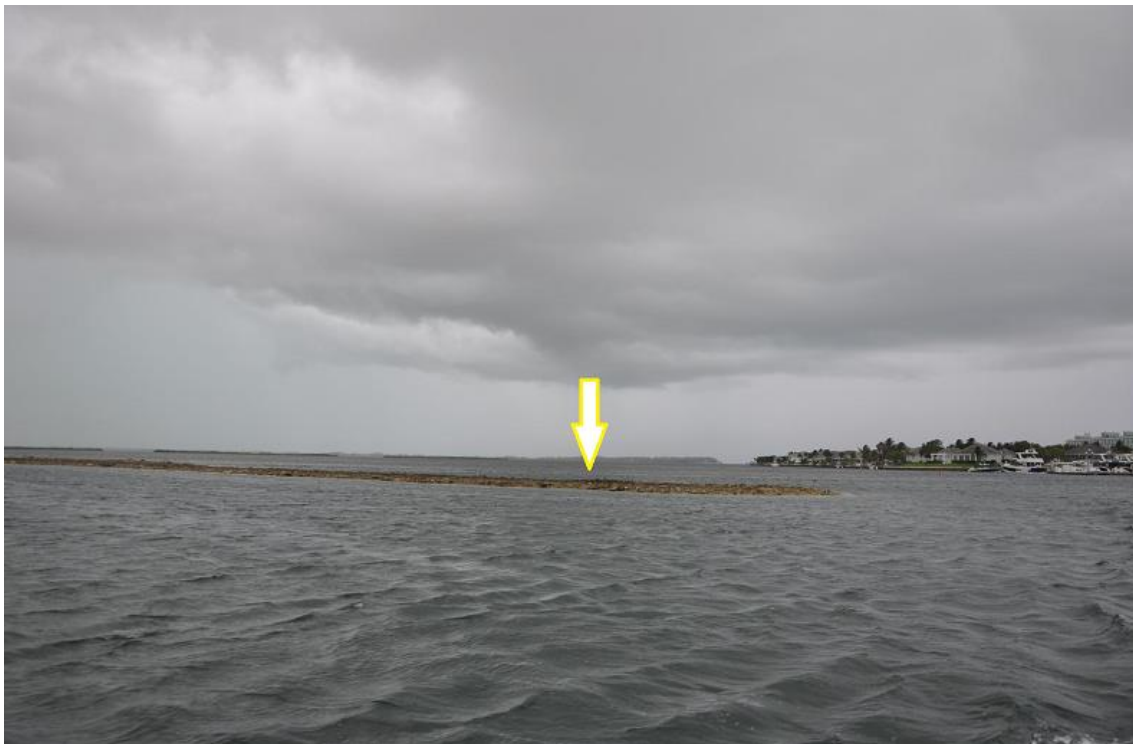
*Fig.1: Photo of exposed embankment*

Secondly, since the power control lever was not set to the full takeoff thrust setting, the aircraft was not producing the thrust required to successfully climb out of ground effect. This resulted in the aircraft impacting the rocky embankment shortly after rotation causing float damage to the left float.

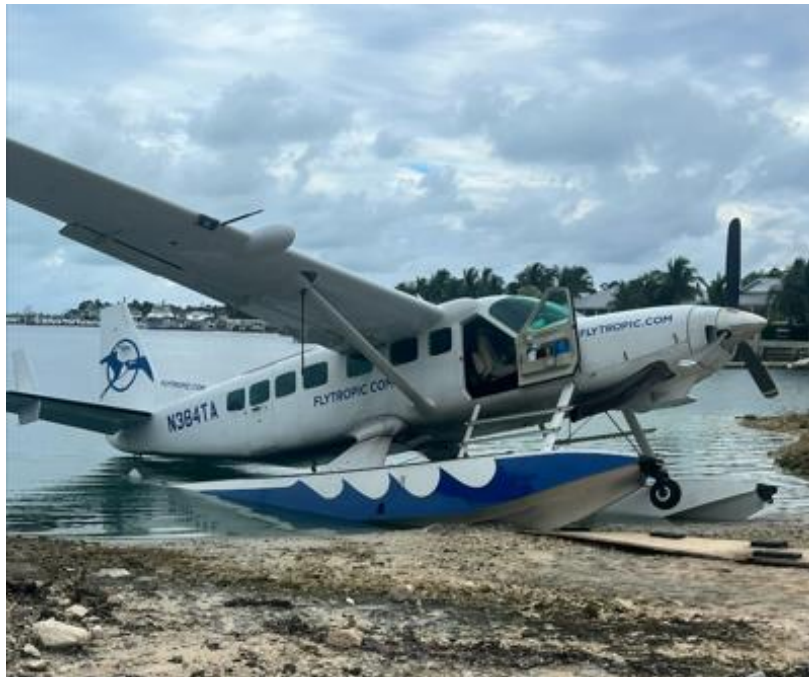
Post incident inspection revealed the left float was punctured and taking on water.

*Fig.2: Photo of Aircraft during Recovery Efforts*

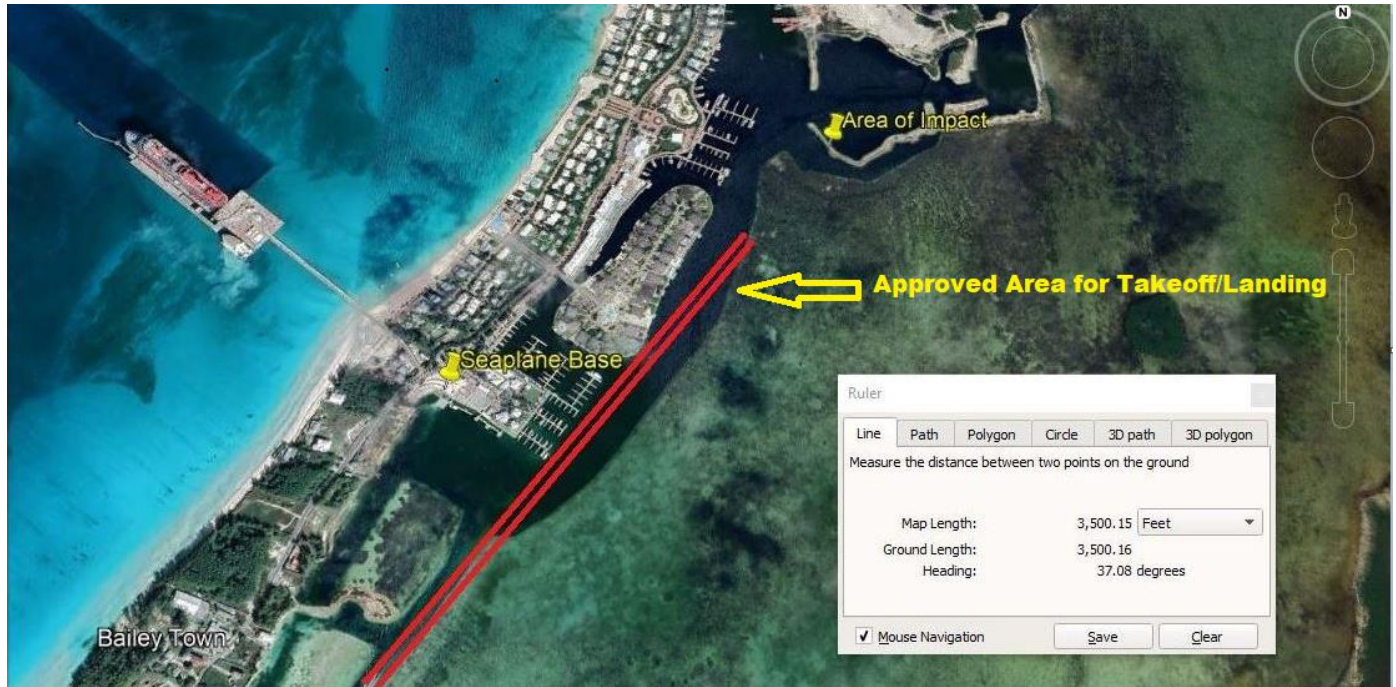
*Fig.3: Approved takeoff and landing area*

The designated area (as depicted above in red lines), covers a distance of 3,500 feet. The flight crew indicated that during the takeoff roll, they did not utilize the full available length of 3,500 feet.

The distance between the end of the approved takeoff/landing area and the area of impact measured approximately 750 feet.

It was noted that the distance between the end of the approved takeoff/ landing area and the area of impact was approximately 750 feet, which is less than the distance the flight crew (approx. 1,200 feet) did not avail themselves of after not back taxiing upon exiting the area of the seaplane base.
