## AVIATION OCCURRENCE BULLETIN

**DATE:** 14<sup>TH</sup> JAN 2021  
**REPORT #** AO-21-000002  
**AIRCRAFT REGISTRATION:** C6-TJJ  
**INVESTIGATION STATUS:** COMPLETED

Aircraft details	
<b>Aircraft Type and Registration:</b>	PA 23-250, C6-TJJ
<b>Year of Manufacture &amp; Serial #:</b>	S/N 27-7554084
<b>Number and Type of Engine(s)</b>	Two, Lycoming IO-540, Reciprocating
<b>Type of operation:</b>	Commercial
<b>Information Source:</b>	AAIA Field Investigation
<b>Nature of Damage:</b>	Left wing tip, left flap and aileron ,left gear and wheel undercarriage, Nose undercarriage

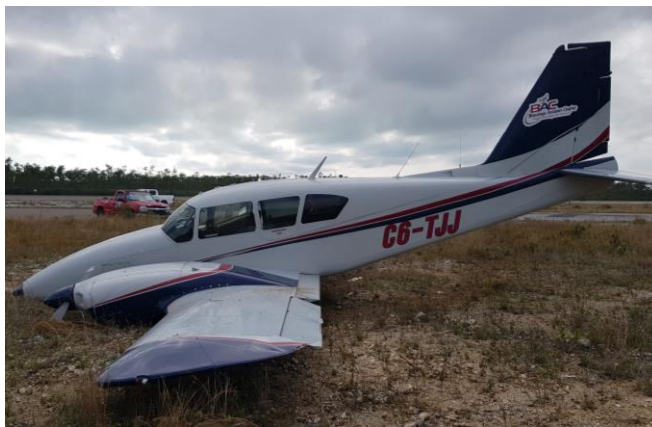
The loss of hydraulic fluid was evident during the onsite investigation. The aircraft sustained damages to the nose undercarriage, left wing, gear doors and wheel well.

Further investigation conducted by the maintenance organization confirmed a broken hydraulic line. It could not be definitively determined what caused the hydraulic line to break. The broken line resulted in the loss of hydraulic fluid which prevented the extension of the left and nose landing gears when selected by the pilot.
