# Aviation Short Investigation Final Report

## Abnormal Runway Contact – (ARC) Learjet 60 – N357WP

**North Eleuthera Int'l Airport (MYEH), Eleuthera, Bahamas  
5<sup>th</sup> February 2023**

**AAIA Aviation Occurrence Investigation  
Report # OCC-2023/0006**

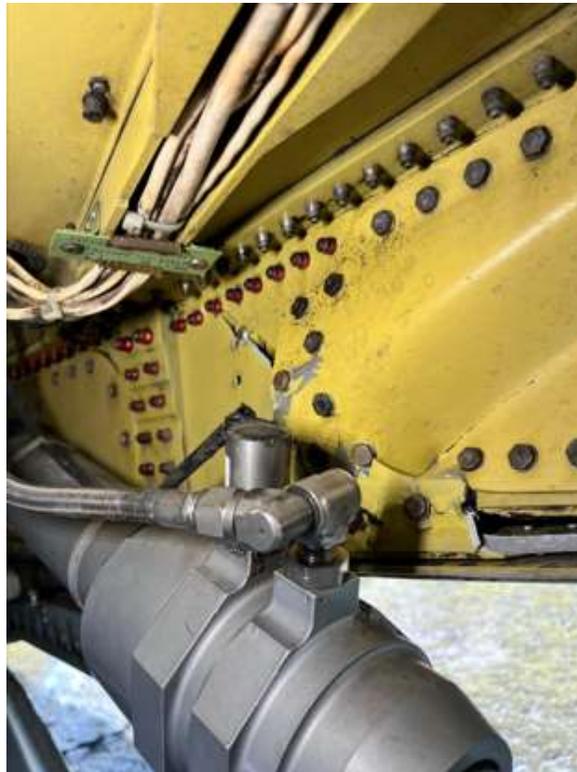
There were no injuries to flight crew reported as a result of this occurrence. An assessment in the aftermath revealed damages to left main landing gear axle, left landing gear aft trunnion support, left wing trailing edge adjacent to aft trunnion support, left and right ventral fins.

Fig. 3: Photo of damages to left landing gear aft trunnion support

- 12) The aircraft made a forceful impact upon landing and became momentarily airborne before making a second forceful impact with the runway.
- 13) The aircraft received damages to left main landing gear axle, left landing gear aft trunnion support, left wing trailing edge adjacent to aft trunnion support, left and right ventral fins.
