Short Investigation Bulletin

DATE: July 19th, 2021
REPORT # AO21-008
AIRCRAFT REGISTRATION: N639MS
INVESTIGATION STATUS: Completed

Occurrence Summary

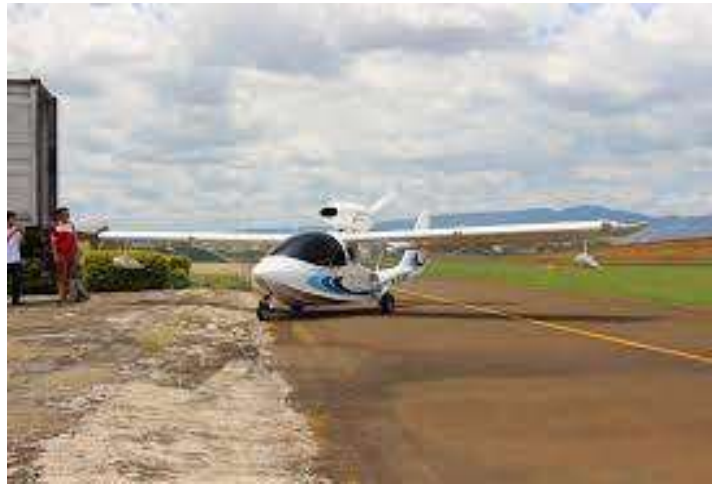
It was reported by the pilot that while taxiing at MYNN, the right brake line failed, resulting in a taxiway excursion after loss of directional control. There was light cosmetic damage to the aircraft, and a taxiway edge light and a taxiway sign were reported damaged. No injuries were reported.
