## Short Investigation Bulletin

**DATE:** 22<sup>nd</sup> February 2024  
**REPORT #** OCC- 2023/0035  
**AIRCRAFT REGISTRATION:** N2162X  
**INVESTIGATION STATUS:** Completed

<b>Aircraft Type and Registration:</b>	Piper PA 32-300 , N2162X
<b>Year of Manufacture &amp; Serial #:</b>	S/N 32-7940089
<b>Number and Type of Engine(s)</b>	Single Lycoming IO 540 SER
<b>Type of operation:</b>	Private
<b>Information Source:</b>	Pilot
<b>Nature of Damage:</b>	Fuselage destroyed; empennage, wings substantial fire damage

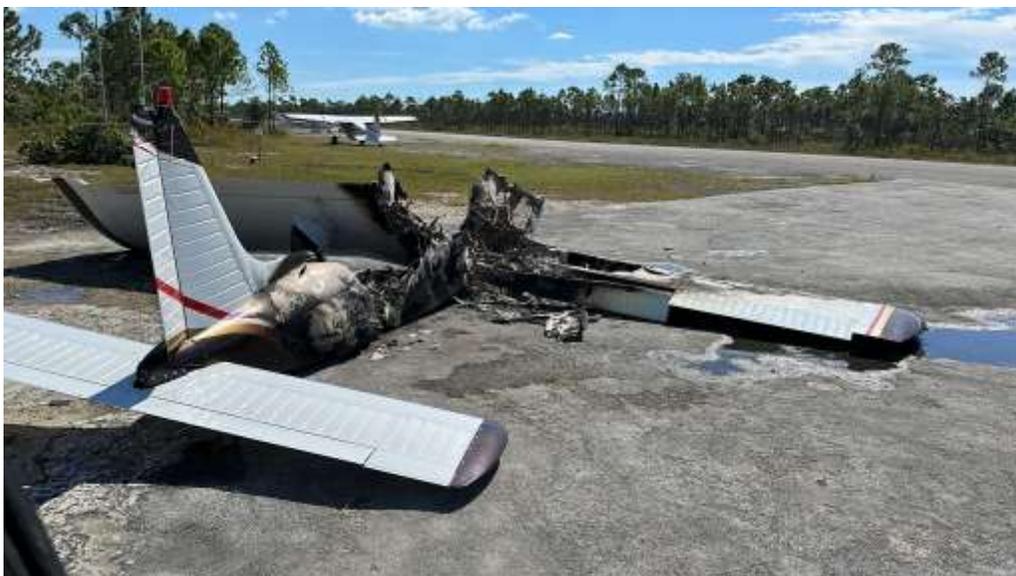
The pilot exited the aircraft and attempted to suppress and extinguish the flames with a fire extinguisher on wheels located at the airport, but he was unsuccessful and the aircraft received extensive damages, with the fuselage destroyed by fire and fire damage to both wings. The empennage (vertical and horizontal stabilizer) and both wings, although fire damaged, were the only parts of the aircraft that were not totally destroyed. There were no injuries reported in relation to this occurrence.

*Fig. Photo of N2162X in aftermath of fire*
