Short Investigation Bulletin

DATE: January 16th, 2023
REPORT # OCC-2022/0036
AIRCRAFT REGISTRATION: N4372L
INVESTIGATION STATUS: Completed

Aircraft Type and Registration:	Piper PA-46-310P, N4372L
Year of Manufacture & Serial #:	S/N 8408087
Number and Type of Engine(s)	Single Jet Prop. PT6A-21
Type of operation:	Private
Information Source:	Pilot
Nature of Damage:	Propeller, and nose landing gear actuator

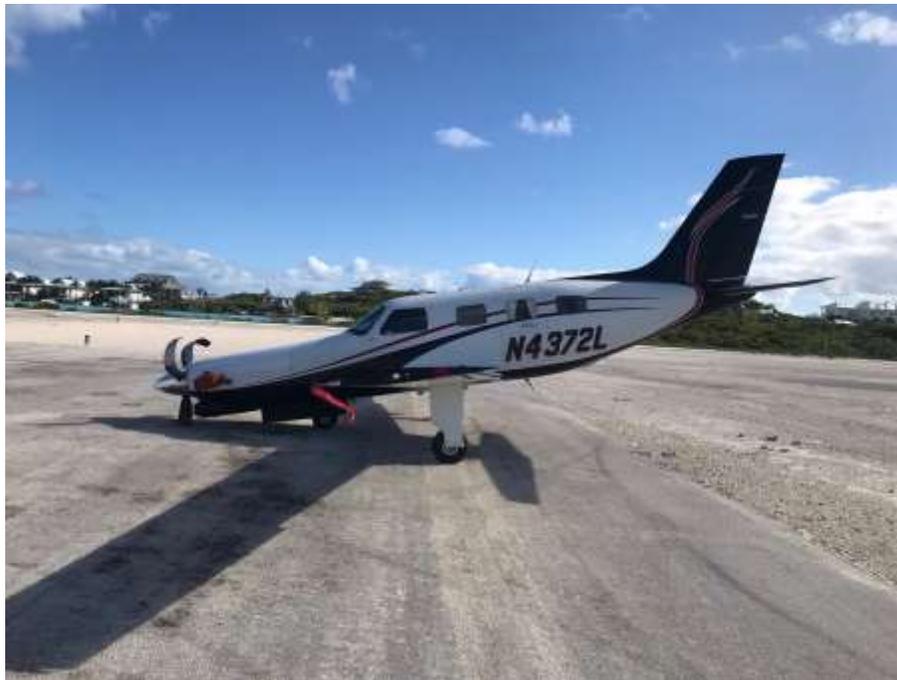
Fig. 1 Photo taken of N4372L at MYES

It was reported by the pilot in command, that during approach into MYES, the gear handle was selected to the down position, and a gear safe indication was observed. The pilot then proceeded to land and stated that during the final approach sequence, while over the runway threshold, a cross wind was encountered. The aircraft then landed and rolled approximately 200 feet before the nose gear partially collapsed.

The aircraft received significant damages to its propeller.

Post-accident, a preliminary assessment was conducted and revealed that the nose gear actuator rod and rod end were both observed to be bent. Further analysis identified that this failure contributed to the prevention of the nose gear staying fully extended.
