Short Investigation Bulletin

DATE: 19th July 2021
REPORT # AO21-23
AIRCRAFT REGISTRATION: N494DS
INVESTIGATION STATUS: Completed

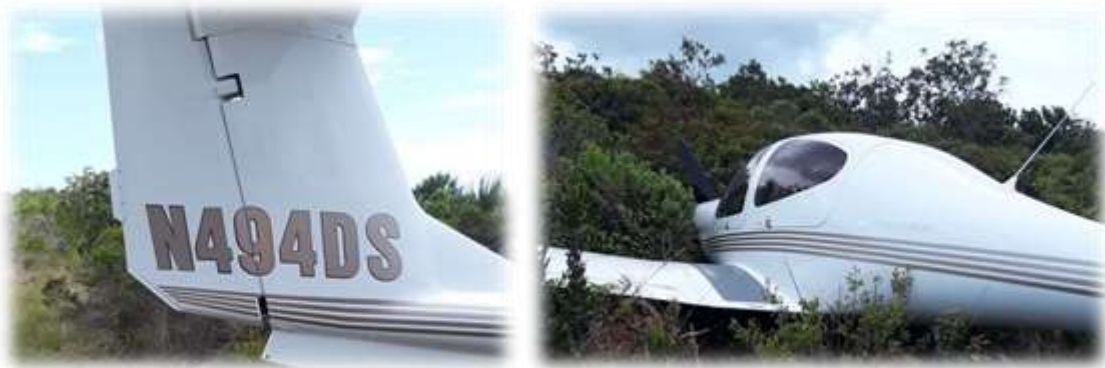
The aircraft departed Massey Ranch Airpark (X50), New Smyrna Beach, Florida, USA and after landing at MYEH, the aircraft exited the useable portion of runway 07/25 resulting in a runway excursion taking place and the aircraft coming to rest in nearby bushes.

The aircraft received minimal damages to the underside of the fuselage, there were no reported injuries.
