## Short Investigation Bulletin

**DATE:** 5<sup>th</sup> September 2023  
**REPORT #** OCC-2023/0026  
**AIRCRAFT REGISTRATION:** C6-LAS  
**INVESTIGATION STATUS:** Completed

<b>Aircraft Type and Registration:</b>	Piper PA-23-250; C6-LAS
<b>Aircraft Serial #:</b>	27-4215
<b>Number and Type of Engine(s)</b>	Two (2); Lycoming IO-540-C4B5
<b>Type of operation:</b>	Commercial
<b>Information Source:</b>	Occurrence Report Notification
<b>Nature of Damage:</b>	Flaps, undercarriage, propellers

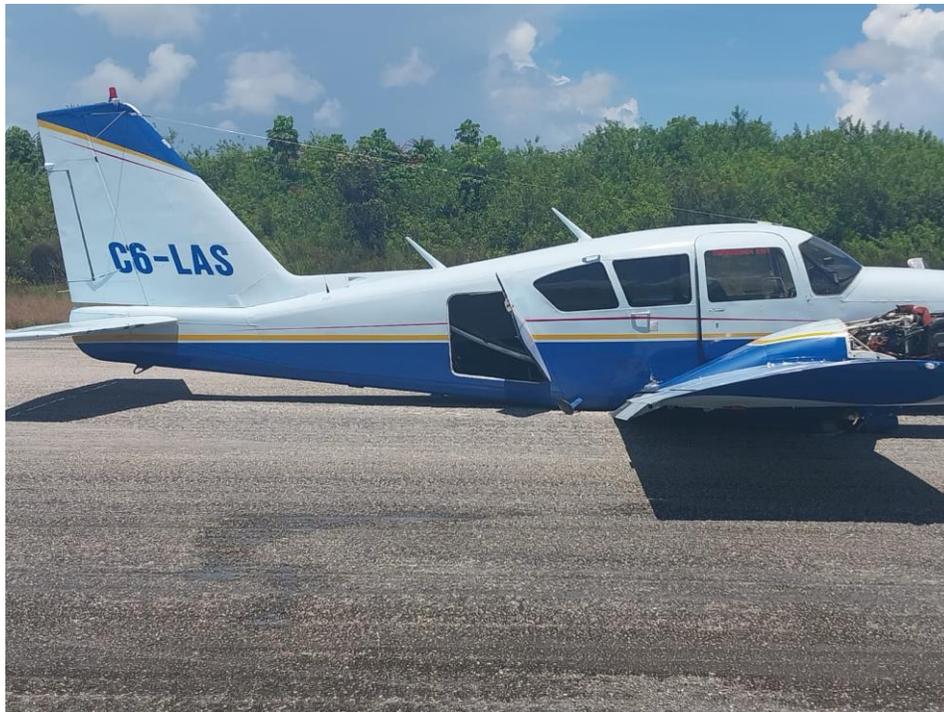
According to the pilot in command of the aircraft, the flight was uneventful up and until the point of landing. Prior to the landing, the pilot in command did not verify or confirm that the landing gear was in the down and locked position, as would be indicated by an illuminated three green light safe gear indication in the cockpit instrument panel.

The pilot proceeded to land the aircraft without the benefit of its landing gear which led to the underside of the aircraft fuselage coming into contact with the runway surface this resulting in damages to the flaps, propellers and undercarriage.

*Fig. 1: Post accident photo of Piper PA-23-250 C6-LAS*
