## Short Investigation Bulletin

**DATE:** August 18<sup>th</sup>, 2021  
**REPORT #** AO21-016  
**AIRCRAFT REGISTRATION:** N997TA  
**INVESTIGATION STATUS:** Closed

<b>Aircraft Type and Registration:</b>	Cessna 402C, N997TA
<b>Year of Manufacture &amp; Serial #:</b>	1980, 402C-0231
<b>Number and Type of Engine(s)</b>	2, Reciprocating
<b>Type of operation:</b>	Commercial
<b>Information Source:</b>	AAIA
<b>Nature of Damage:</b>	Gear and fuselage damage

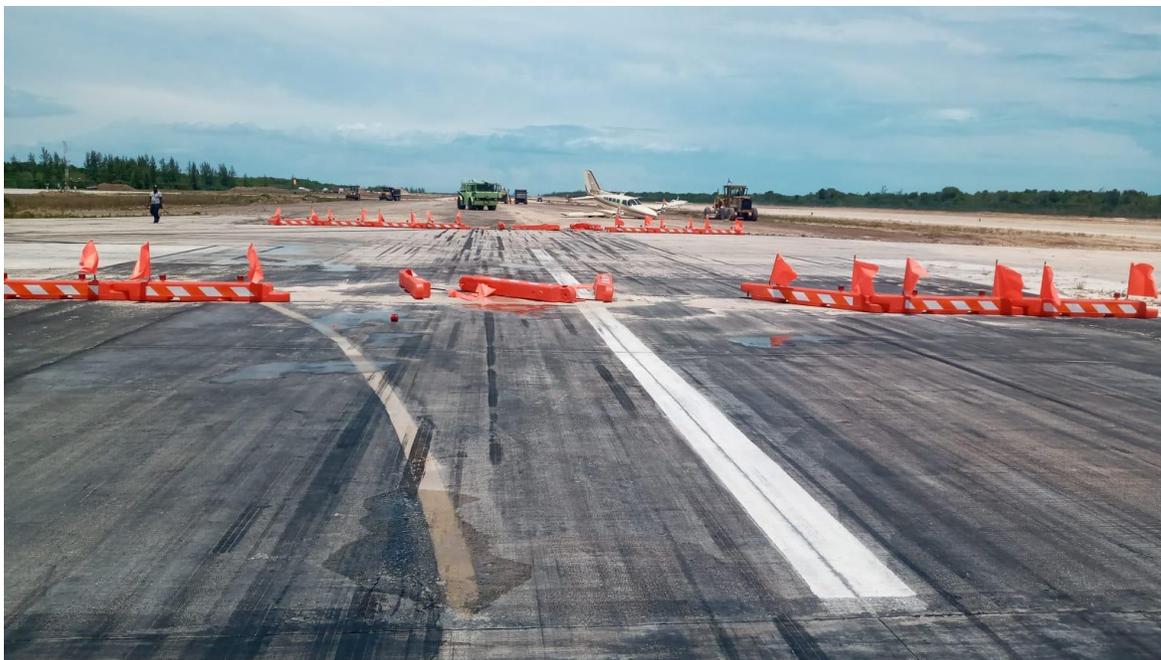
Upon landing, the aircraft collided with the orange barricades which had been erected across the runway to warn pilots that the runway was unserviceable. As a result of this collision the nose gear and right main gear collapsed forcing the aircraft to spin to the right resulting in a runway excursion. There were no injuries reported; however, the aircraft sustained substantial damages.

Despite all notification and physical barriers erected, the pilot landed the aircraft on the closed runway, proceeded through the barriers, resulting in damages to the aircraft before the runway excursion occurred.
