Short Investigation Bulletin

DATE: 16th December, 2021
REPORT # OCC-2021-0035
AIRCRAFT REGISTRATION: N6670Y
INVESTIGATION STATUS: Complete

Aircraft Type and Registration:	PA 23-250, N6670Y
Year of Manufacture & Serial #:	1969, 27-3987
Number and Type of Engine(s)	2; Lycoming
Type of operation:	Private
Information Source:	Field Investigation
Nature of Damage:	Underside of fuselage; both propellers

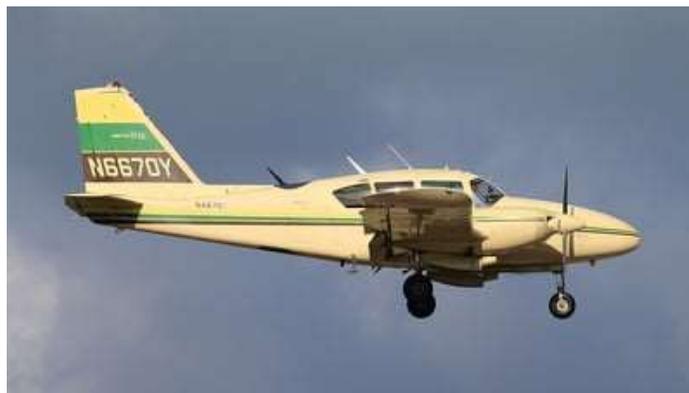
The pilot reported that prior to landing, he observed a safe gear indication on the instrument panel, which subsequently led him to proceed with the approach. However, he advised that upon landing, there was a loss of control of the aircraft that ultimately led to a runway excursion taking place. The aircraft came to rest on the right side of runway 10.

A limited scope investigation was conducted. No injuries were reported. The aircraft received damages to both propellers and underside of the fuselage. No safety recommendations or safety messages were issued in relation to this occurrence.
