Short Investigation Bulletin

DATE: 21st February, 2024
REPORT # OCC - 2023/0036
AIRCRAFT REGISTRATION: C-GCWI
INVESTIGATION STATUS: Completed

Aircraft Type and Registration:	Maule M-5-235C; C-GCWI
Year of Manufacture & Serial #:	1976; 7006C
Number and Type of Engine(s)	Single, Lycoming 0-540-J1A5D
Type of operation:	Private
Information Source:	Notification
Nature of Damage:	Substantial

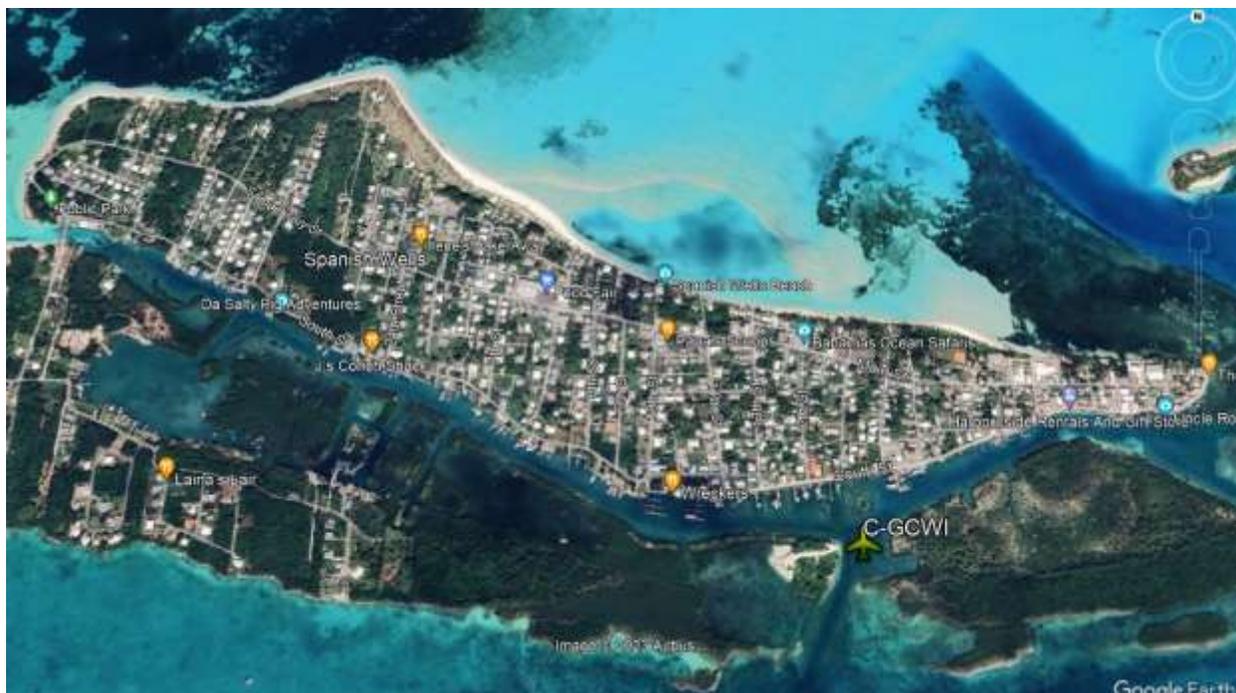
Fig.2: Google Earth imagery of accident site at Spanish Wells, Eleuthera, Bahamas

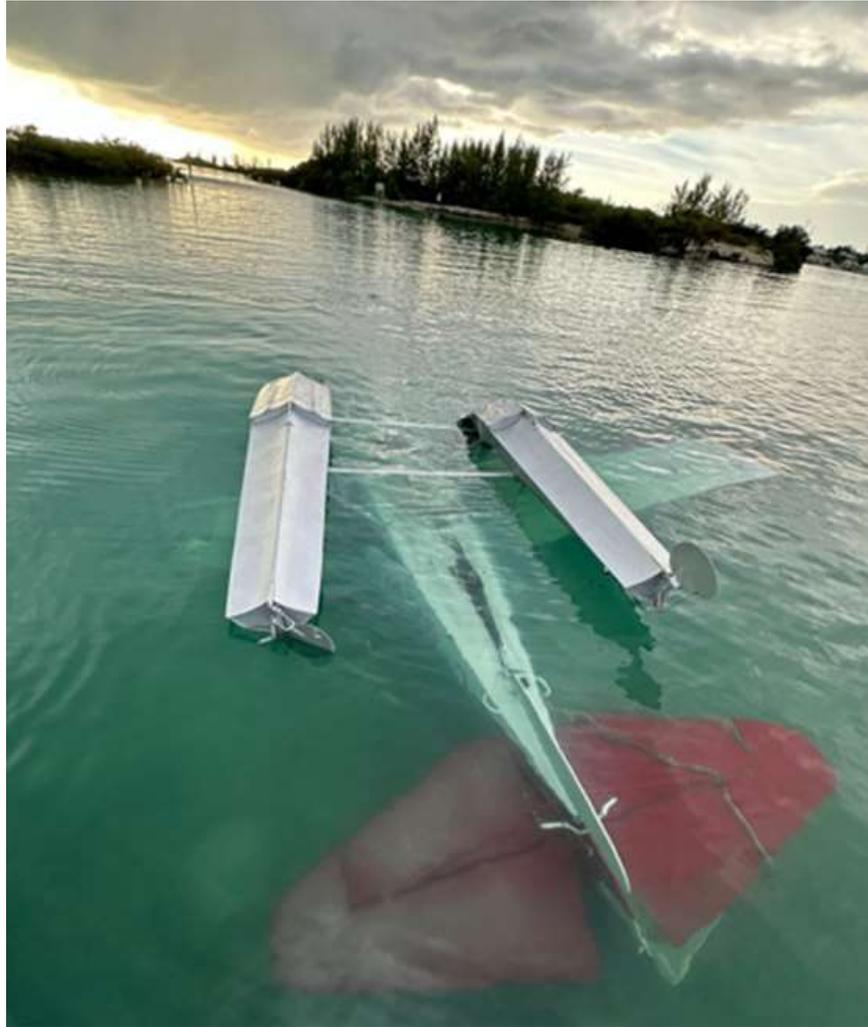
There were no injuries reported in relation to the accident. The aircraft received substantial damage in multiple areas including both wings, both floats and the fuselage.

Fig. 3: C-GCWI partially submerged in waters near settlement of Spanish Wells, Eleuthera, Bahamas
