Short Investigation Bulletin

DATE: March 10th, 2021
REPORT # AO21-000003
AIRCRAFT REGISTRATION: N909TT
INVESTIGATION STATUS: Closed

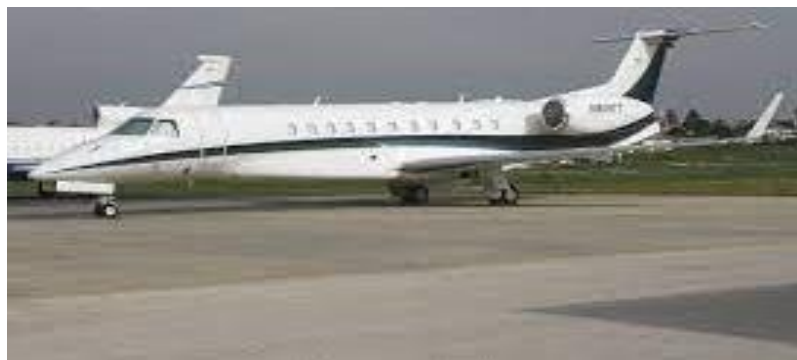
On March 10th 2021 an Embraer 145 aircraft, United States registration N909TT was involved in an incident, System Component Malfunction (none powerplant) at Lynden Pindling International Airport Nassau, Bahamas runway 14.

It was reported that the flight from Punta Cana, Dominican Republic (MDPC) was diverted to Lynden Pindling International Airport Nassau, Bahamas (MYNN) after the landing gears were unable to retract. No injuries were reported. There was 16 souls on board. No damage was reported.
