N522AR Accident Final Report

Published 27th December 2023

Location Norman’s Cay Airport (MYEN), Norman’s Cay, Exuma, Bahamas	Accident number OCC – 2023/0018
Occurrence Date & Time 26 th May 2023 9:40 am EDT (1340 UTC)	Registration N522AR
Aircraft Flight Conducted Under Instrument Flight Rules	Aircraft Make/Model Cirrus SR22

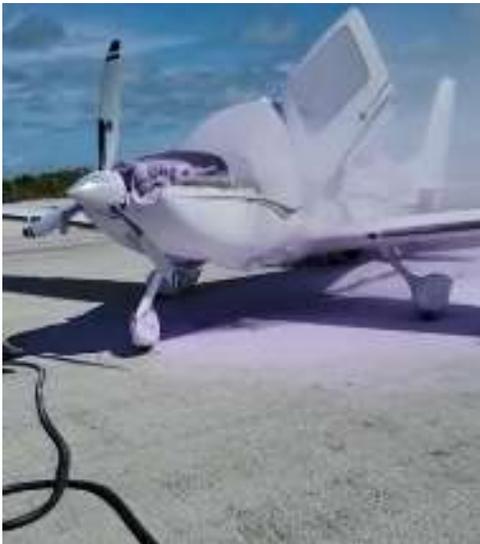
Fig.1: N522AR after landing MYEN

The pilot successfully landed the aircraft at Norman’s Cay Airport, but upon landing the aircraft, smoke was observed coming from the aircraft’s engine and after quickly exiting the aircraft, fire was seen emanating from the engine. A fire extinguisher on wheels was used to suppress the flames and it was brought under control and extinguished a short while after.

There were no injuries reported in relation to this occurrence and the aircraft’s engine and front of fuselage was fire damaged.

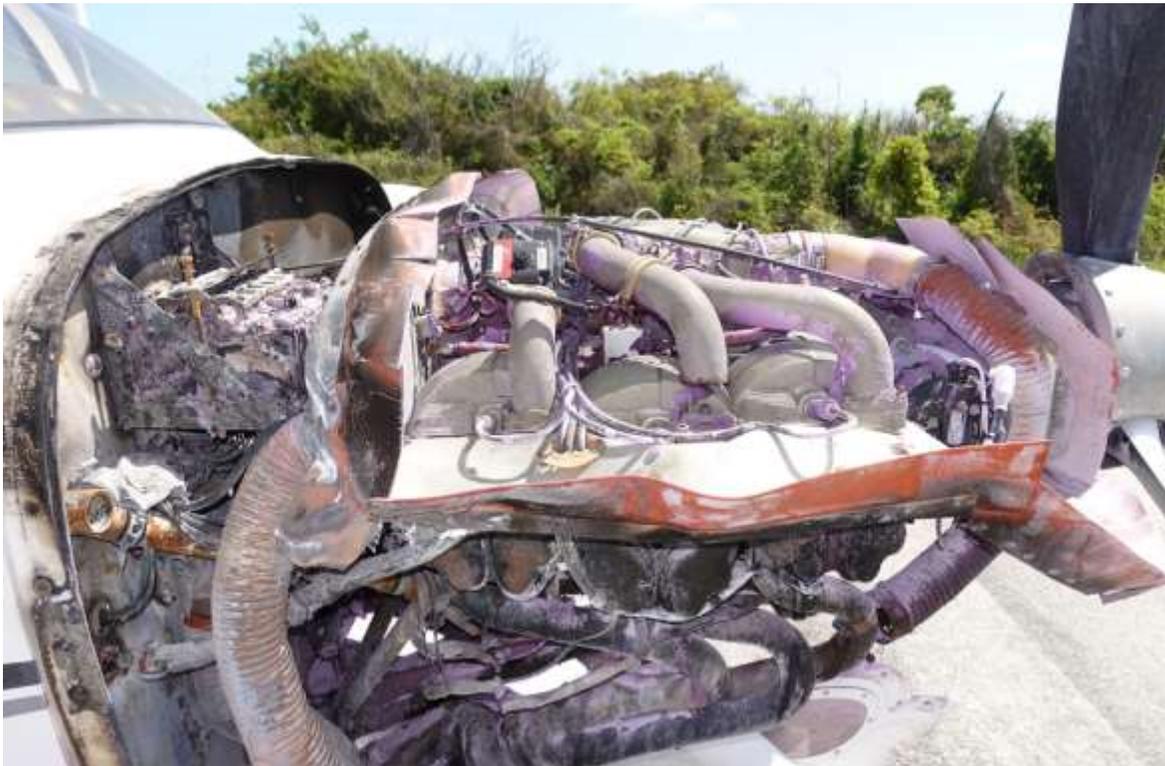
Further investigations revealed that the cylinder head of #3 cylinder assembly had separated from the barrel of that assembly. The barrel is made of steel whereas the cylinder head is made of aluminum and the two are joined by a threaded interface. They are screwed together in a permanent manner during the manufacturing process and are not designed to be disassembled. The exact cause of the separation was not determined.

Fig.3: Photo of aircraft engine at MYEN

The result of the failure of the cylinder assembly was an engine compartment fire. It would appear that the fire may have started due to the fuel injection line being torn off the cylinder assembly, which would then have led to raw fuel being pumped directly on top of the hot cylinder assembly which had an ignition source in the form of two exposed spark plugs. The spark plugs would likely still be firing and the engine driven fuel pump would continue pumping fuel as long as the engine continued to rotate.

As the pilot continued to operate the engine through the remaining time airborne, and then during landing and taxiing, this continued to feed to the existing fire resulting in substantial damage to the aircraft.

The AAIA lists the probable cause of this accident to be separation of the #3 cylinder head from the cylinder assembly resulting in an engine compartment fire.
