Short Investigation Bulletin

DATE: December 17, 2020
REPORT # 20-000274
AIRCRAFT REGISTRATION: C6-TOY
INVESTIGATION STATUS: Closed

Aircraft Type and Registration:	Piper Cherokee 32-300, C6-TOY
Year of Manufacture & Serial #:	1967, 32-40403
Number and Type of Engine(s)	1, Piston
Type of operation:	Private
Information Source:	Field
Nature of Damage:	Wing and propeller damage

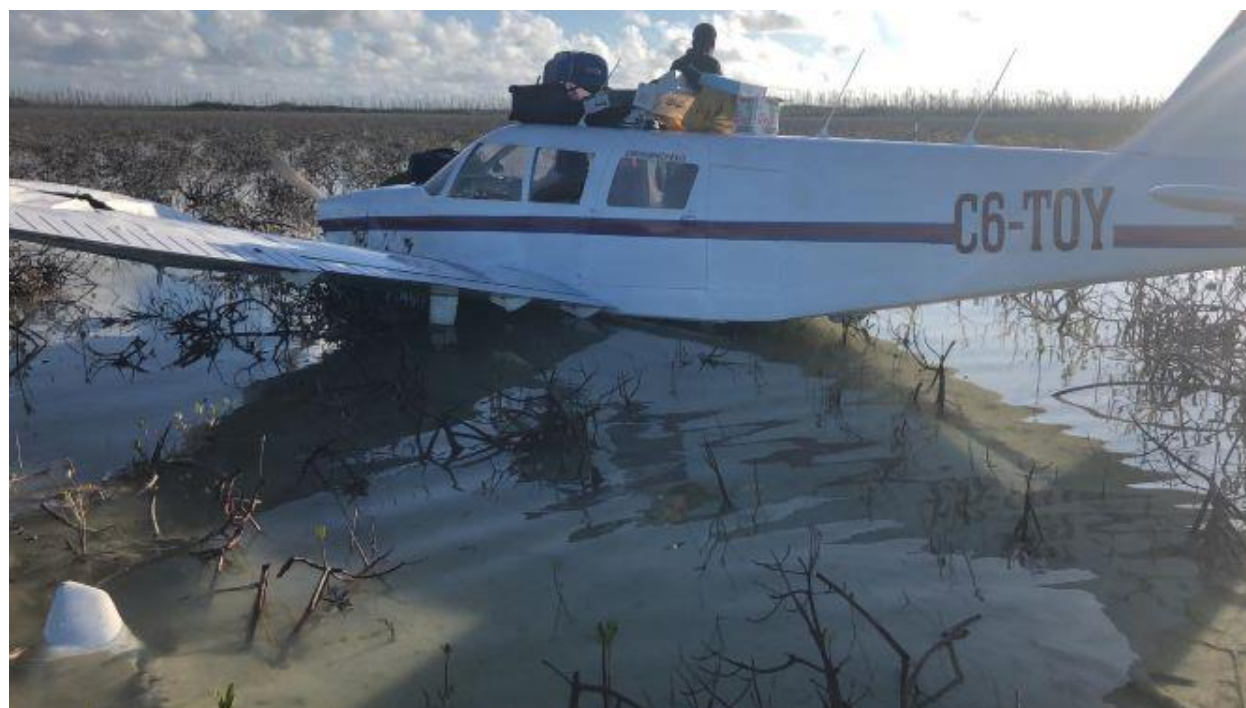
There were no reports of injuries to persons; however, the aircraft suffered damage to wings and propellers.
