Short Investigation Bulletin

DATE: 2nd September, 2022
REPORT # Occ-2022-0024
AIRCRAFT REGISTRATION: HI-919
INVESTIGATION STATUS: Complete

Aircraft Type and Registration:	Piper PA-34-200T, HI-919
Year of Manufacture & Serial #:	S/N 34-7770230
Number and Type of Engine(s)	Two Engines/ Continental (TSIO/LTIO-360EB) Reciprocating
Type of operation:	Private
Information Source:	Pilot
Nature of Damage:	Both Propellers and undercarriage

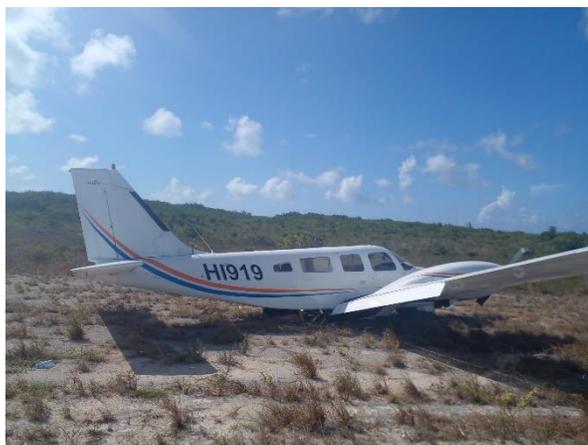
Upon landing at MYMM, the aircraft rolled on the runway for approximately two hundred feet, after which, both main landing gears collapsed. The aircraft received damages to both propellers and the underside of the aircraft fuselage. There were no injuries reported.
