## Short Investigation Bulletin

**DATE:** November 16<sup>th</sup>, 2021  
**REPORT #**A021-027  
**AIRCRAFT REGISTRATION:** N300TA  
**INVESTIGATION STATUS:** Closed

<b>Aircraft Type and Registration:</b>	Beech F90, N300TA
<b>Year of Manufacture &amp; Serial #:</b>	N/A / LA-9
<b>Number and Type of Engine(s)</b>	Two/ Turbo Prop
<b>Type of operation:</b>	Commercial
<b>Information Source:</b>	AAIA
<b>Nature of Damage:</b>	Right Engine Failure

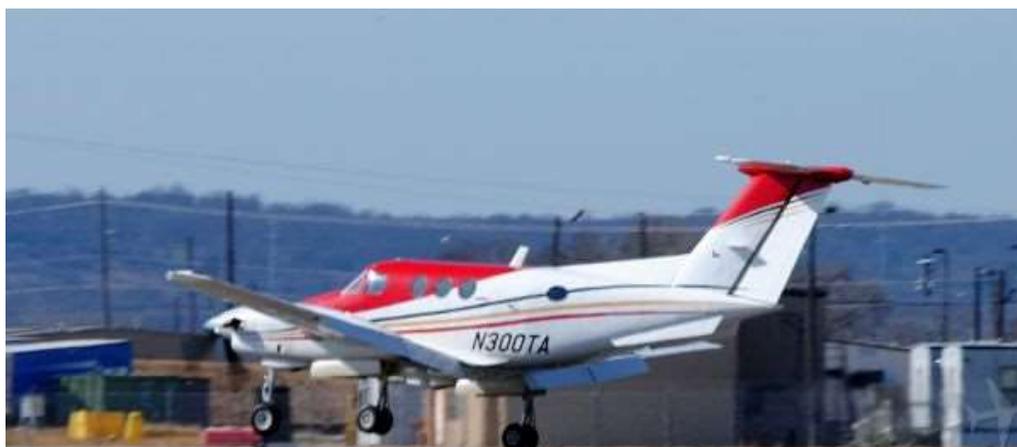
According to the pilot, while enroute to KBCT, he observed a right engine low oil pressure warning light indication on the annunciator panel. The warning light was extinguished, but re-illuminated shortly after followed by smoke in the cabin. The decision was then made to shut down the right engine and divert to MYNN.

The aircraft landed safely without further incident. There were no injuries were reported and the aircraft did not receive damages.
