Short Investigation Bulletin

DATE: November 16th, 2021
REPORT # OCC-2021/0032
AIRCRAFT REGISTRATION: C6-TTJ
INVESTIGATION STATUS: Closed

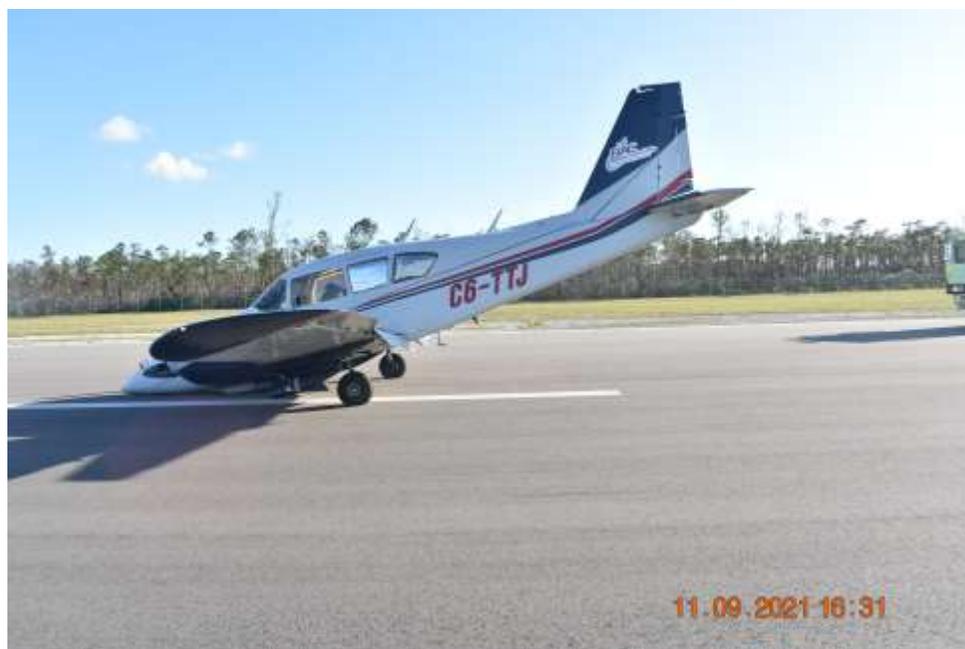
The flight departed the Exuma International Airport (MYEF), Exuma, Bahamas with six (6) souls on board. According to the pilot, after landing runway 10 at MYNN, the nose landing gear collapsed which subsequently left the aircraft temporarily disabled on the runway.

There were no injuries reported. The aircraft received damages to the underside of the nosecone and both propellers.

A limited scope investigation was conducted and later revealed mechanical failure of the nose landing gear locking mechanism.
