N91119 Preliminary Occurrence Report

Release Date 19th December 2024

| Near Grand Bahama Int'l Airport (MYGF), Freeport, Bahamas | OCC-2024/0049 |
| Piper PA-23-250 | 27-4121 |

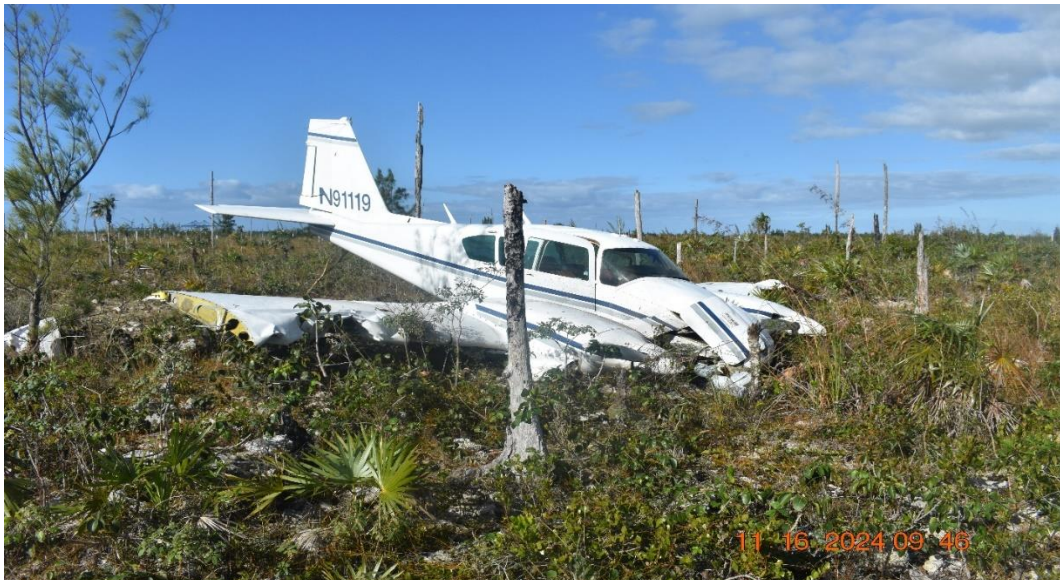
The aircraft crashed into bushes approximately 0.98 miles west of MYGF runway 06.

The aircraft received substantial damage, including to the leading and trailing edges of both wings, both propellers, underside of the fuselage, landing gear and nose cone.

Fig.1: Photo of N1119 point of rest

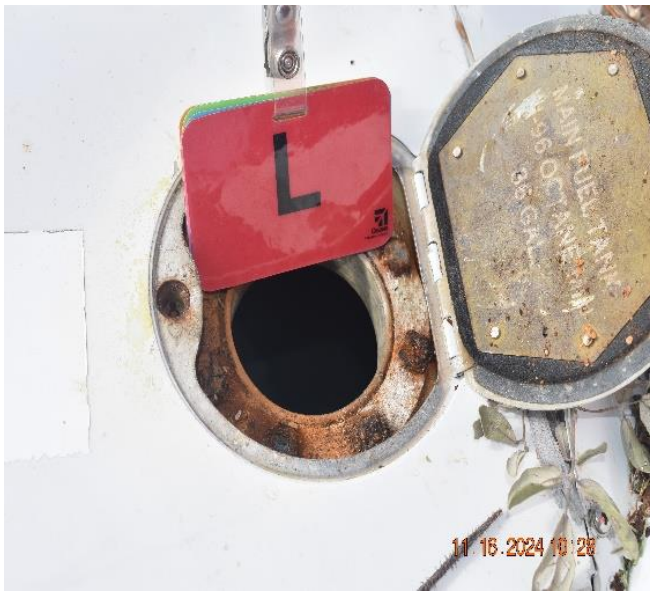
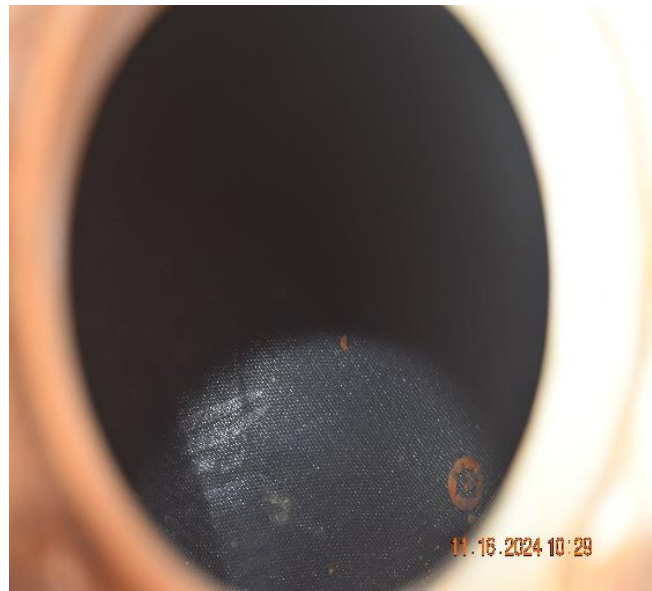
- No liquid consistent with AVGAS fuel was observed in the left wing outboard or inboard tank, nor was there observed any presence of AVGAS fuel under or around the left wing

Fig.2: Photos of left wing inboard fuel tank
