Short Investigation Bulletin

DATE: 22nd March, 2024
REPORT # OCC- 2024/0014
AIRCRAFT REGISTRATION: C6-WET
INVESTIGATION STATUS: Completed

Aircraft Type and Registration:	Maule M-7-260, C6-WET
Year of Manufacture & Serial #:	2007, 26020C
Number and Type of Engine(s)	1; Lycoming IO-540-V4A5
Type of operation:	Commercial
Information Source:	Occurrence Notification
Nature of Damage:	Right wing damage, float supports broken

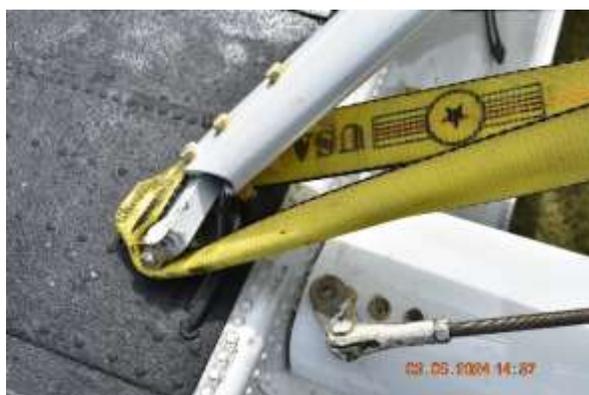
Post-accident review and analysis was conducted by AAIA investigators. It was observed that the aircraft lower right forward and aft drag wire (pull) assemblies were detached from their float connecting points. The rear lower wire pull was broken at its clevis pin connecting point. The forward lower wire pull remained fully intact (whole) and detached while its connecting bolt was found broken inside the right float.

Fig.1: Forward Lower Wing Pull

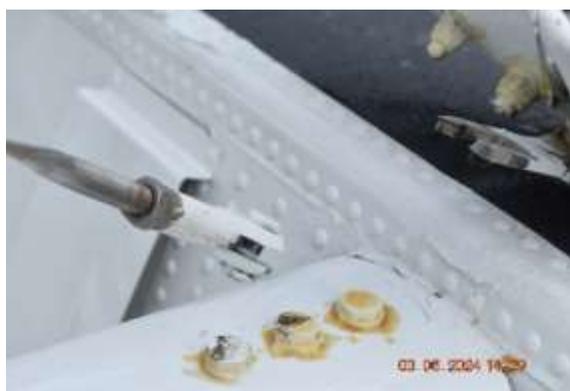
Fig.2: Aft Lower Wing Pull

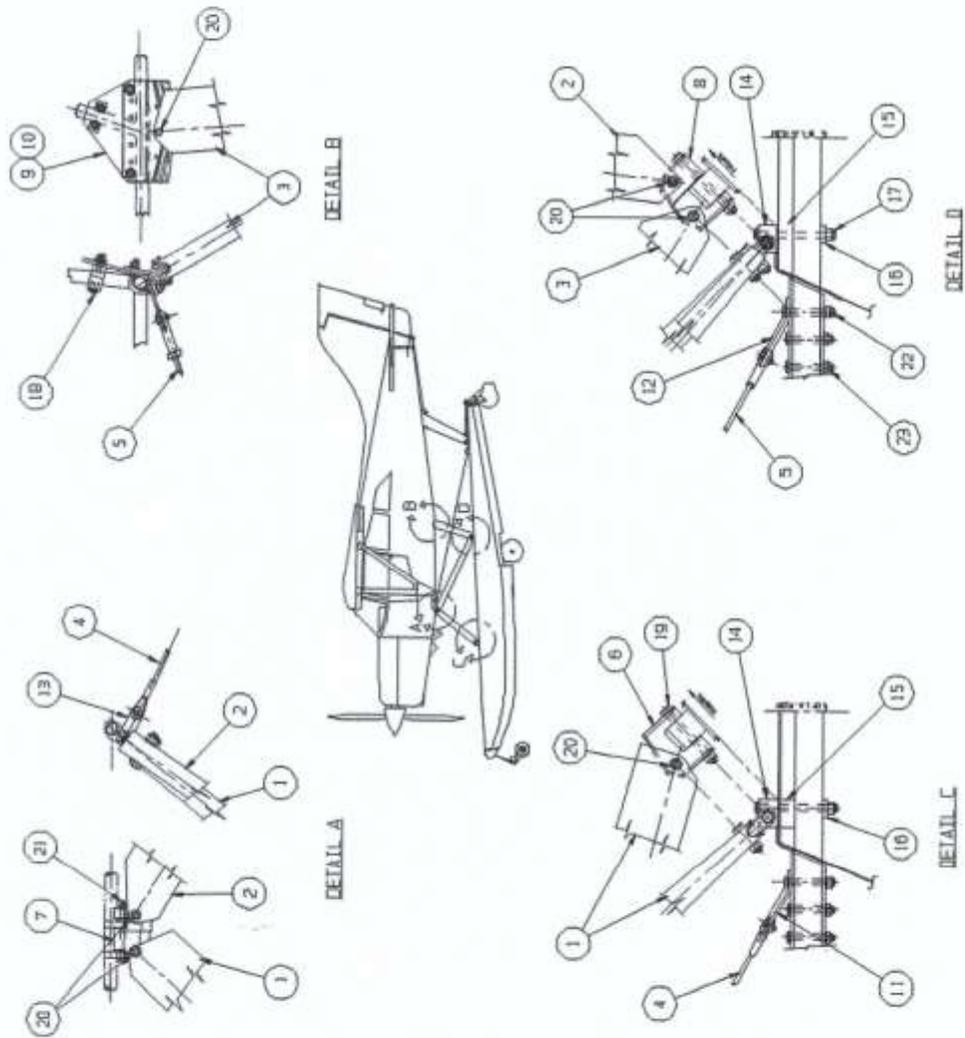
Fig.3: Excerpt from Maule Parts Manual

1. Front Strut
2. Center Strut
3. Rear Strut
4. Drag wire- Forward
5. Drag wire- Aft
11. Wire Pull- Lower FWD
12. Wire Pull- Lower AFT

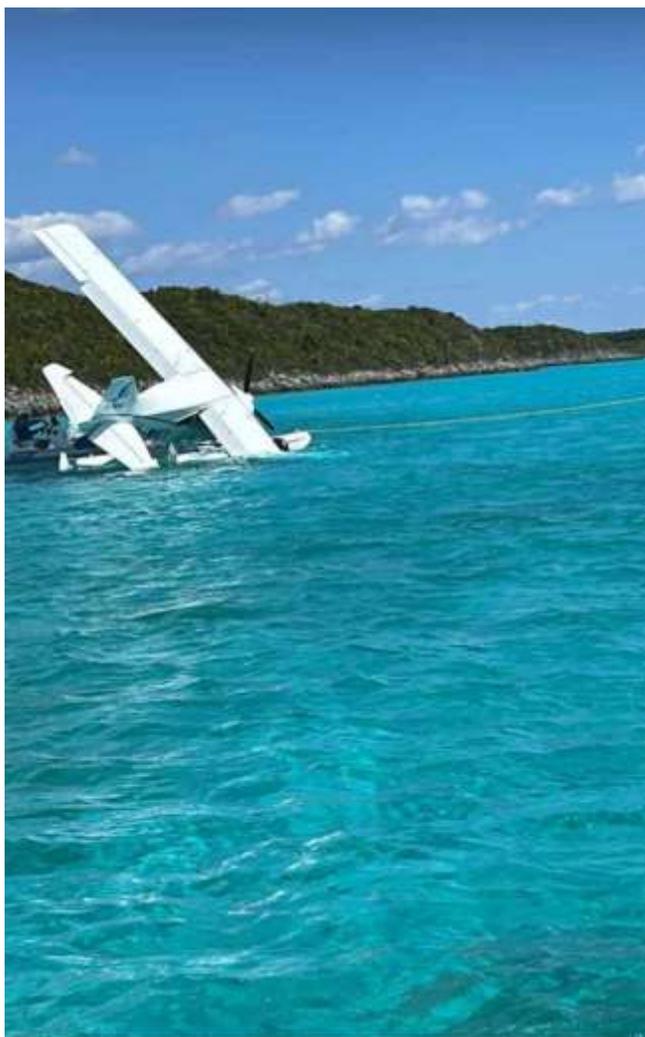
As a result, the aircraft fuselage rolled and pivoted at its right forward, center and aft strut connecting points causing the wing strut supports to collide with the float upon landing. The visual damage was noted to the aircraft right wing struts, right aileron and right wing.

Fig.4: Photo of C6-WET in aftermath of occurrence
