Aviation Short Investigation Final Report

Beech B99, C6-OFM

Black Point Airport (MYEB), Black Point, Exuma, Bahamas
17th October 2022

AAIA Aviation Occurrence Investigation
Report # OCC-2022/0031

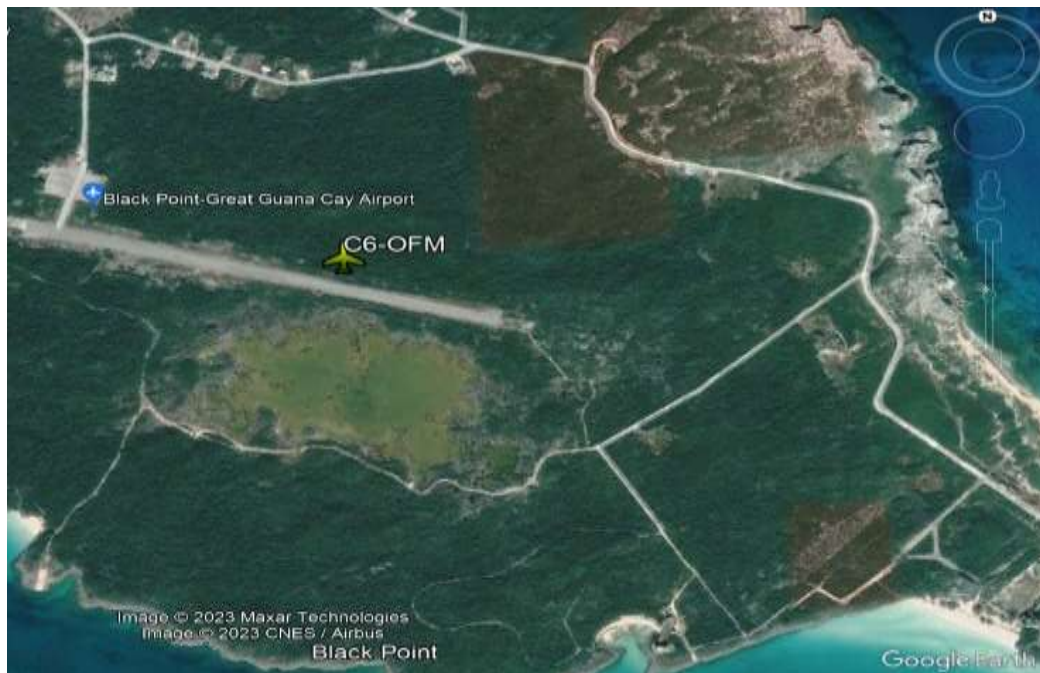
Fig. 2 Google Earth Imagery of Crash site at MYEB

Investigations indicated that upon landing runway 11 at MYEB, there was a collapse of the left main landing gear which led to the aircraft veering off to the left side of the runway's centerline. It then travelled a distance of approximately 1,516 feet down the runway, at which point it exited the useable paved portion of the runway (left side), ultimately coming to rest in bushes after travelling an additional 265 feet.

The aircraft came to rest at coordinates 24° 05'21.20"N 76°23'48.10"W And was oriented in a northerly direction (approximately 355°) at a distance of approximately 50 feet from the runway's edge. There were damages observed to the left wing, left propeller, and

aircraft undercarriage including the pod. There were no reported injuries in relation to the occurrence.

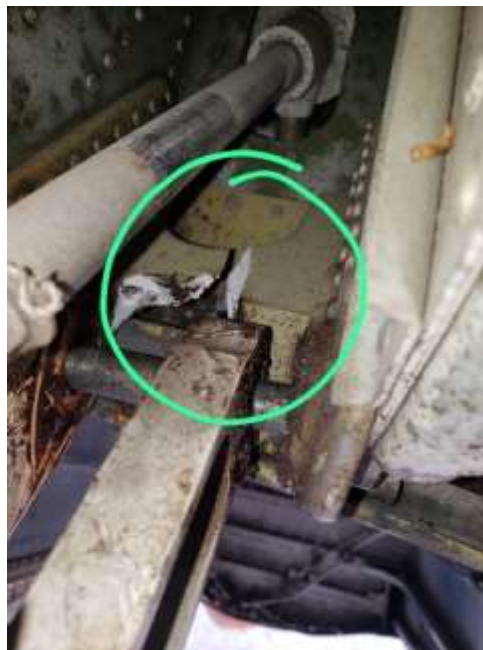
Fig. 3 Left main landing gear drag brace support fitting

Post-accident, upon inspection of the left main landing gear, it was discovered that there was a fracture in the left main landing gear drag brace support fitting.

- 9) Post-accident inspection revealed a failure of left main landing gear drag brace support fitting.
- 10) The Black Point Airport (MYEB) was void of runway markings as required by applicable Bahamas CAR AGA Regulations.

The AAIA has determined the probable cause of this accident to be system component failure – non powerplant (SCF-NP) – left main landing gear drag leg support fitting.

Subsequently, in a letter dated 30th November 2022, the CAA-B issued the following to the Operator: ***In accordance with CAR OPS1.890 (a) (5) and in the interest of safety, the Authority require the amendment of Flamingo Air Limited Approved Maintenance Program FL/B99/AAIP for incorporation and implementation of the element of Beech 99 Maintenance Manual 05-50-00 (2) Inspection After Hard Landing; (2) Landing Gear; Inspections (a-h) every 25 hours of flight time to detect any fault and mitigate any failure of the main landing gear drag brace support, the drag brace assembly and attaching parts.***

The AAIA was in agreement with the measure utilized by the CAA-B, as it would seek to take a proactive posture by requiring the shortening of the inspection interval from 200 hours to 25 hours which would potentially provide an opportunity to identify the development of faults or signs of fatigue within the component.

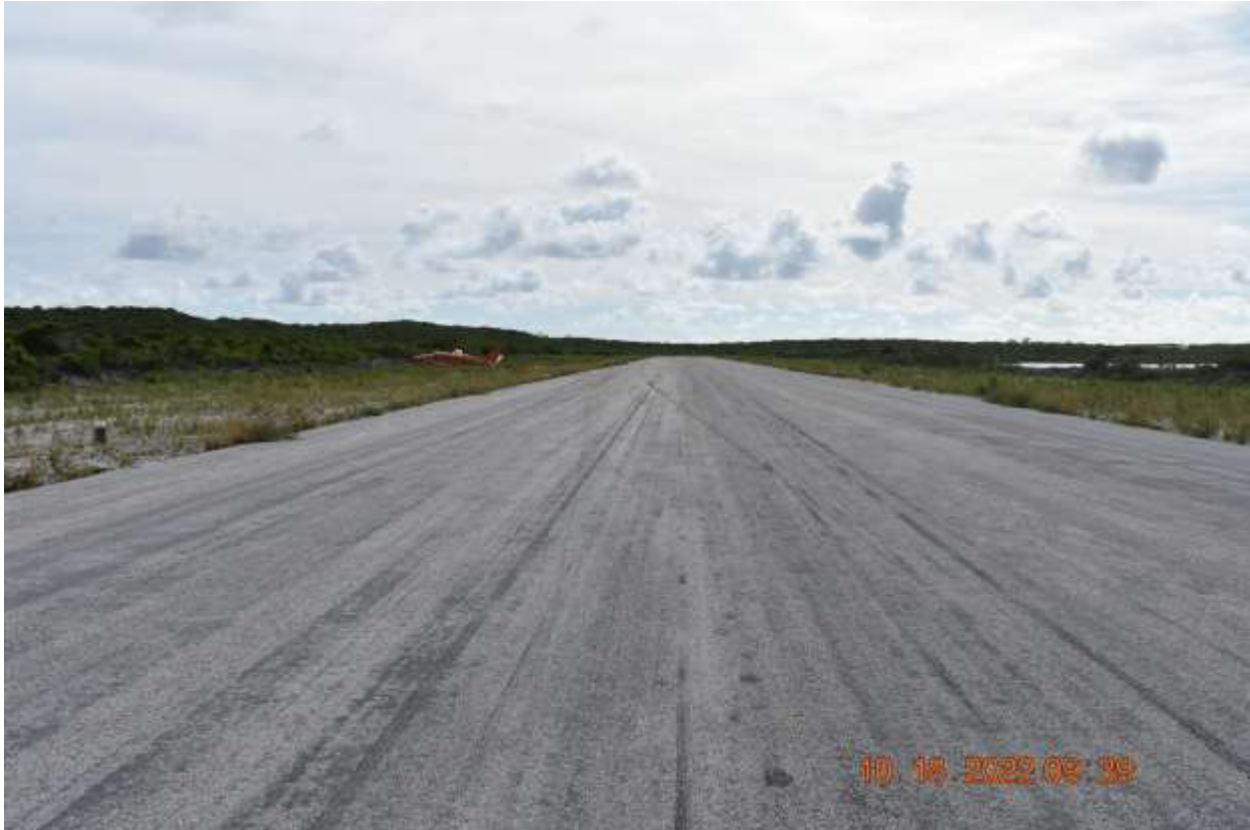
Fig. 4 Runway 11 at MYEB

Runway edge lights, runway end lights, and taxiway edge lights are installed at the aerodrome. The aerodrome is void of runway markings (runway threshold markings, runway designation markings, runway holding position markings, and runway centerline marking).

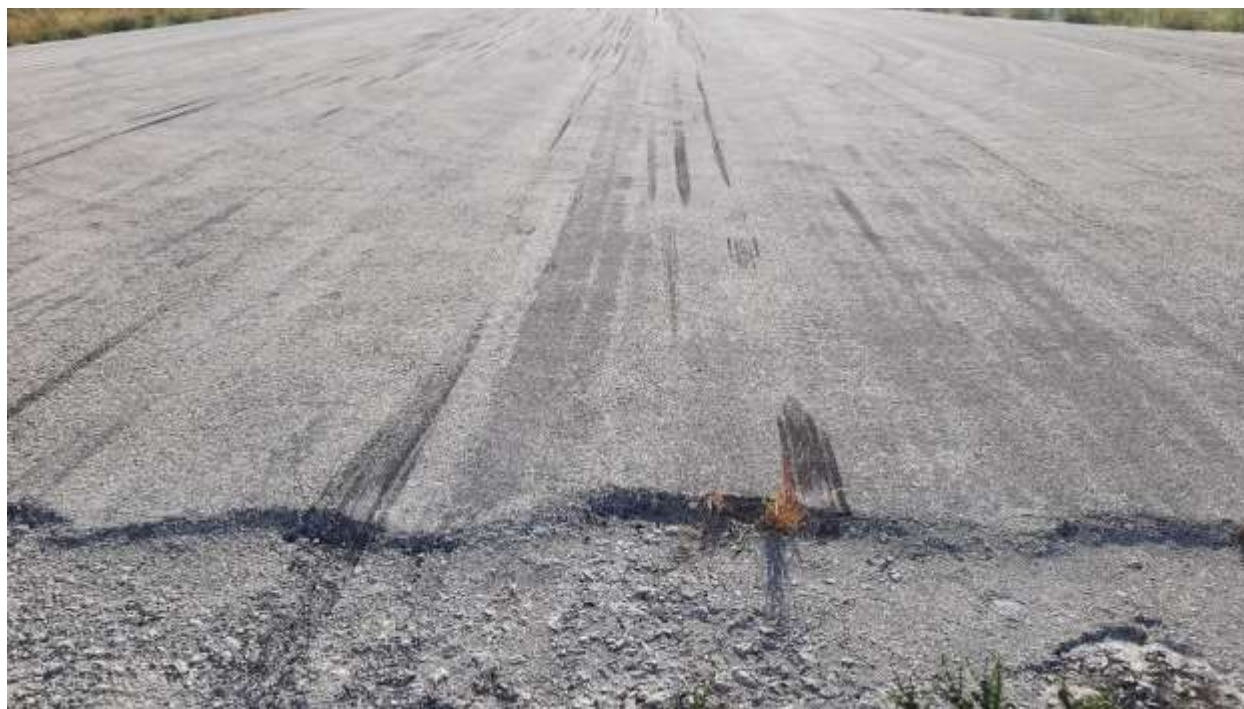
Fig.5 Threshold of Runway 11 at MYEB

In review of several occurrences that would have taken place at the Black Point Airport (MYEB), Black Point, Exuma, Bahamas during the three (3) years prior to this accident, there were similarities seen in a few of the events with regard to pilots touching down prior to the paved usable portion of the runway, as evidenced by the presence of tire signature markings prior to the paved runway surface.

The fact that these occurrences involved more than one operator, and aircraft of varying types, highlights the possibility that the common factor, which is the aerodrome, may have presented some deficiencies that are contributory.

- 5) The aircraft was not equipped with a flight data recorder (FDR) or a cockpit voice recorder (CVR); neither was required by regulation.
- 6) Tire signature markings were observed prior to the beginning of the paved usable portion of runway 11/29 at MYEB.

As the MYEB aerodrome was void of any runway markings up to the time of this occurrence, and in consideration of the prior similar occurrences and the above mentioned regulations, the AAIA issued safety recommendation SR2022-002 to the Airport Authority of The Bahamas on 20th October 2022: ***The Aircraft Accident Investigation Authority (AAIA) recommends that, without delay, the Airport Authority implements the placement of appropriate runway markings at Black Point Airport (MYEB), including threshold markings that will aid pilots in landing operations.***

In a correspondence dated 14th November 2022, the Airport Authority presented to the AAIA, a corrective action plan (CAP) to address the deficiencies noted in safety recommendation SR2022-002. The CAP included the addition of runway threshold markings, runway designation markings, and runway holding position markings at MYEB.
