# Aviation Investigation Final Report

<b>Location:</b>	Big Grand Cay,	<b>Accident Number:</b>	ERA19FA210
<b>Date &amp; Time:</b>	July 4, 2019, 01:53 Local	<b>Registration:</b>	N32CC
<b>Aircraft:</b>	Agusta AW139	<b>Aircraft Damage:</b>	Substantial
<b>Defining Event:</b>	Loss of control in flight	<b>Injuries:</b>	7 Fatal
<b>Flight Conducted Under:</b>	Part 91: General aviation - Personal

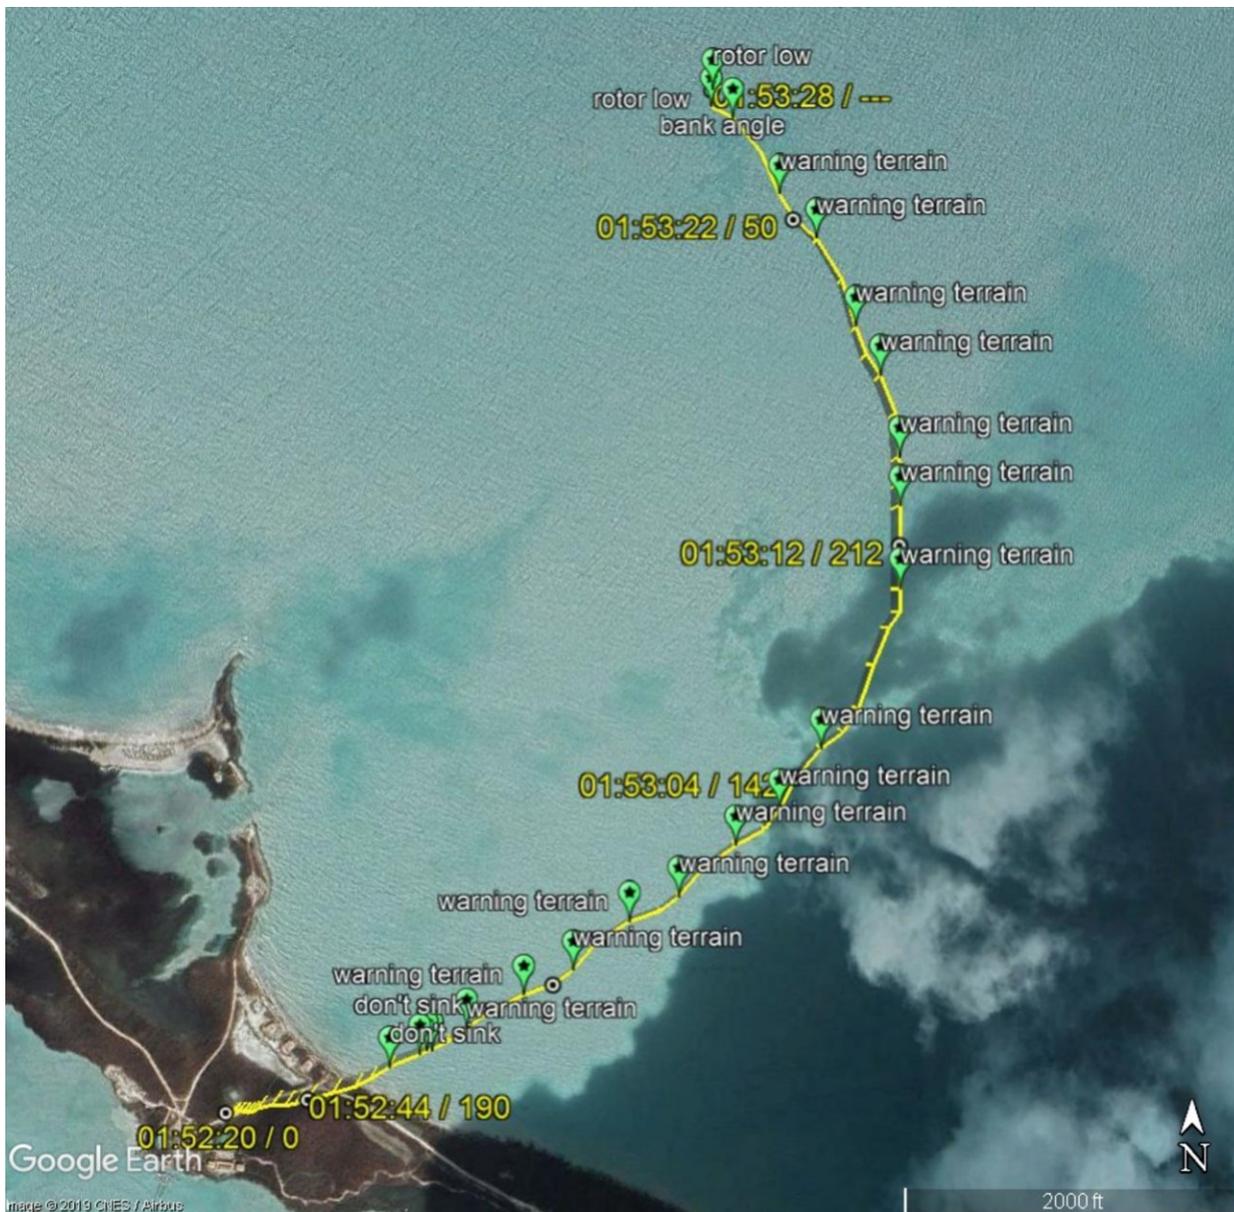
At 0153:13, the helicopter again began to descend, and the SIC stated, "there was a fatal accident in the United Kingdom and this is exactly what happened there." (EGPWS warnings continued through this time.) Two seconds later, with the collective control about 70%, the rate of collective increase slowed as power index (PI) values increased to about 80%. Over the next 8 seconds, the collective position gradually increased to about 75% and PI values increased to about 86%. While descending in a nose-down attitude with the airspeed increasing, the PIC asked the SIC multiple times for headings and once for altitude, but the SIC did not respond. According to an NTSB performance study, the helicopter impacted the water about 0153:22 while in a 7°-nose-down and 12°-left-bank attitude. The CVR recorded no aural master cautions or warning annunciations during the flight. Figure 1 shows the cockpit annunciations recorded on the CVR and select times and altitudes.

Figure 1. Cockpit announcements recorded on CVR with select times and altitudes (Figure contained in the NTSB Performance Study)
