Short Investigation Bulletin

DATE: 14th April 2023
REPORT # OCC-2023/0015
AIRCRAFT REGISTRATION: N619MW
INVESTIGATION STATUS: Completed

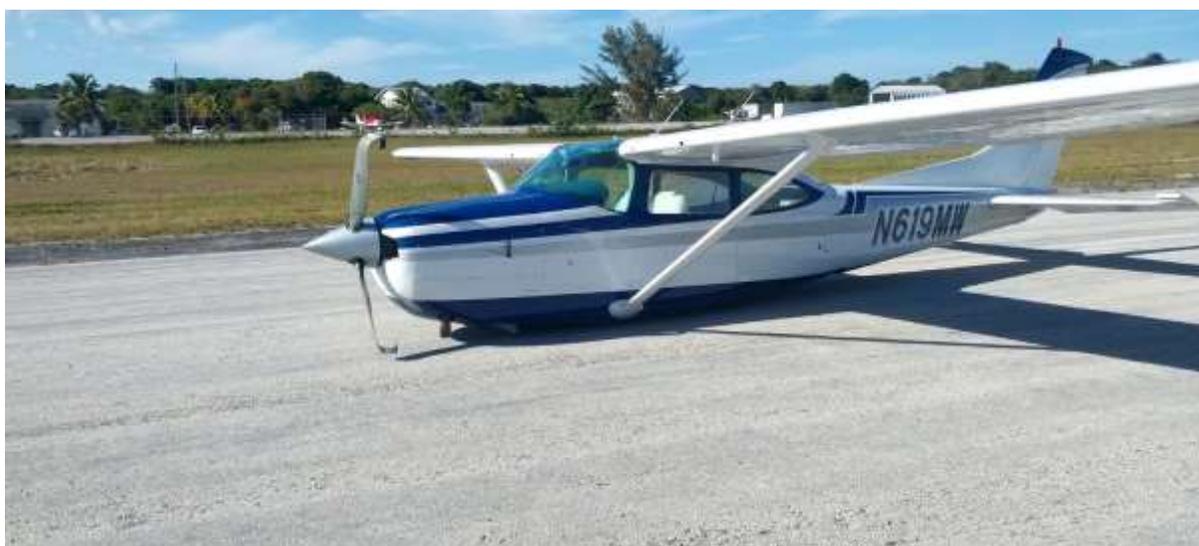
Reports received indicate that the pilot in command proceeded to land the aircraft without the benefit of its landing gear. This resulted in the aircraft propeller blades and underside of the fuselage coming into contact with the runway surface causing subsequent damage to the aircraft.

Fig. 1 Photo of N619MW at MYEH
