# Aviation Short Investigation Final Report

Fuel Related – (Fuel)  
Piper PA-32-301 – N106MR

**Marsh Harbour, Abaco, Bahamas**  
**10<sup>th</sup> September 2023**

**AAIA Aviation Occurrence Investigation**  
**Report # OCC-2023/0033**

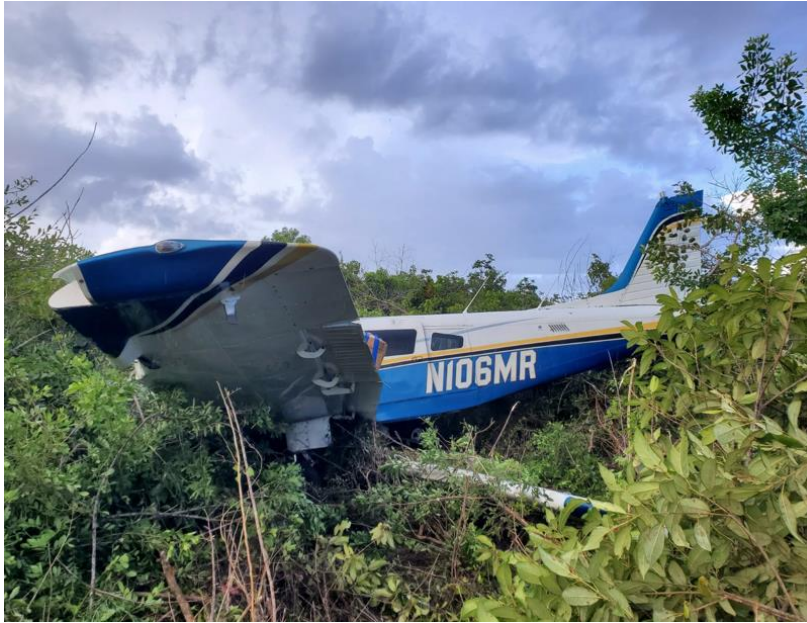
*Fig.2: N106MR Point of Rest*

The aircraft came to rest in an area of dense brush at coordinates 26 26 25.6N 77 06 08.1W, at a distance of approximately 4.97 miles south of the Leonard Thompson International Airport (MYAM), Marsh Harbour, Abaco, Bahamas.

The aircraft was oriented in a westerly direction facing a heading of approximately 280° and positioned in a slightly nose down attitude on its right side. The right wing of the aircraft was detached from the fuselage at the wing chord and rested inverted diagonally.

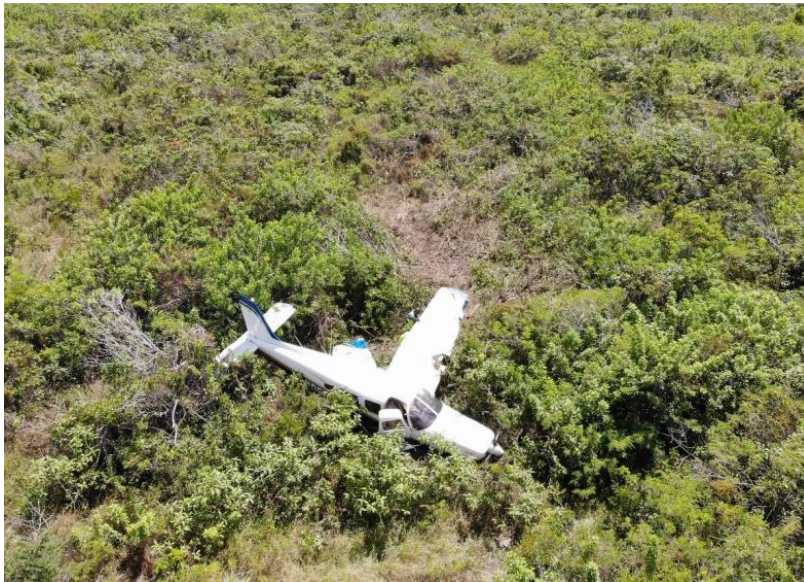
*Fig.3: Drone shot of N106MR*
