# CS-CHJ Preliminary Occurrence Report

Release Date 12<sup>th</sup> February 2025

<b>Location</b>	<b>Occurrence Number</b>
Lynden Pindling Int'l Airport (MYNN), Nassau, Bahamas	OCC-2025/0002
<b>Occurrence Date &amp; Time</b>	<b>Registration</b>
20 <sup>th</sup> January 2025 3:55 pm local (2055 UTC)	CS-CHJ
<b>Aircraft Make/Model</b>	<b>Serial Number</b>
Bombardier BD-100-1A10 (Challenger 350)	20832
<b>Flight Conducted Under</b>	<b>Occurrence Category</b>
Visual Metrological Conditions	Serious Incident

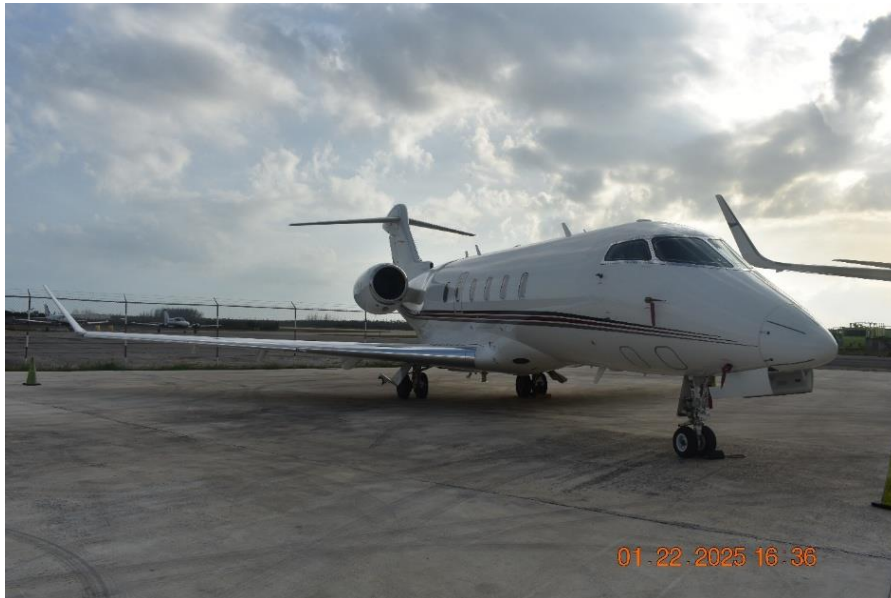
*Fig.1: Photo of aircraft parked at MYNN*

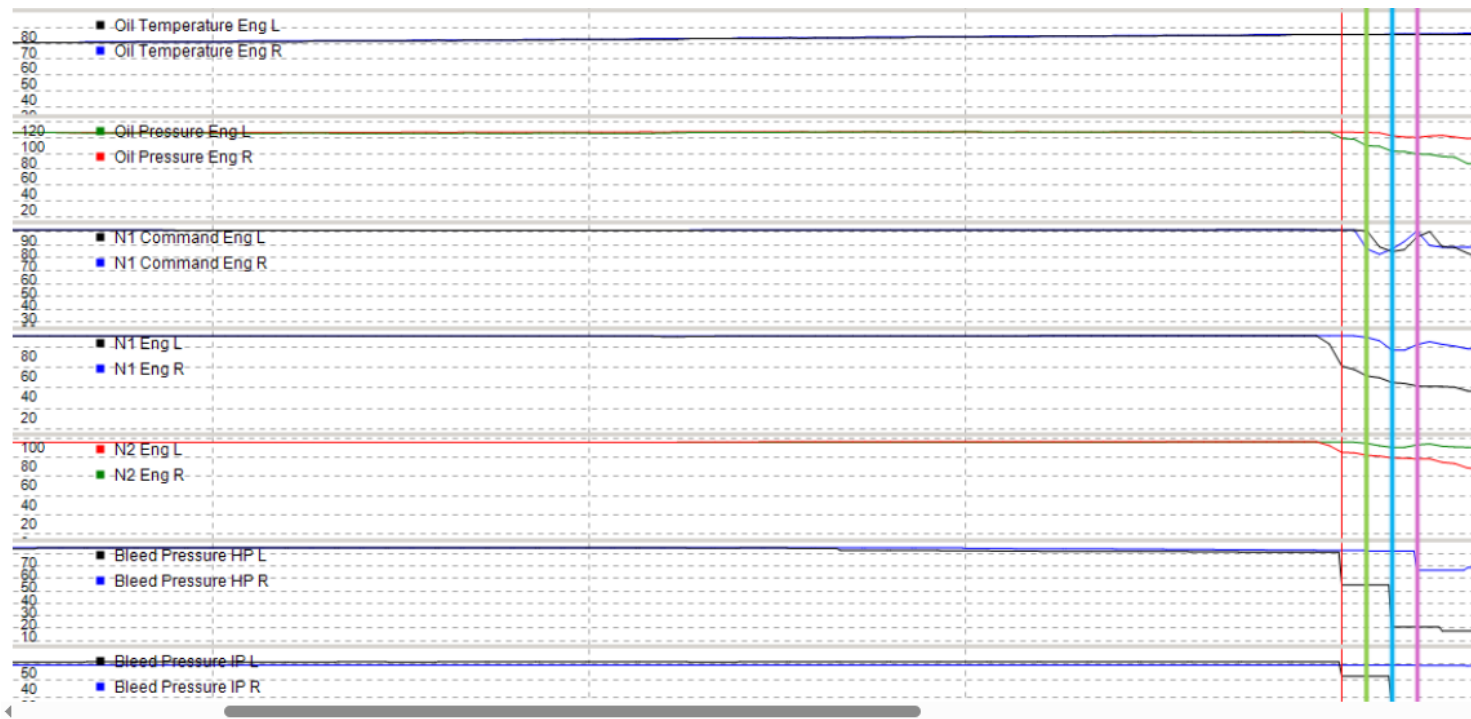
*Fig. 2: Excerpt taken from Initial Assessment of FDR readout (Plot 1)*

After take-off from MYNN, at 20h55min38s UTC, at 6405ft pressure altitude (“Altitude Pressure L”) and airspeed equal to 218kts (“Computed Airspeed ISI”), vibration in Engine #1 (“Vibration Eng L”) equaled 0.34in/s, while Engine #2 vibration (“Vibration Eng R”) equaled 0.13in/s.

The vibration increase on engine #1 only lasted circa 2 seconds, as it can be seen on plot 1.

“Bleed Pressure HP L” and “Bleed Pressure IP L”, which had been similar, respectively “Bleed Pressure HP R” and “Bleed Pressure IP R”, had a drop:

- “Bleed Pressure HP L” from 71.5Psi to 45Psi
- “Bleed Pressure IP L” from 51.3Psi to 42.5Psi

- “Bleed Pressure HP L” reached 0.3Psi (at 20h59min08s) and value was the same for the remainder of the flight.
- “Bleed Pressure IP L” reached minimum value of 11.3Psi (at 20h59min14s) increasing afterwards to values similar to “Bleed Pressure IP R”.

“Oil Pressure Eng L” dropped from 108psid to 100psid. Continued decreasing to 0psid (at 20h59min33s).

“Fuel Flow Eng L” had a drop. Previously 2978lb/hr, at this moment equaled 2830lb/hr; later reduced to 0lb/hr (at 20h58min59s) and so it remained for the remainder of the flight.

One second later, parameter “CAS Alert L Engine Exceedance” was equal to “Exceed”.

“N1 Command Eng R” was reduced from 91.9% to 77.1%. Minimum value recorded was 73%. It was later increased again.

“Throttle Lever Angle L” and Throttle Lever Angle R”, which had been equal to 40.2° and 40.1°, respectively, changed to 17.8° and 17.6°, respectively.

“Throttle Lever Angle L” continued decreasing until 0° (at 20h55min49s); “Throttle Lever Angle R” later increased to 40.1° (at 20h55min56s)

Parameter “ITT High Eng L” equal to recorded value ITT High.

“Lateral acceleration” and “Longitudinal acceleration” minimum values recorded: -0.103g and 0.101g, respectively.

“ITT Eng L”, which had been similar to “ITT Eng R”, reached the maximum of 1162°C (for reference, “ITT Eng R” was equal to 840°C).

“ITT Eng L” then started to decrease to the minimum of 42°C (at touchdown)
