# N13984 Final Report

<b>Location</b> 0.38 NM from the Exuma International Airport (MYEF), George Town, Exuma, Bahamas	<b>Accident number</b> OCC-2023/0002
<b>Date &amp; Time</b> 6 <sup>th</sup> January 2023 10:15 AM EST (1515 UTC)	<b>Registration</b> N13984
<b>Flight Conditions</b> Visual Flight Rules	<b>Injuries</b> Nil

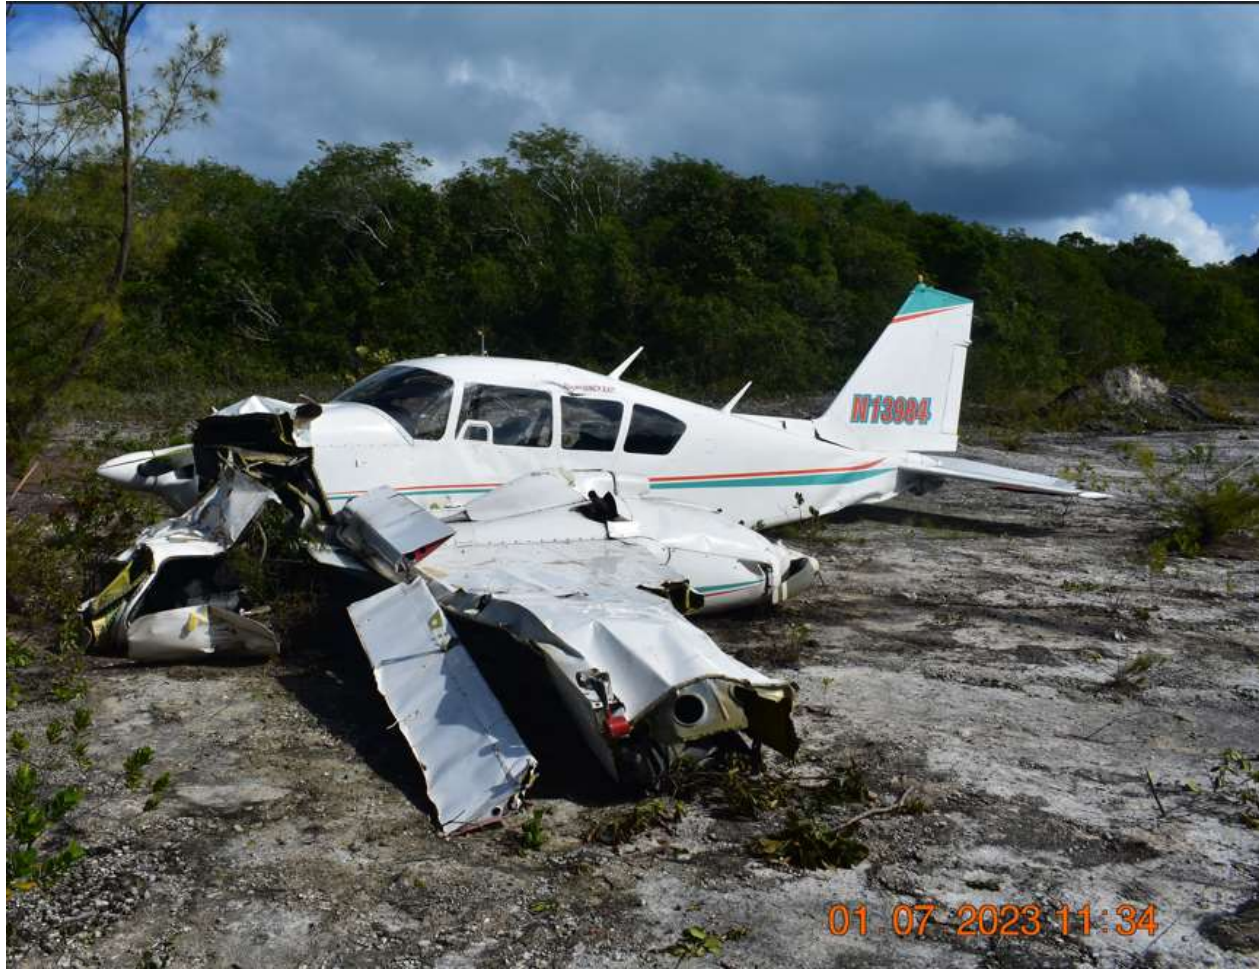
Fig. 1 Photo of N13984 at accident site

The left wing of the aircraft received substantial damage and was detached from the fuselage at the wing chord, resting in an inverted position with one of the propeller blades bent extremely aft and the aileron partially separated from the trailing edge. The right wing was heavily damaged with a crumpled leading edge, but remained attached to the fuselage with one of the propeller blades bent aft. The nose section of the aircraft was separated and crumpled, resting in front of the inverted left wing of the aircraft. Impact damages were also observed to the tail section of the aircraft.

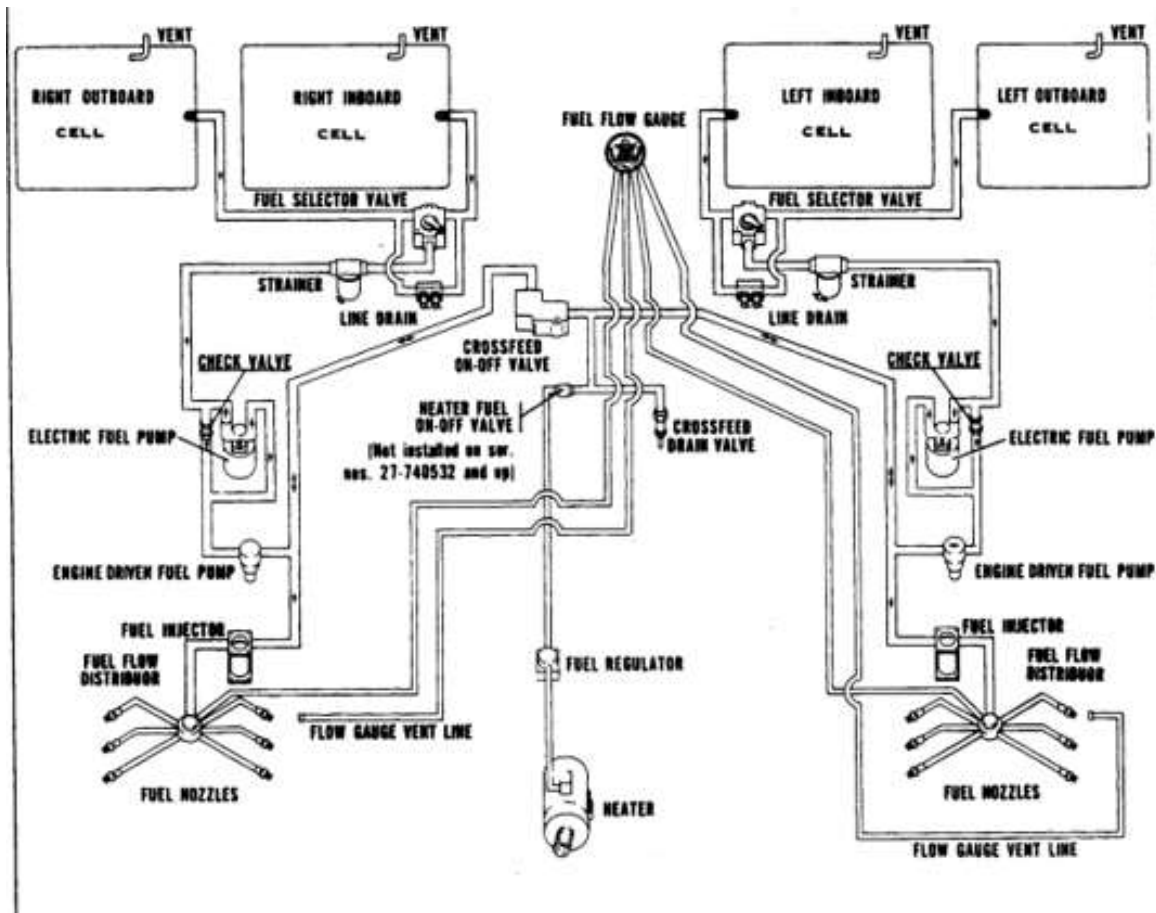
A pressure crossfeed system is incorporated for extended range during single-engine operation. To utilize the fuel on the inoperative engine side, turn the crossfeed on, the main valve on the inoperative engine on, the electric fuel pump of the inoperative engine on, then the main valve of the operating engine off.

Fuel can thus be used from one tank or the other by shutting off one main valve, and turning on the crossfeed, to balance fuel loads or to extend range. For all normal operation, it is recommended that fuel be pumped directly from the tanks to their respective engines, with the crossfeed off.

Fig. 2 Fuel System Diagram Piper PA-23-250  
(Piper Service Manual Reissued 2/18/81)

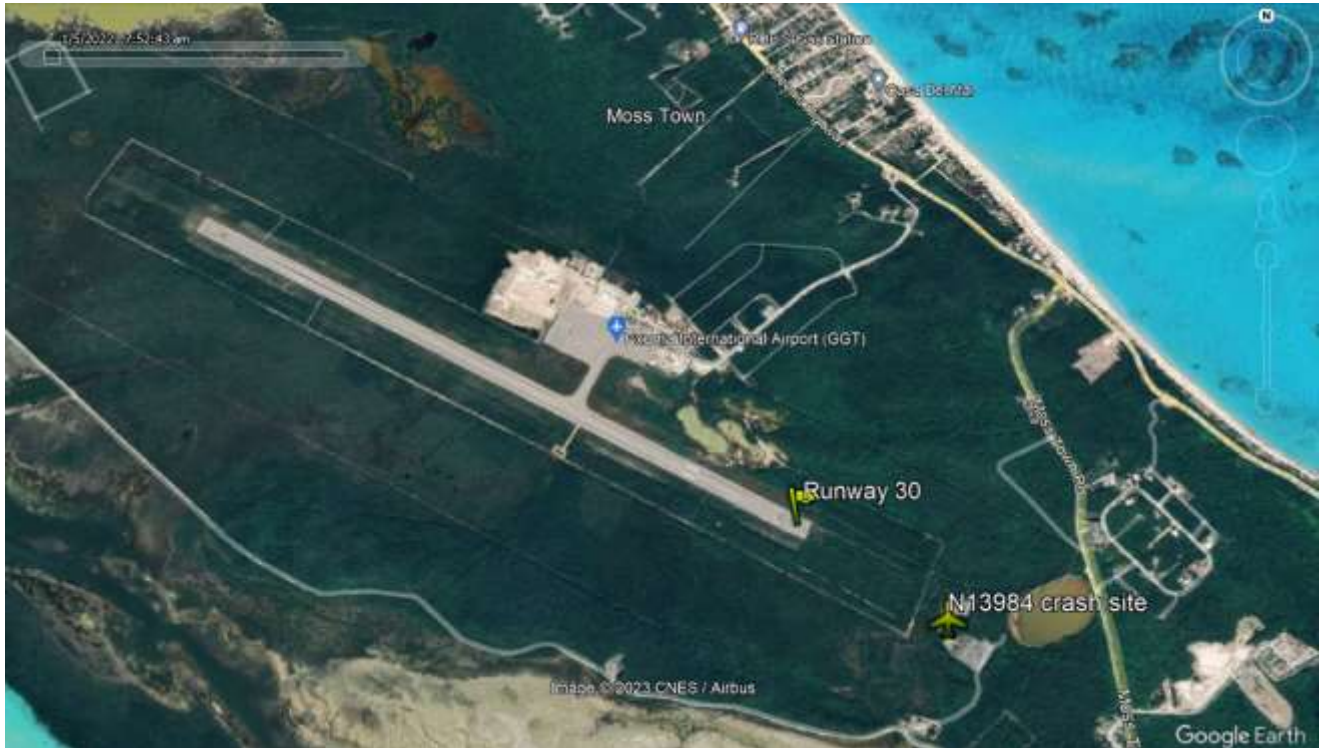
**Fig. 3 Google Earth imagery of crash site**

On the 7th January 2023, a team of investigators were dispatched to the accident site to conduct the on scene portion of the investigation. The aircraft point of rest was at coordinates 23°33'16.70"N 75°51'48.80"W at a distance of approximately 2,020 feet (0.38 NM) from the threshold of runway 30 at MYEF.

The first point of impact with trees (left wing) was measured to be approximately 1,820 feet from the threshold of runway 30 and the aircraft travelled for an additional 200 feet before coming to rest. The aircraft debris field was observed and it was noted where the aircraft travelled along a path of approximately 130° through trees and into a cleared area of land, leaving behind various aircraft components.

The left wingtip of the aircraft was observed at a distance of approximately 194 feet from the aircraft. The next piece of debris was the aircraft nosecone at a distance of approximately 60 feet from the aircraft, and the right wingtip a distance of approximately 25 feet from the aircraft (measurements taken from aircraft forward bulkhead).

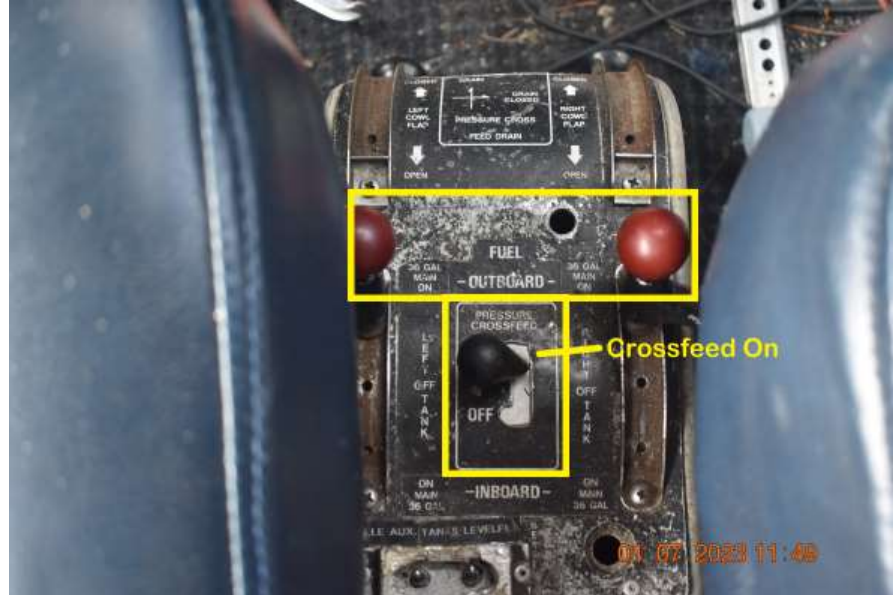
Photo documentation of the aircraft instrument panel was conducted. The following control positions were observed:

Mixture levers – Full Rich  
Propeller levers – High RPM  
Left Throttle lever - Open  
Right Throttle – Aft position  
Left Electric Fuel Pump – On  
Right Electric Fuel Pump – On  
Master Switch – Off  
Pressure Crossfeed – On  
Left Fuel Selector – Outboard  
Right Fuel Selector – Outboard  
Left Engine Magnetos – Off  
Right Engine Magnetos – Off  
Flaps – Down position  
Landing Gear – Down position  
Landing Light - Off  
Taxi Light – Off  
Anti-collision Light – On  
Position – Light – On

During the on scene investigation, the pressure crossfeed was observed and documented in the "ON" position. No verification was received to indicate that it was positioned to "ON" position prior to or during the accident sequence.

However, this observation suggests that if the crossfeed lever was positioned to the "ON" position prior to takeoff, then the aircraft would not be properly configured for takeoff in accordance with the Manufacturer's procedures and recommendations, which advise that "fuel be pumped directly from the tanks to their respective engines, with the crossfeed off". Aircraft configuration in accordance with manufacturers' procedures provide for optimal aircraft performance.
