N13984 Preliminary Accident Report

Location	Accident number
Exuma International Airport (MYEF), George Town, Exuma, Bahamas	OCC-2023/0002
Date & Time	Registration
6 th January 2023 10:15 AM EST (1515 UTC)	N13984
Flight Conditions	Injuries
Visual Flight Rules	Nil

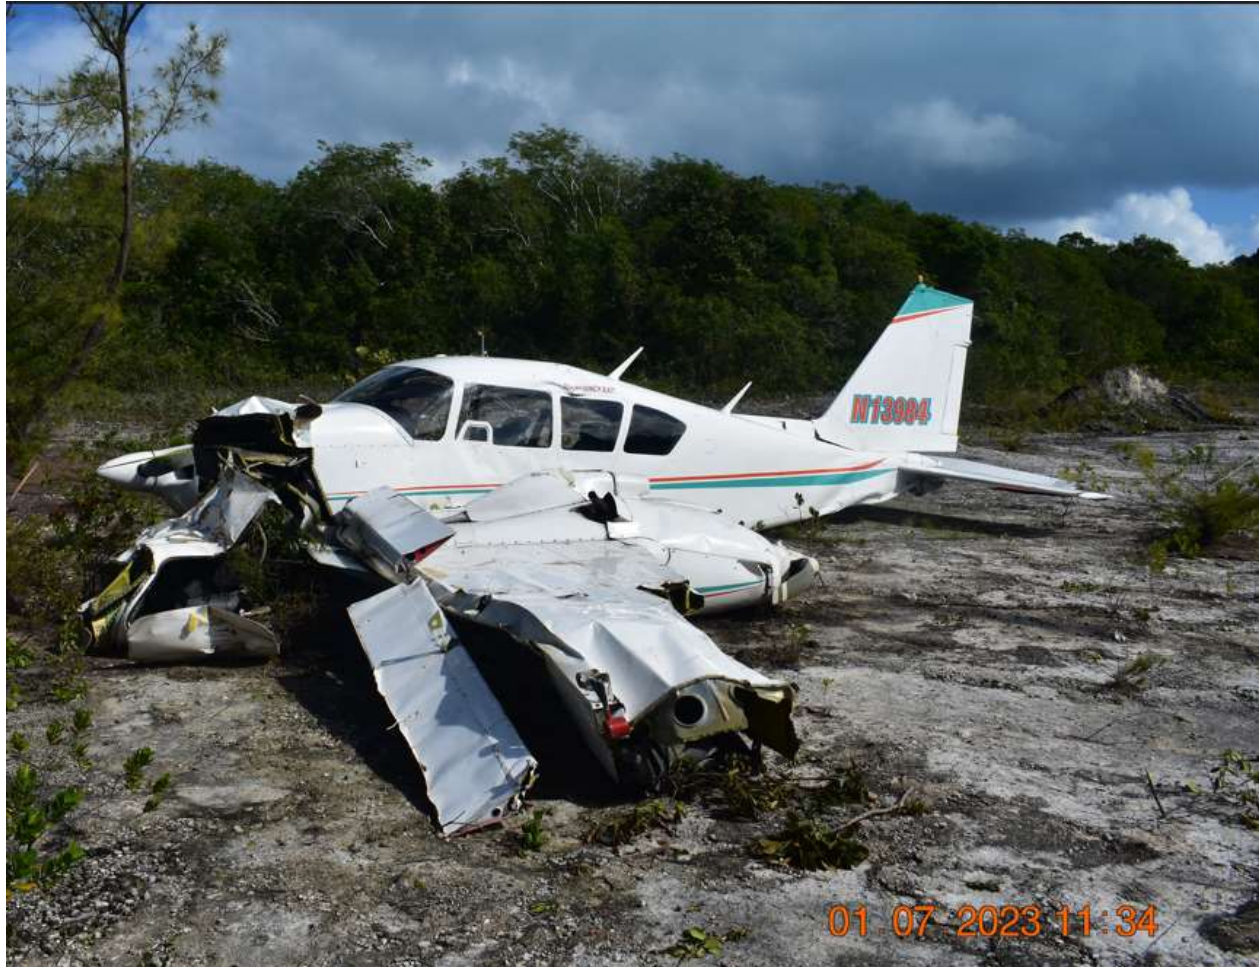
Fig. 1 Photo of N13984 at accident site

Crew Injuries Nil	Aircraft Damage Both wings, both propellers, aircraft nose, underside of fuselage
Passenger Injuries Nil	Aircraft Fire Nil
Ground Injuries Nil	Aircraft Explosion N/A
Total Injuries Nil	Latitude, Longitude 23°33'16.70"N 75°51'48.80"W

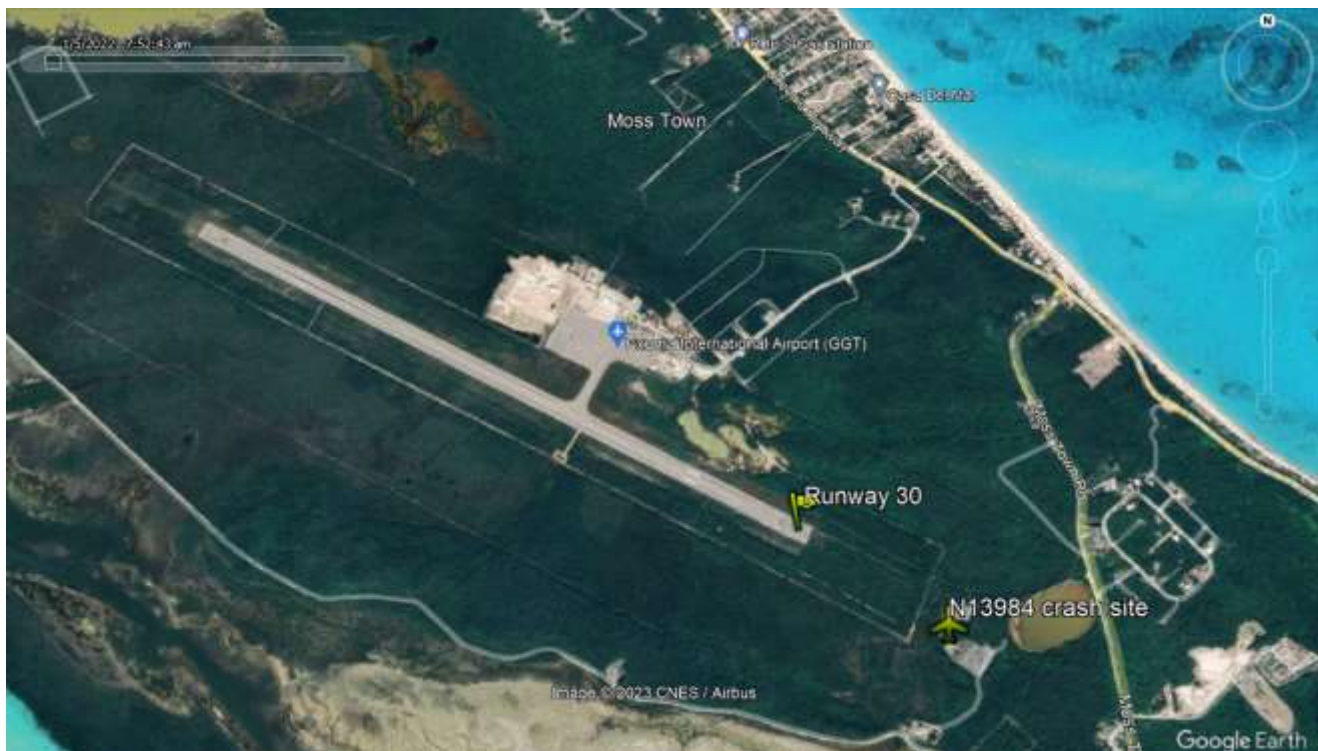
Fig. 2 Google Earth imagery of crash site

On the 7th January 2023, a team of investigators were dispatched to the accident site to conduct the on scene portion of the investigation. The aircraft point of rest was at coordinates 23°33'16.70"N 75°51'48.80"W at a distance of approximately 2,020 feet (0.38 NM) from the threshold of runway 30 at MYEF.

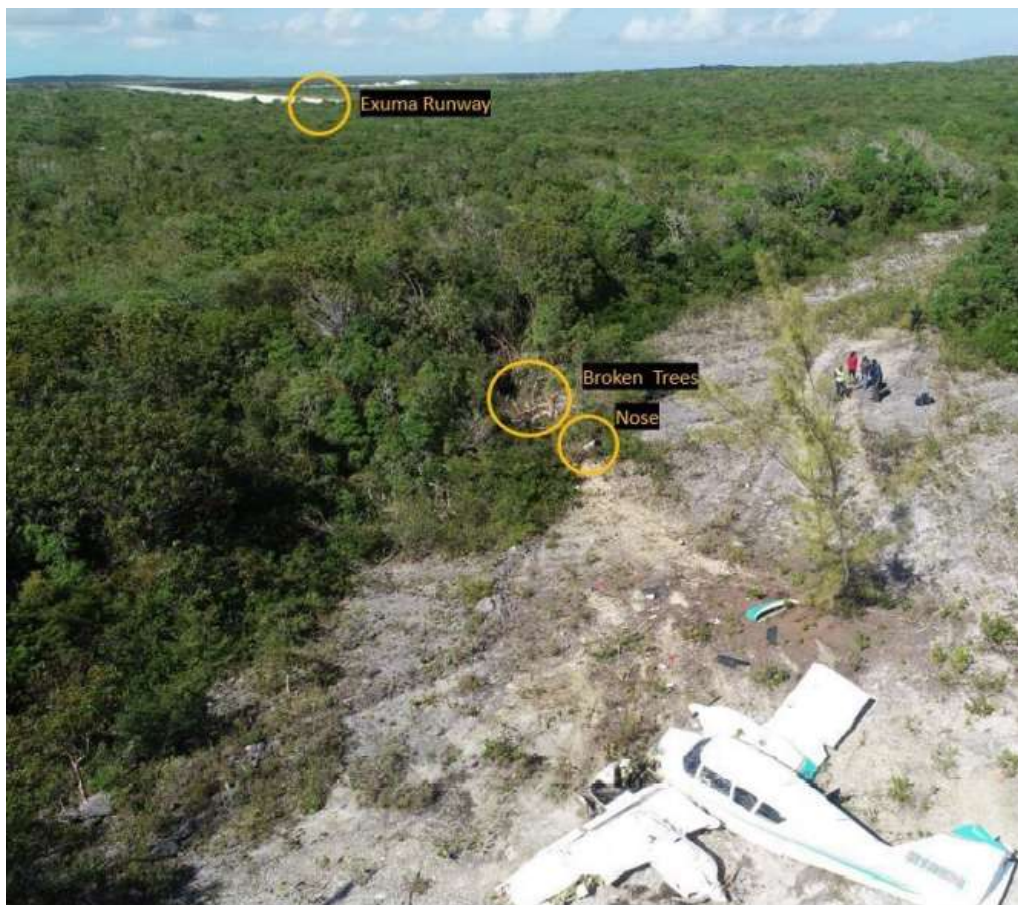
The first point of impact with trees (left wing) was measured to be approximately 1,820 feet from the threshold of runway 30 and the aircraft travelled for an additional 200 feet before coming to rest. Along the flight path that the aircraft travelled (heading of approximately 130°) through trees and into the cleared area of land, a debris field was observed with various aircraft components.

The left wingtip of the aircraft was observed at a distance of approximately 194 feet from the aircraft. The next piece of debris was the aircraft nosecone at a distance of approximately 60 feet from the aircraft, and the right wingtip a distance of approximately 25 feet from the aircraft (measurements taken from aircraft forward bulkhead).

The left wing of the aircraft received substantial damage and was detached from the fuselage at the wing chord, resting in an inverted position with one of the propeller blades bent extremely aft and the aileron partially separated from the trailing edge. The right wing was heavily damaged with a crumpled leading edge, but remained attached to the fuselage with one of the propeller blades bent aft. The nose section of the aircraft was separated and crumpled, resting in front of the inverted left wing of the aircraft. Impact damages were also observed to the tail section of the aircraft.

Fig. 3 Drone photo of accident site (c/o Flytec)
