AIRCRAFT ACCIDENT REPORT

AAIA# AO-2022/0018

Piper Navajo PA-31-310

N711JW

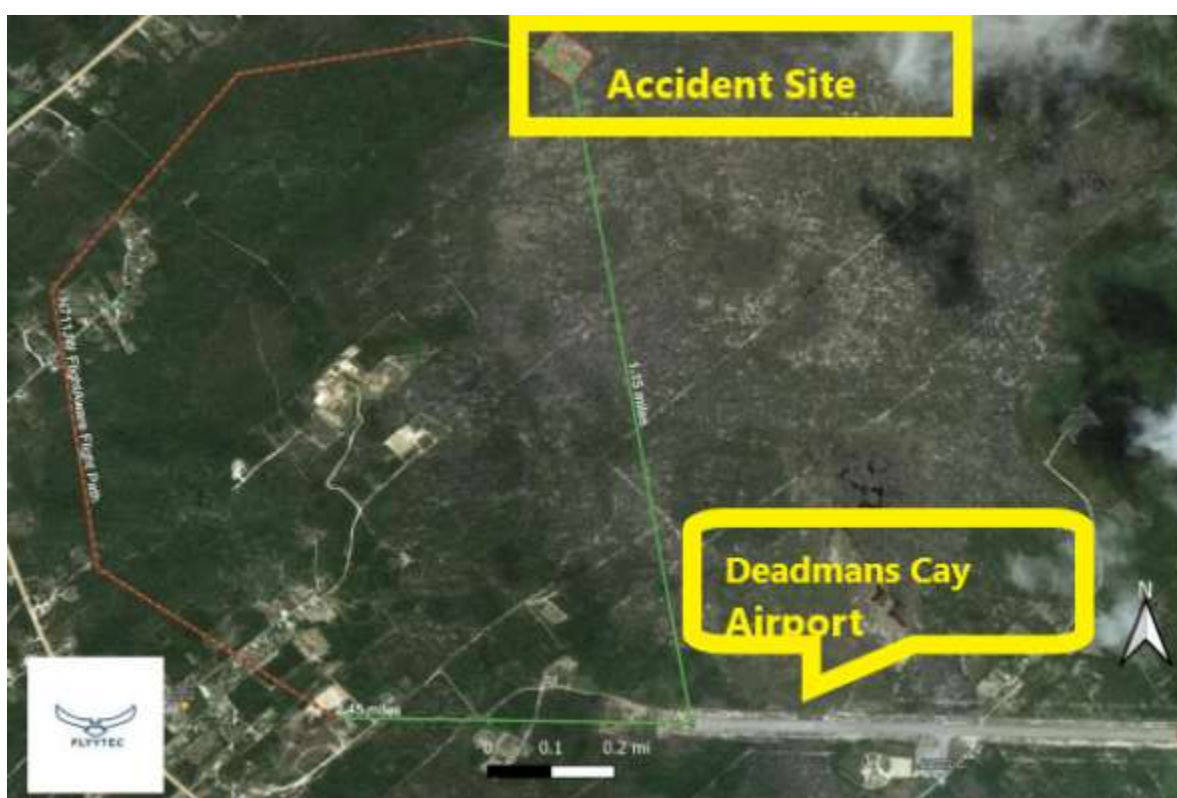
The aircraft, from the point of the take-off roll, travelled approximately 2 nautical miles and came to rest in dense brush approximately 75 ft. from point of first contact with trees. The center of the aircraft was documented at coordinates N023° 11' 44" and W075° 06' 10". The debris field appeared to be contained in an area with a radius of approximately 100 feet from the center of the fuselage.

The right wing of the aircraft appeared to have made first impact with the trees. Shortly thereafter, the fuselage of the aircraft and the left wing made contact with the ground and surrounding trees. The density and thickness of the trees in the area where the aircraft crashed, limited the distance the aircraft traveled after impact with the surface.

The extent of damages sustained by the aircraft were substantial. The left side of the aircraft appeared more heavily damaged than the right side, which indicated that the left side of the aircraft was the first portion of the aircraft to make contact with the surface at high speed. The aircraft travelled a distance of approximately 75 ft. from the initial impact point before coming to rest.

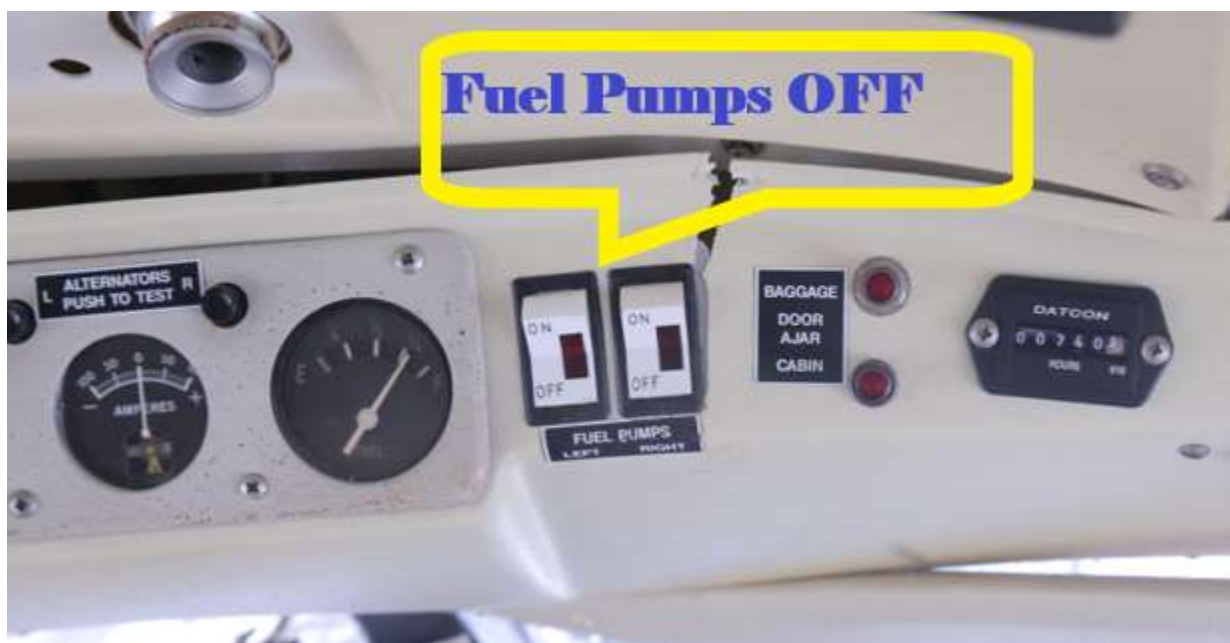
Of interest during the documentation of the control switches on the flight deck the following were noted:

- Left fuel pump: off
- Right fuel pump: off

About two gallons of liquid was observed within the inboard fuel cell and was determined to contain water when tested with water finding paste. It could not be determined whether the water present in the fuel cell contributed to the accident, or if the abundance of water found was as a result of heavy rains post-accident.
