## C6-OFM Accident Preliminary Report

Location	Accident number
Black Point Airport (MYEB), Black Point, Exuma, Bahamas	OCC-2022/0031
Date & Time	Registration
17th October 2022 4:30 pm EST (1630 UTC)	C6-OFM
Flight Conditions	Injuries
Visual Flight Rules	Nil

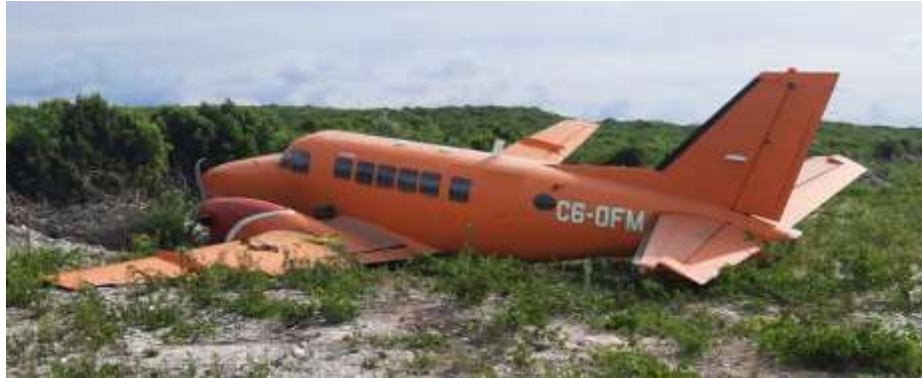
Reports received indicated that upon landing runway 11 at MYEB, there was a collapse of the left main landing gear which led to the aircraft veering off to the left side of the runway's centerline. It then travelled a distance of approximately 1,516 feet down the runway, at which point it exited the useable paved portion of the runway (left side), ultimately coming to rest in bushes after travelling an additional 265 feet.

The aircraft was oriented in a northerly direction (approximately 355°) almost perpendicular to runway 11/29 at a distance of approximately 50 feet from the runway's edge. There were damages observed to the left wing, left propeller, and aircraft undercarriage including the pod. There were no reported injuries in relation to the occurrence.
