# Aviation Short Investigation Final Report

System Component Failure – Non-Powerplant  
(SCF-NP)

Beech B99, C6-OFM

**AAIA Aviation Occurrence Investigation**  
**Report # OCC-2022/0031**

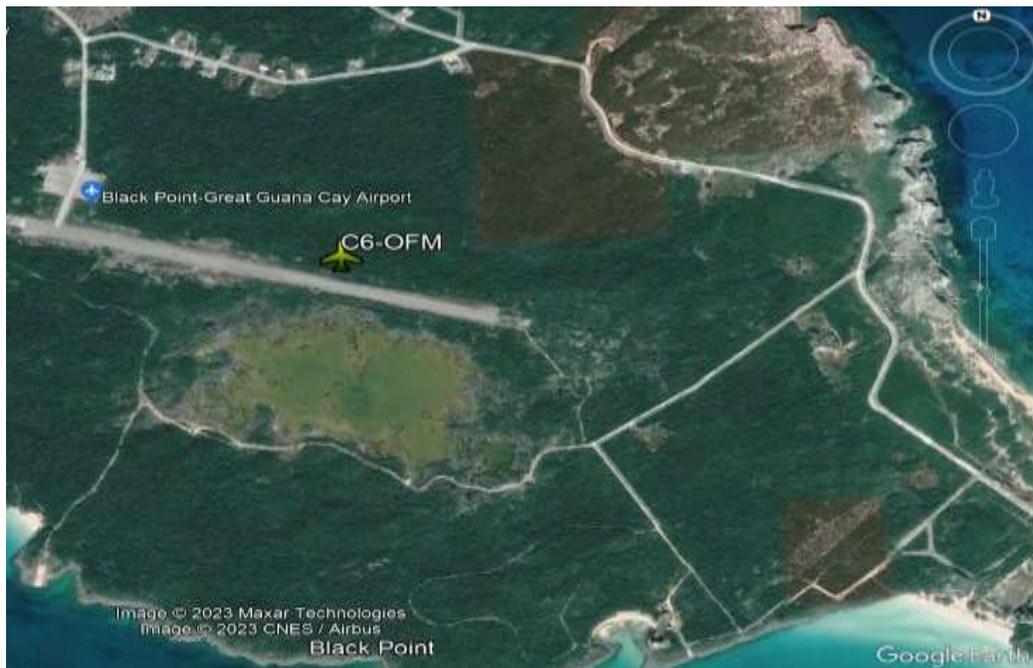
Investigations indicated that upon landing runway 11 at MYEB, there was a collapse of the left main landing gear which led to the aircraft veering off to the left side of the runway's centerline. It then travelled a distance of approximately 1,516 feet down the runway, at which point it exited the useable paved portion of the runway (left side), ultimately coming to rest in bushes after travelling an additional 265 feet.

The aircraft came to rest at coordinates 24° 05'21.20"N 76°23'48.10"W And was oriented in a northerly direction (approximately 355°) at a distance of approximately 50 feet from the runway's edge. There were damages observed to the left wing, left propeller, and

**Fig. 2 Google Earth Imagery of Crash site at MYEB**

aircraft undercarriage including the pod. There were no reported injuries in relation to the occurrence.

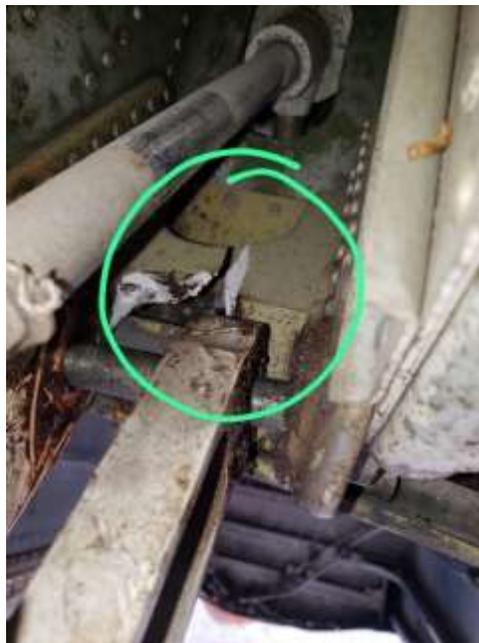
Post-accident, upon inspection of the left main landing gear, it was discovered that there was a fracture in the left main landing gear drag brace support fitting.

*Fig. 3 Left main landing gear drag brace support fitting*

During the course of the investigation, upon assessment of previous reported landing gear incidents involving this specific make and model aircraft within the operator's fleet, associated with the landing gear drag brace support fitting and accompanying parts, it became evident that the required maintenance inspection interval of 200 hours within the approved maintenance inspection program may not be adequate.

- 9) Post-accident inspection revealed a failure of left main landing gear drag brace support fitting.
- 10) The Black Point Airport (MYEB) was void of runway markings as required by applicable Bahamas CAR AGA Regulations.

The AAIA has determined the probable cause of this accident to be system component failure – non powerplant (SCF-NP) – left main landing gear drag leg support fitting.

Subsequently, in a letter dated 30<sup>th</sup> November 2022, the CAA-B issued the following to the Operator: ***In accordance with CAR OPS1.890 (a) (5) and in the interest of safety, the Authority require the amendment of Flamingo Air Limited Approved Maintenance Program FL/B99/AAIP for incorporation and implementation of the element of Beech 99 Maintenance Manual 05-50-00 (2) Inspection After Hard Landing; (2) Landing Gear; Inspections (a-h) every 25 hours of flight time to detect any fault and mitigate any failure of the main landing gear drag brace support, the drag brace assembly and attaching parts.***

The AAIA was in agreement with the measure utilized by the CAA-B, as it would seek to take a proactive posture by requiring the shortening of the inspection interval from 200 hours to 25 hours which would potentially provide an opportunity to identify the development of faults or signs of fatigue within the component.

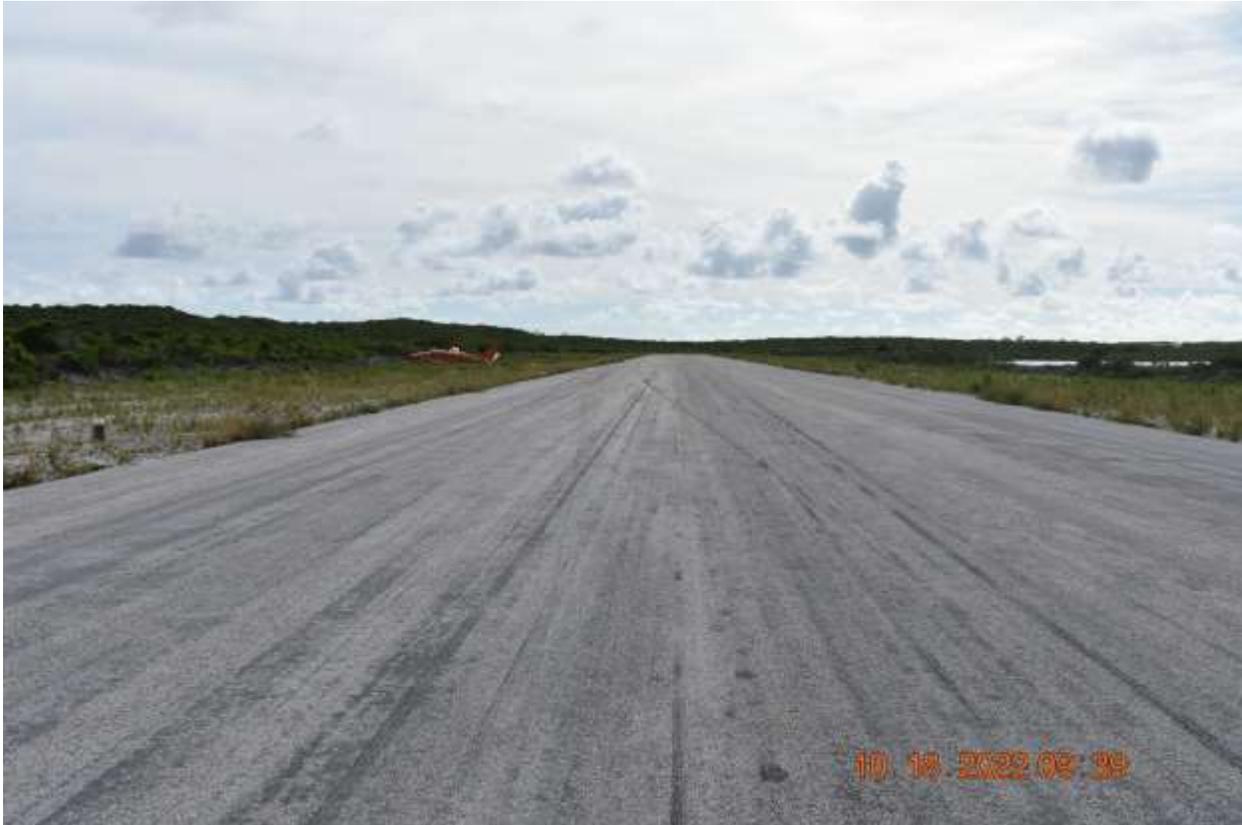
***Fig. 4 Runway 11 at MYEB***

Runway edge lights, runway end lights, and taxiway edge lights are installed at the aerodrome. The aerodrome is void of runway markings (runway threshold markings, runway designation markings, runway holding position markings, and runway centerline marking).

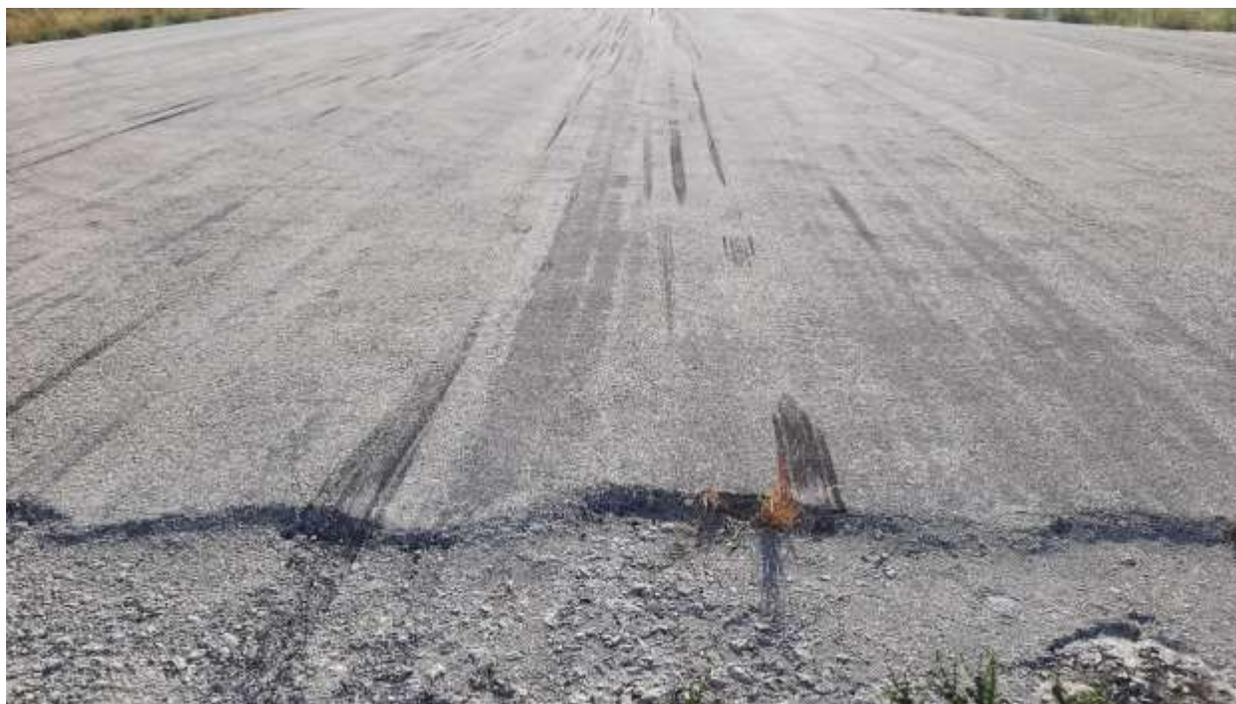
In review of several occurrences that would have taken place at the Black Point Airport (MYEB), Black Point, Exuma, Bahamas during the three (3) years prior to this accident, there were similarities seen in a few of the events with regard to pilots touching down prior to the paved usable portion of the runway, as evidenced by the presence of tire signature markings prior to the paved runway surface.

*Fig.5 Threshold of Runway 11 at MYEB*

The fact that these occurrences involved more than one operator, and aircraft of varying types, highlights the possibility that the common factor, which is the aerodrome, may have presented some deficiencies that are contributory.

As the MYEB aerodrome was void of any runway markings up to the time of this occurrence, and in consideration of the prior similar occurrences and the above mentioned regulations, the AAIA issued safety recommendation SR2022-002 to the Airport Authority of The Bahamas on 20<sup>th</sup> October 2022: ***The Aircraft Accident Investigation Authority (AAIA) recommends that, without delay, the Airport Authority implements the placement of appropriate runway markings at Black Point Airport (MYEB), including threshold markings that will aid pilots in landing operations.***

In a correspondence dated 14<sup>th</sup> November 2022, the Airport Authority presented to the AAIA, a corrective action plan (CAP) to address the deficiencies noted in safety recommendation SR2022-002. The CAP included the addition of runway threshold markings, runway designation markings, and runway holding position markings at MYEB.
