Short Investigation Bulletin

DATE: 6th November 2020
REPORT # AO- 20-000277
AIRCRAFT REGISTRATION: C6-EDD
INVESTIGATION STATUS: Completed

Aircraft Type and Registration:	PA23-250; C6-EDD
Year of Manufacture & Serial #:	1979, 27-7954042
Number and Type of Engine(s)	Two;
Type of operation:	Commercial
Information Source:	Field Investigation
Nature of Damage:	Damage to nose landing gear, aircraft main frame

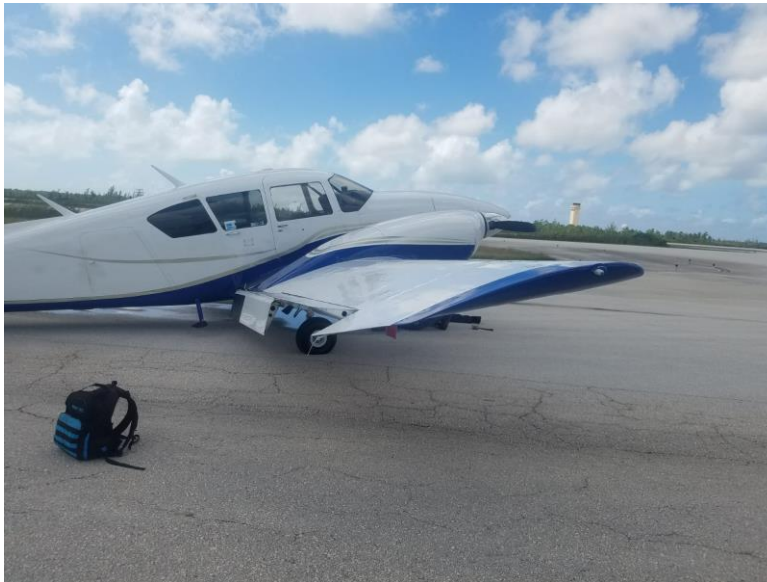
The on-demand commercial flight was preparing to depart MYNN enroute to the Grand Bahama International Airport (MYGF) with a total of four souls (1 crew, 3 passengers) on board. The pilot advised that while maneuvering in the area of Apron 5 and taxiing toward Taxiway Hotel (H), after falling in a pot hole, he felt the aircraft pitch forward and he subsequently realized that the nose gear had failed.
