Aviation Short Investigation Final Report

No Gear Landing

EMB110, C6-KMC

AO-19-000057

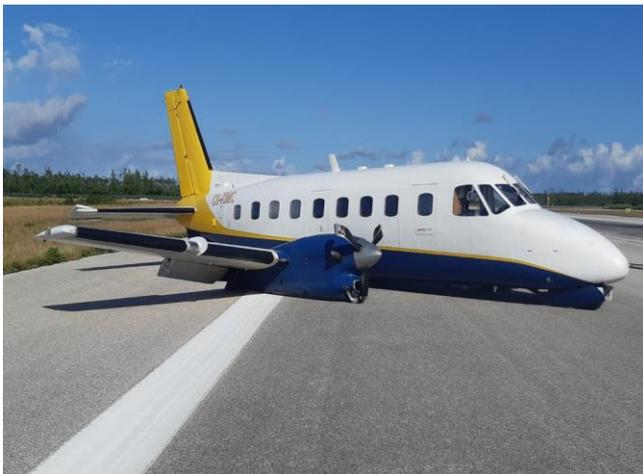
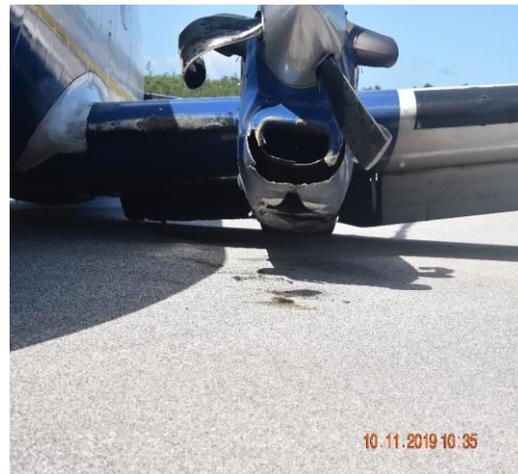
The aircraft travelled a distance of approximately 1,206 ft. from where it initially impacted the runway (based on pavement markings) before coming to rest. The majority of the aircraft remained on the paved, usable portion of runway 14. Damages were documented to both engines, propellers, lower engine nacelle, gear doors and bottom fuselage (forward and aft).

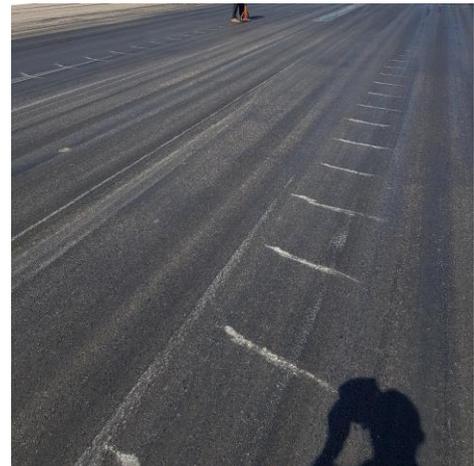
Post-accident investigation uncovered signature marks on the runway surface (propeller gouges and blue paint from the underside of the gear doors, underside of the fuselage and engine nacelle) and damages sustained to the lower fuselage and gear doors, which further indicated that the first parts of the aircraft to make contact with the runway were the propellers, followed by the gear door, engine nacelle and underside of the fuselage which is inconsistent with reports supplied by the crew that the gear collapsed after landing.

There were no tire marks attributed to the aircraft prior to, during or immediately after the propeller markings made in the runway surface.

Based on the evidence documented, the conclusion of the investigation team is that the aircraft made contact with the runway surface while the gear was not selected in the appropriate position for landing as required by their company's standard operating procedures and checklists.
