Aviation Short Investigation Final Report

Runway Excursion

EMB-110, C6-MIC

Governors Harbor, Eleuthera, Bahamas, 9th January 2018

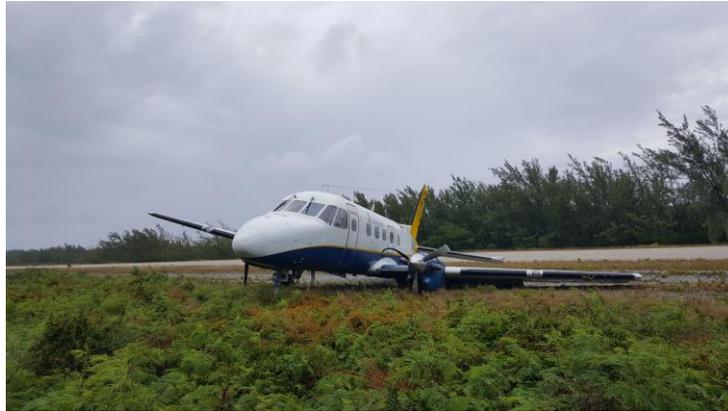
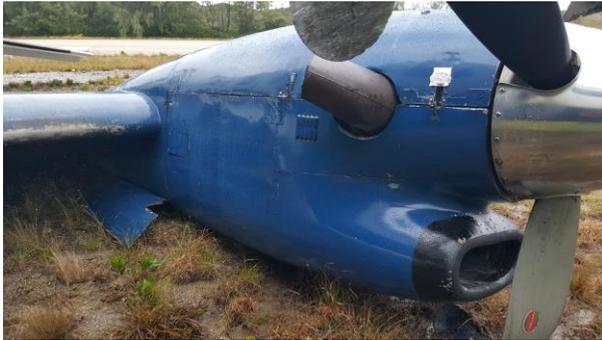
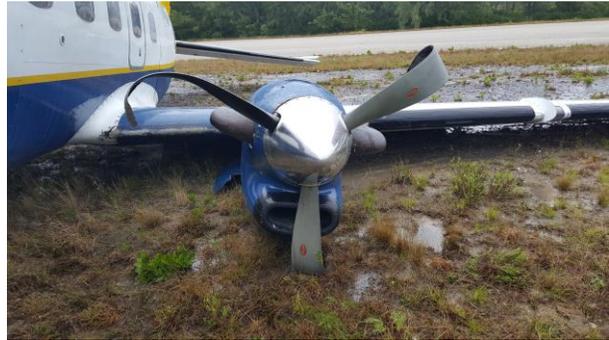
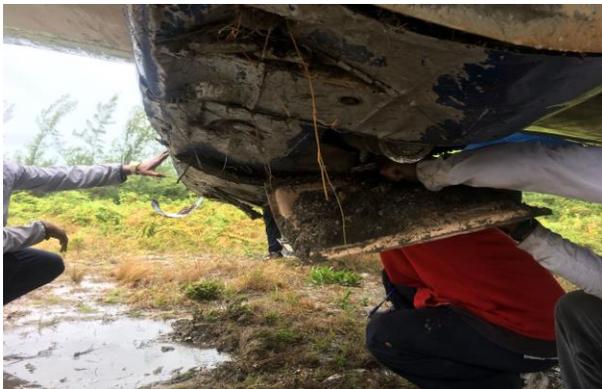
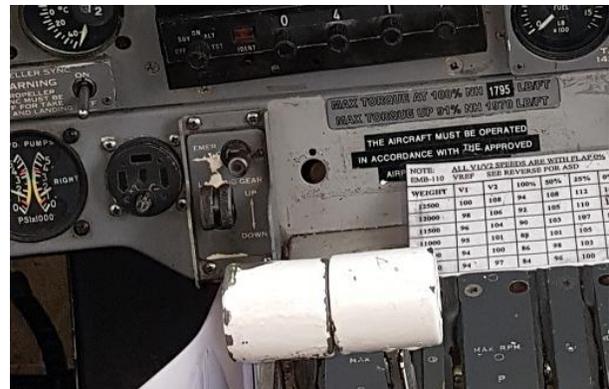
On 10th January 2018, investigators from the AAID along with personnel from the Airport Authority (AA) were dispatched to the scene to investigate. Remnants of the thunderstorms, including persistent

rain remained in the area at the time of investigators arrival and throughout the onsite investigation process.

During the documentation of the aircraft and the flight deck, the landing gear selector switch was observed in the “Up” position, despite the right main and nose gear being fully extended and locked in position. While the investigation did not uncover any other abnormalities, which may have contributed to the collapse of the left main landing gear, investigations uncovered other safety and security related concerns that required attention.
