AVIATION OCCURRENCE BULLETIN

DATE: 20TH AUGUST, 2019
REPORT # AO-19-000008
AIRCRAFT REGISTRATION: N6376V
INVESTIGATION STATUS: COMPLETED

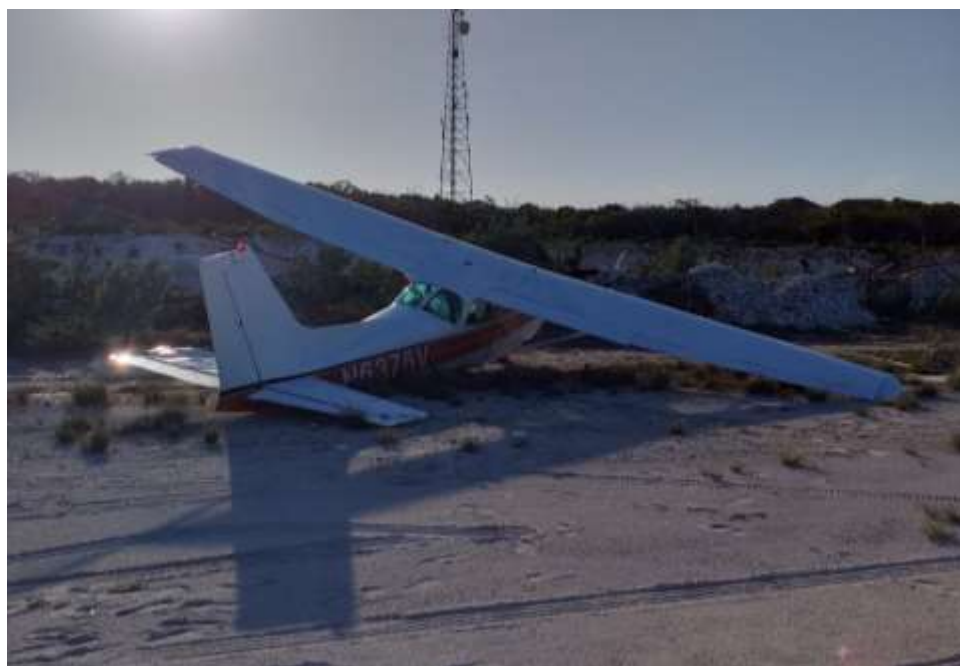
During aircraft landing and rollout, there was a collapse of the right main gear that resulted in the aircraft exiting the runway and impacting perimeter fencing.

The aircraft received extensive damages, including to its propeller, nose and main gear, and both wings. There were no injuries reported in relation to this accident. The weather at the time of this occurrence was visual meteorological conditions and not a factor.
