Aviation Short Investigation Final Report

EMBRAER: ERJ 190-100 IGW

N273JB

NASSAU, NEW PROVIDENCE, Bahamas, on March 25th 2016

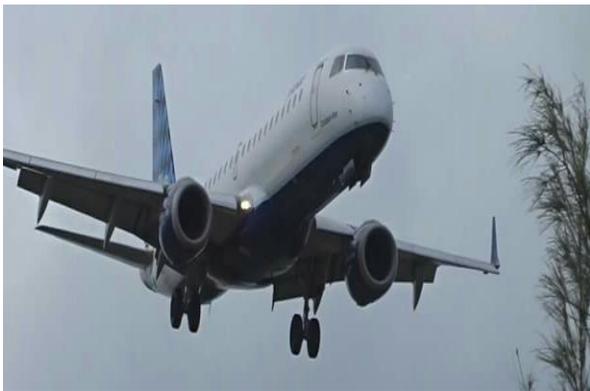
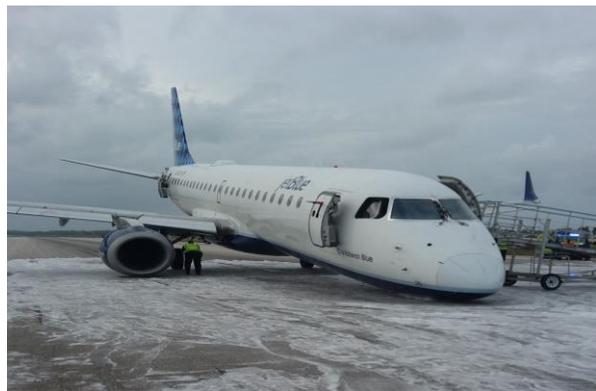
The aircraft nose gear was found jammed in the wheel bay. According to the flight crew the aircraft nose gear made an unusual sound when the gear handle was placed in the extend position. Main gears showed down and locked. Nose gear showed in transit. The aircraft circled for a while to burn off the excess fuel; upon landing the under lying nose structure was damage.

The Air Accident Investigation Department has determined the probable cause of this accident to be system component failure or malfunction within the nose landing gear operating system. Analysis conducted uncovered that the nose gear was not centered during its transit to the down position, causing the gear to become jammed and never fully extended.

Service Bulletins for Performed Rigging, Service Bulletin to modify NWSCW, as well as software upgrades.

With regard to this particular occurrence, the AAID deems it unnecessary to issue associated safety recommendation(s) as there already existed, processes to mitigate against such accidents in the form of Service Bulletin 170-32-0076; SB 190-32-0063 – Rigging (nose steering) and Service Bulletin 170-32-0082; SB 190-32-0070 – to modify Nose Wheel Sensor Control Module.
